*Ryedale Archaeology Services Ltd*

**Archaeological Report on  
St Helen's Church South Wheatley**

Survey work and report undertaken by  
Stuart Harrison F.S.A.

July 2013

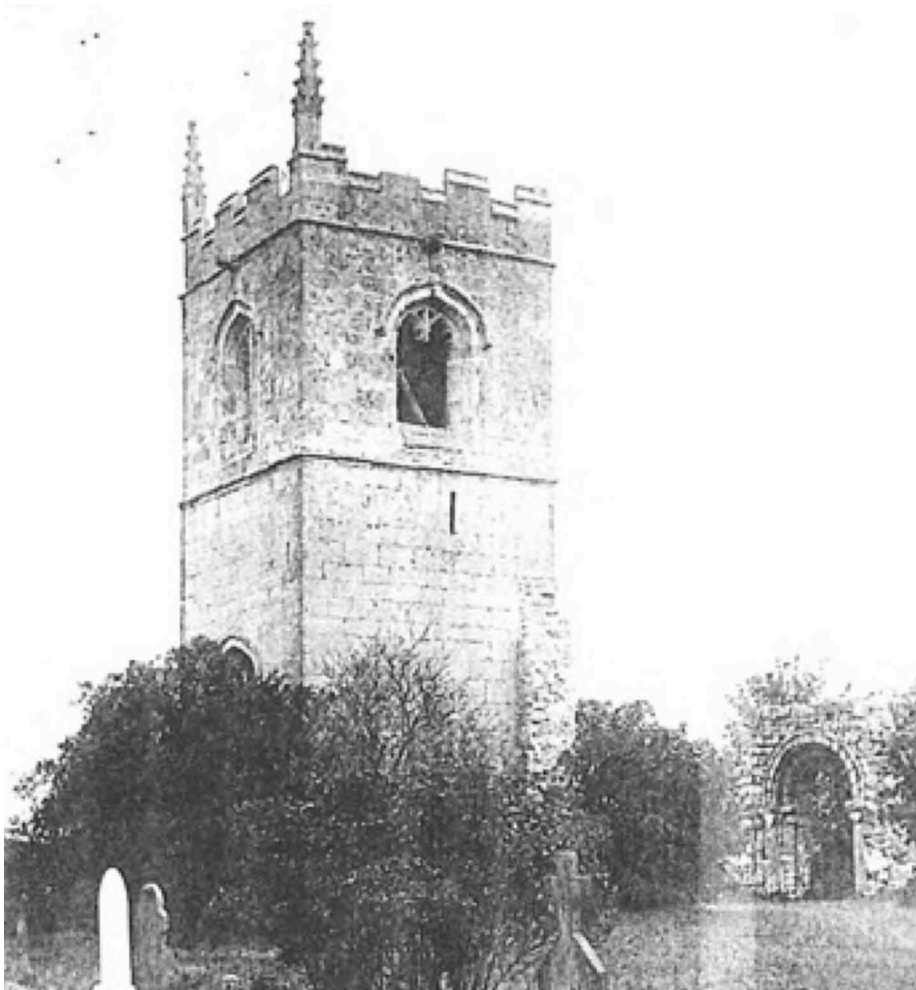
Above the church around 1910- two pinnacles & mullion lost

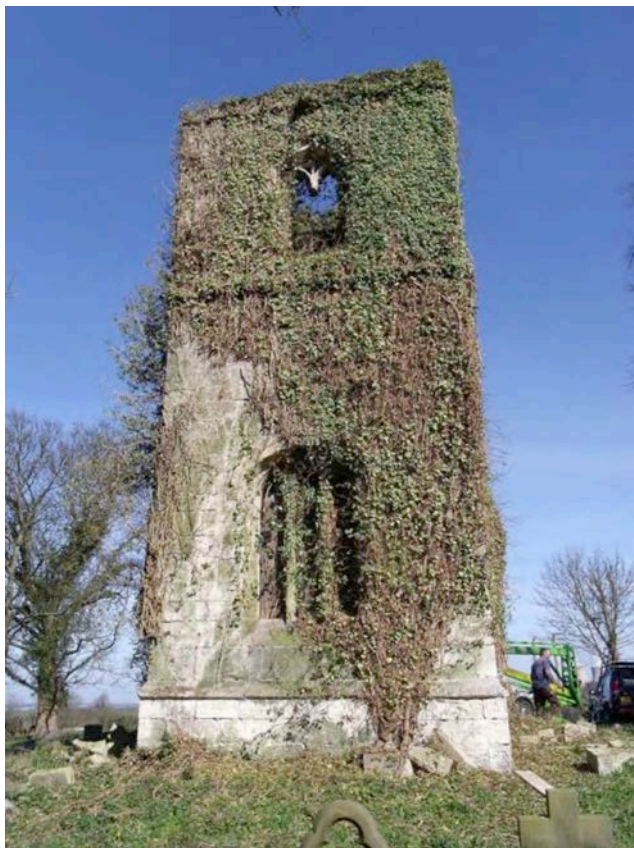
The ruin had become dilapidated through neglect and the growth of ivy. Most of the tower was engulfed by huge amounts of ivy to the extent that little masonry was visible. It had lost all trace of the parapets, which had either collapsed or more likely had been pushed off the top over the years. Similarly the window mullions had gone leaving the tracery they supported hanging in space. The idea that masonry was deliberately pushed off the tower is supported by the fact that two of the windowsills had also gone. It seems most unlikely that these would have simply fallen out as a natural part of the decay process. A spiral staircase in the south-west corner formed the original access to the upper parts and roof of the tower. Locals visiting during work at the site told how when they were children they had been able to climb to the top of the tower and play in the stair turret. This shows clearly that access to the upper parts of the tower had been easily available in the past.

The north arcade pier had also disappeared except for its base which is much decayed. The chancel arch was also covered in ivy and on the verge of collapse. Both the chancel arch and the tower had lost the pointing in the mortar joints which was letting in water and advancing the decay process. The mason had to dismantle and reset some blocks of the upper parts of the tower forced out of alignment by the action of ivy roots, water seepage and freezing conditions.

Above the tower covered with ivy growth

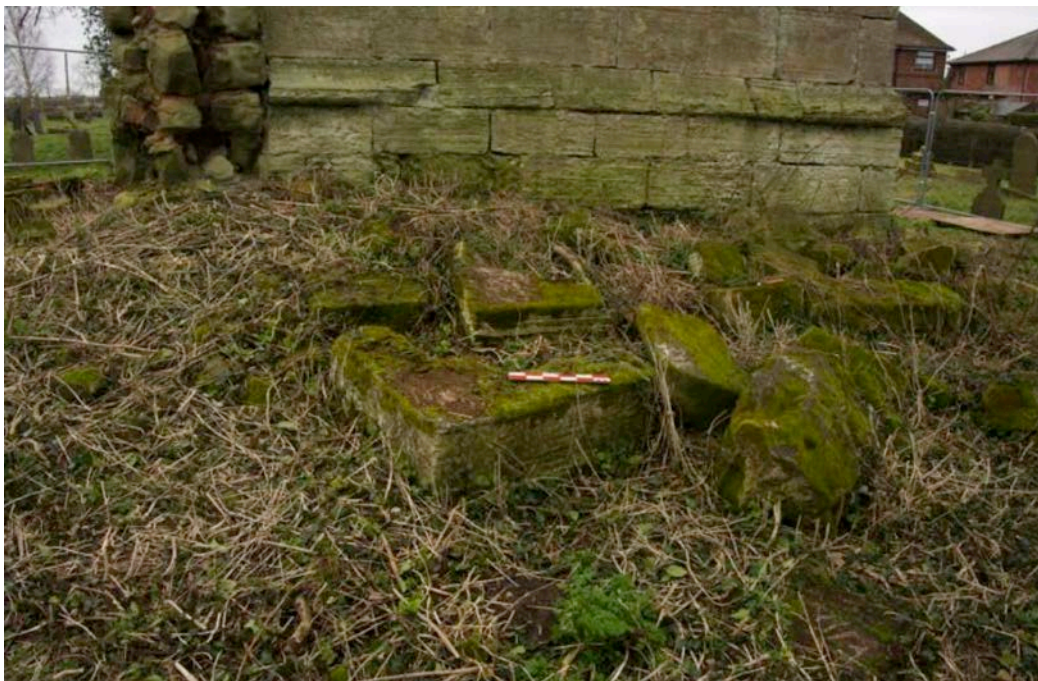
Around the base of the tower and chancel arch were piles of masonry from the fallen parapets and other features. The archeological brief was to sort out this material with a view to recovering stone that could be reused during the conservation works to the upper parts of the tower. Much grass, ivy, shrubs and other vegetation had grown up around these piles of stone and it was uncertain how much material actually survived, though some very large blocks could be seen.

Above heavily overgrown piles of stone set against the tower base

The methodology adopted to sort the material was to remove the vegetation and release each block of stone from the pile. Each one was then moved away from the tower but keeping it on the particular tower side of the location where it was found. This enabled four discrete assemblages to be established. In practice it rapidly became apparent that stones were stacked on each other in a careful fashion and were not where they had fallen from the tower. All stones

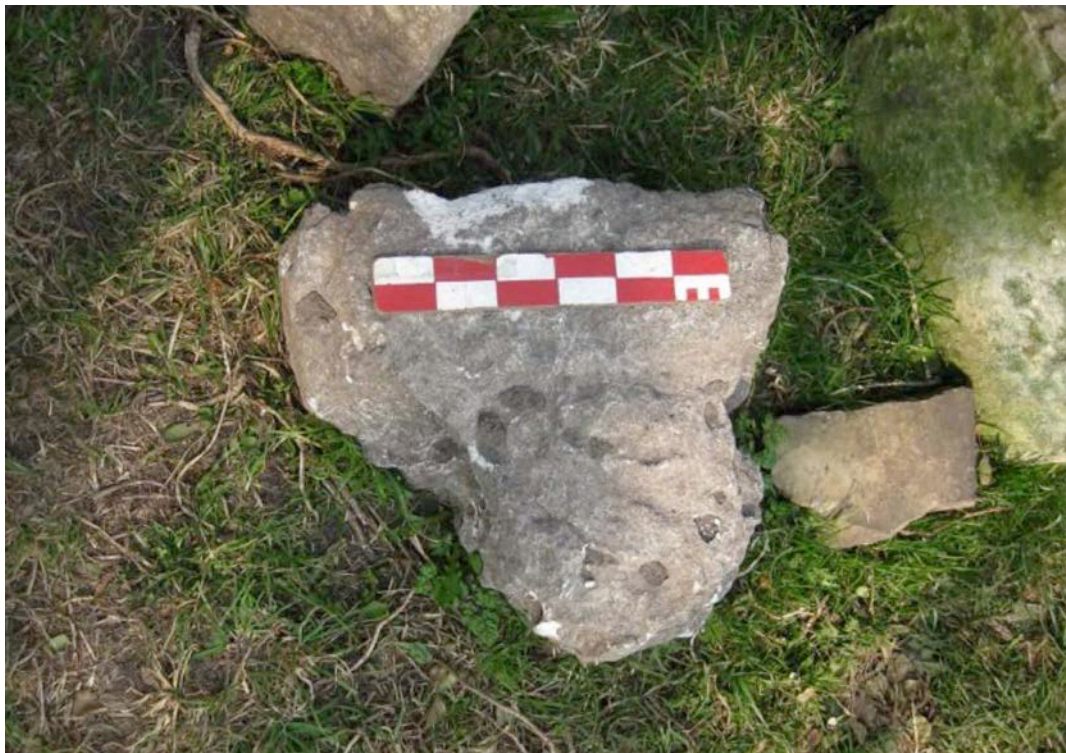
earlier repairs was observed in the form of hard cement pointing and making up. This was apparent in the middle of the south face where packing stones had been inserted to fill a void in the coursing that had formerly contained a projecting carved waterspout support. Examples of these remained in situ on the west and north sides- the east side did not have such a projecting support. Fortunately the missing example from the south wall, covered with worn carved foliage, had already been identified amongst the loose stone and it proved possible to reinstate it during the conservation work. It had broken from its tailstone in the wall core and fallen off. Earlier repairs had patched the hole where it had been located.

Above foliate waterspout support fallen from south side of the tower parapet stringcourse

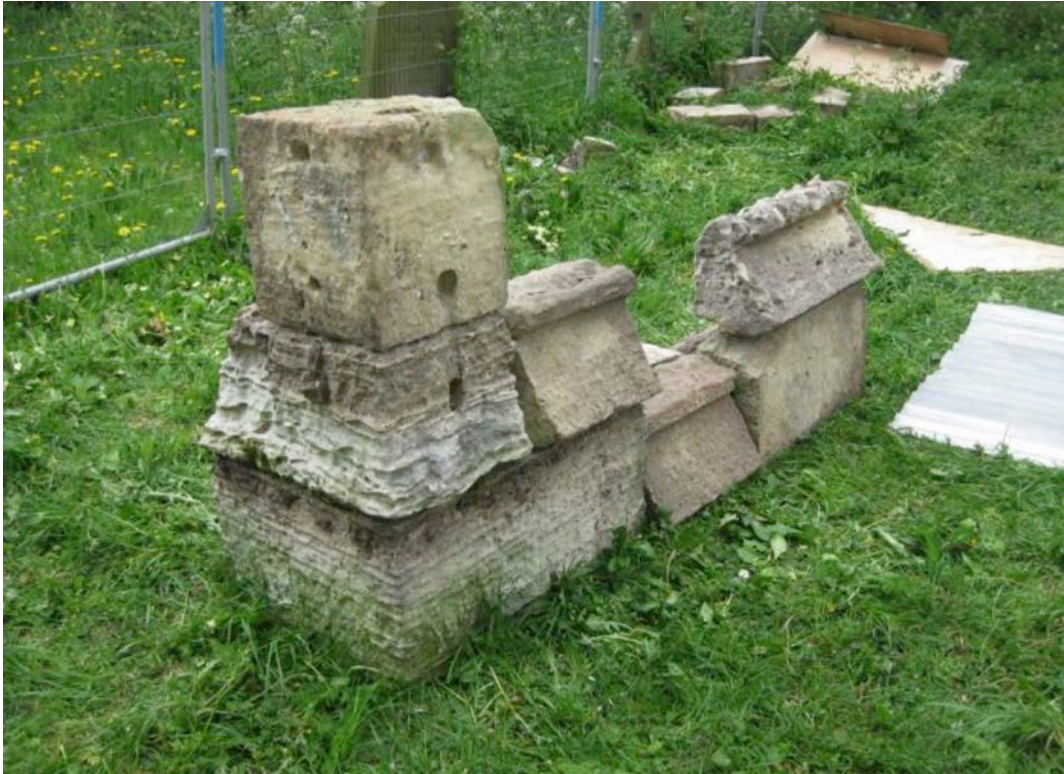
Above south-west corner assemblage showing taller corner L-shaped block, moulded upper section for crenellations and corner base block for pinnacle. Note holes for face cramps.

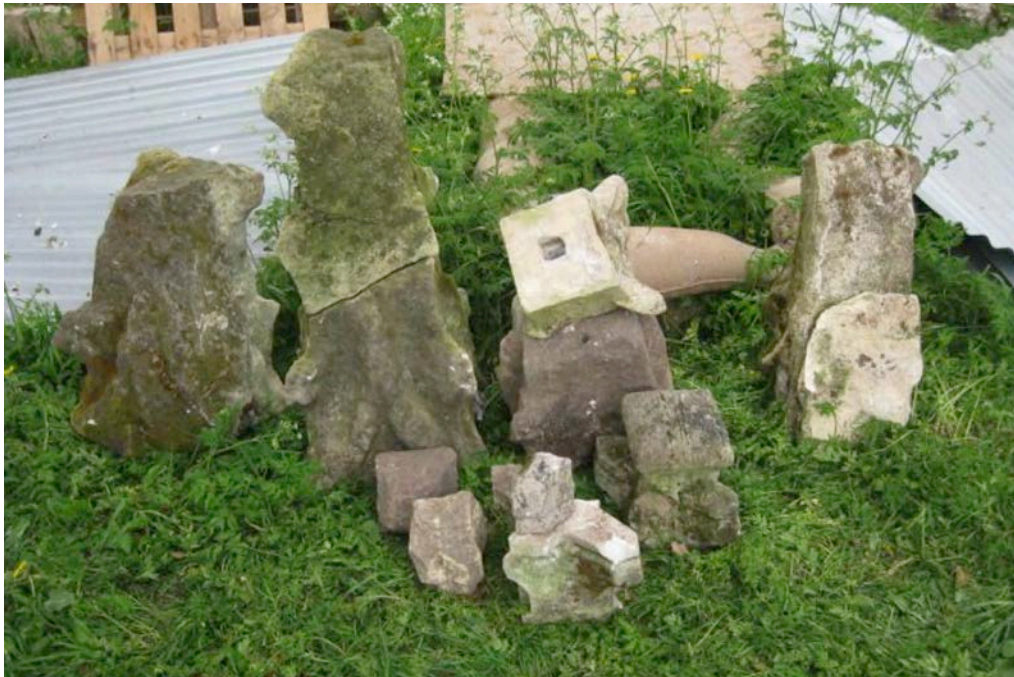
Above the collected pieces of the pinnacles

The reinstatement of the masonry was undertaken by the contractors following the guidance given in the reconstruction drawings of the parapets and the relevant assemblages of material on the ground. Though all four pinnacles survived and a fifth in a different stone that may be a replacement, they were too damaged to be replaced on the tower without substantial reinforcement.

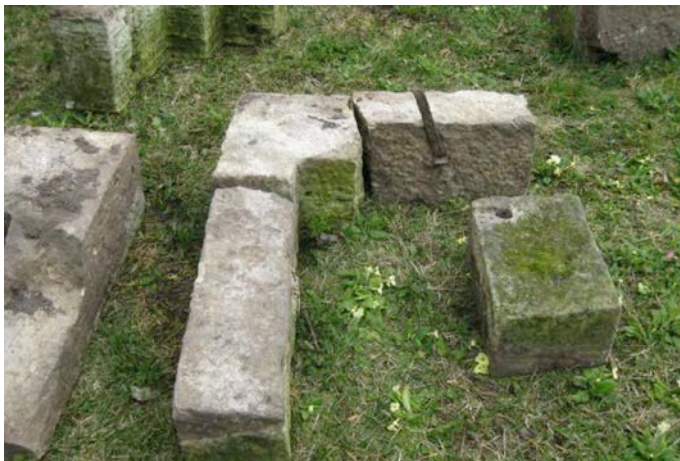
Sockets in the corner blocks showed that iron face cramps had been leaded into the blocks. These were set vertically or at a slight angle and spanned the horizontal joints, rather like large staples. Some remained attached to the stones but most were lost. They are likely to have been a later, possibly 18<sup>th</sup> or 19<sup>th</sup>-century addition, to reinforce the structure, rather than an original feature.

Left L-shaped corner block with iron cramp in situ

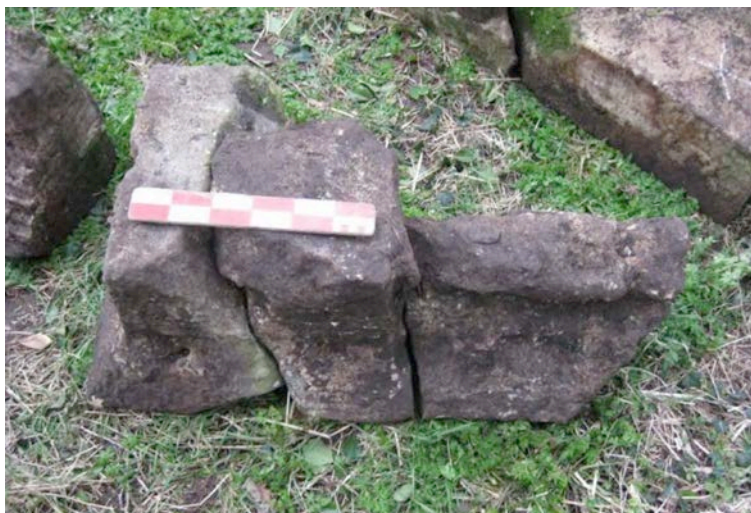
The surviving stones showed a considerably variety in completeness. Whilst some were completely intact others had lost sections through falling from the tower. In some cases the blocks had broken into several pieces but through careful observation it proved possible to reunite many broken pieces so that they could be reused.

Left three broken stones re-assembled from upper corner parapet section

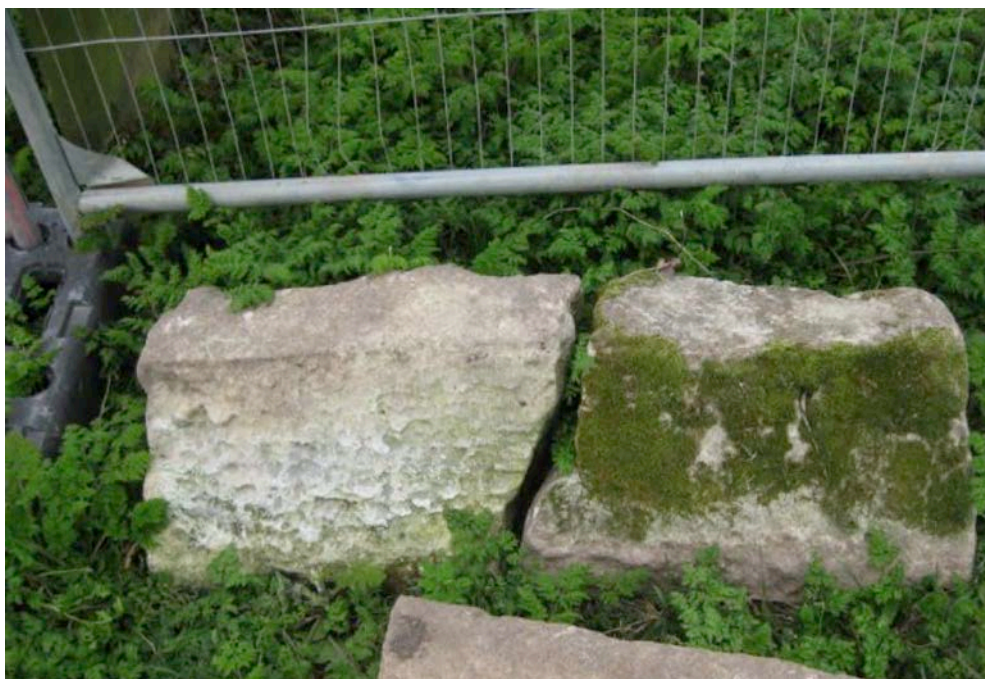
In addition to the tower parapets two of the windows had lost their windowsills. These were formed of two sections of stone, a sloping base sill and an upper chamfered sill with a central mullion seating. One window had only lost the latter stone but in the other both sections had been lost. Careful searching of the material enabled all three lost stones to be relocated, though some pieces were broken into several sections. These were successfully reinstated and new timber mullions provide to support the tracery. Amongst the loose stone one fragmentary mullion had been identified but this was too damaged and too short to be reused.

Below lower section of windowsill

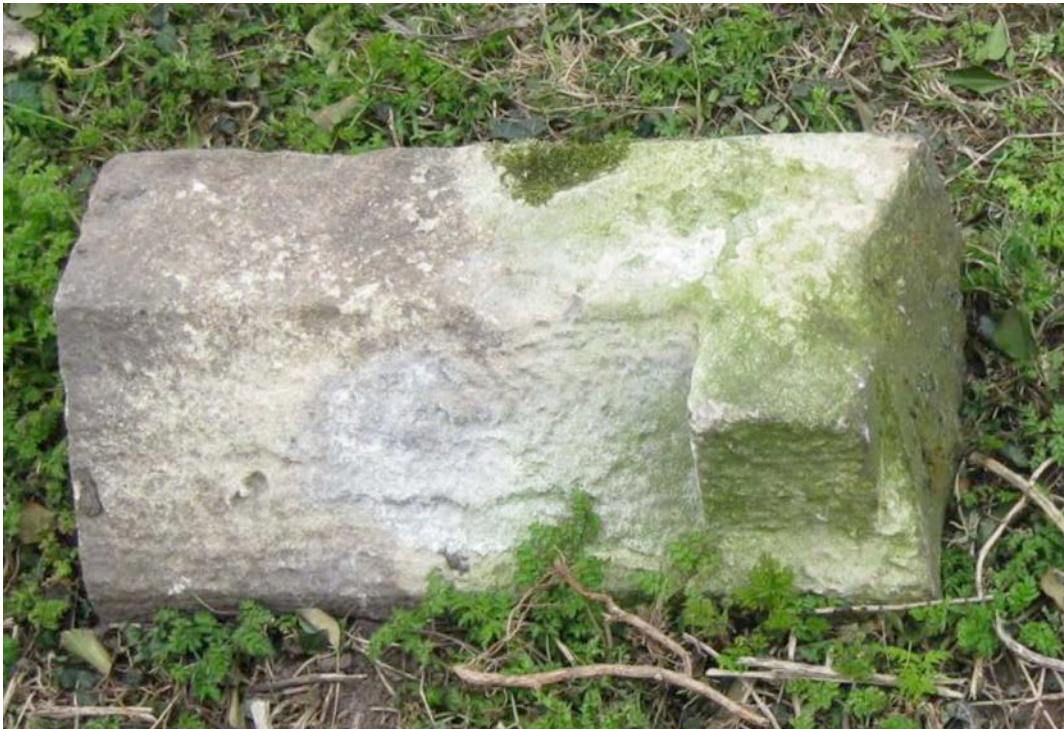
Above upper section of windowsill with mullion seating
