# **CHURCH OF ST ANDREW, SKEGBY, NOTTINGHAMSHIRE:**

**ARCHAEOLOGICAL MONITORING**

**Contractor Project Code: CAK.1**

**Report Number: 016/2026**

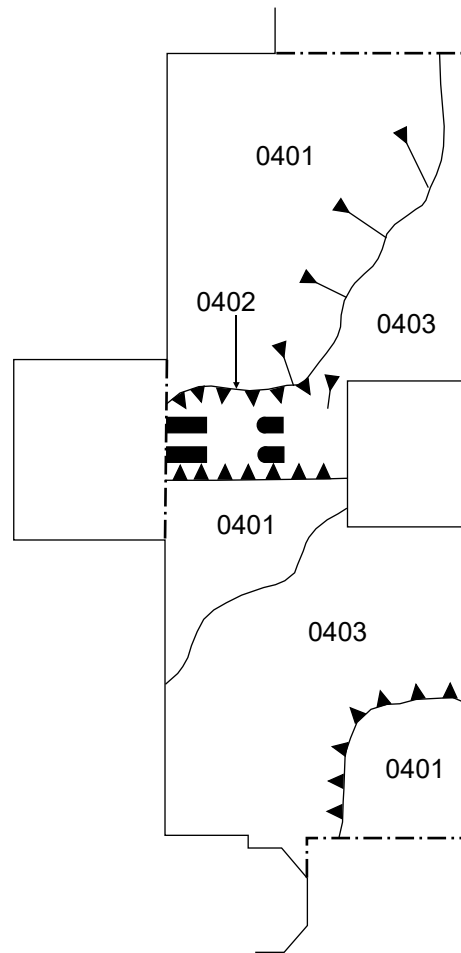
CAK.1 Church of St Andrew, Skegby, Nottinghamshire.  
Figure 9: Area 04 post excavation plan.  
Scale 1:50 at A4.

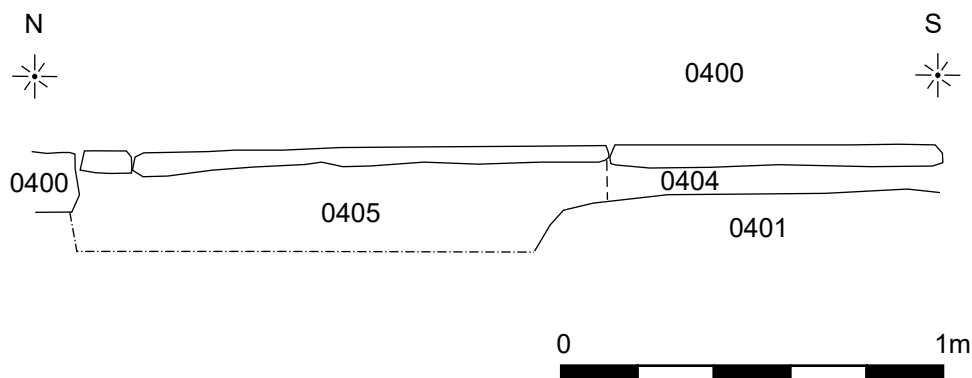
- 5.3 At the west end of the nave subsidence has been an issue relatively recently with 0201 slumping, becoming 0201a, upon which new parallel brick walls 0205 were built to support the pews (Figure 5). Over the subsidence loose rubble 0204, which contained a single skeletal fragment, had been deposited. It is possible that at this time the heating system failed as much of it was either taken out, sunk into a void below the church or a mixture of the two and infilled with light reddish brown sand 0207 and 0403. The flags in the slumped area had been reset and bonded with grey concrete 0405.

CAK.1 Church of St Andrew, Skegby, Nottinghamshire.  
Figure 10: Area 04, south end, west facing section through subsided floor.  
Scale 1:20 at A4.

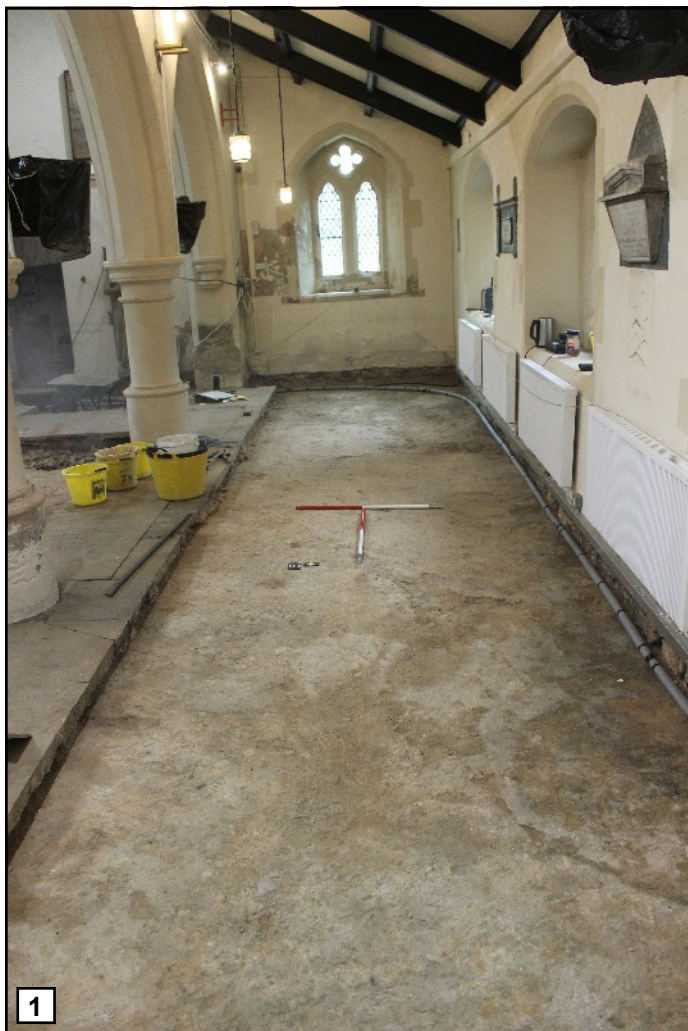
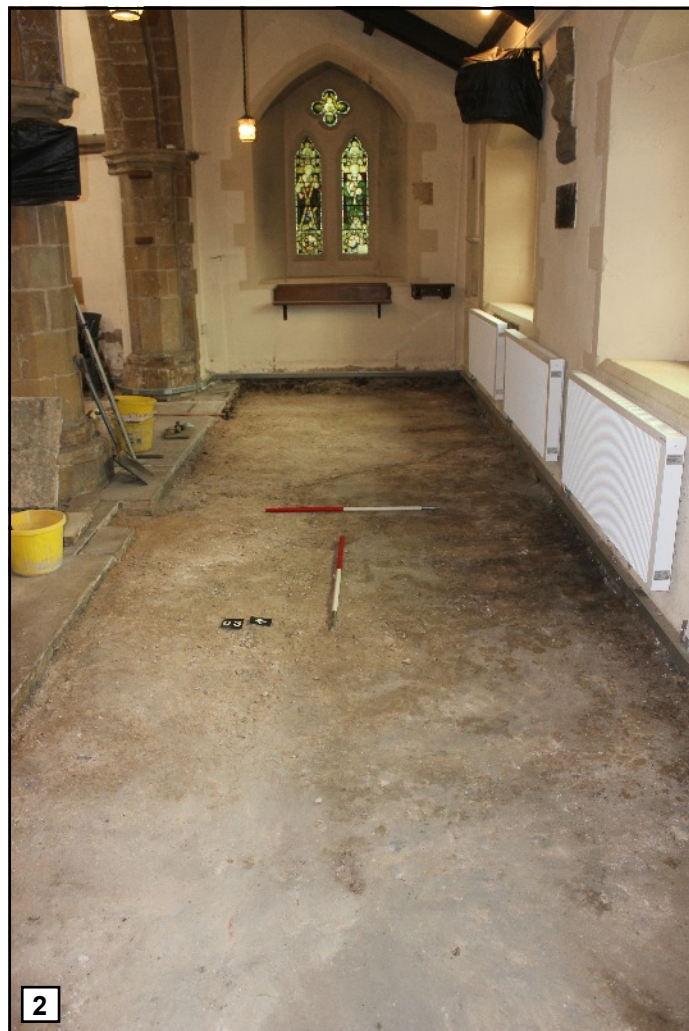
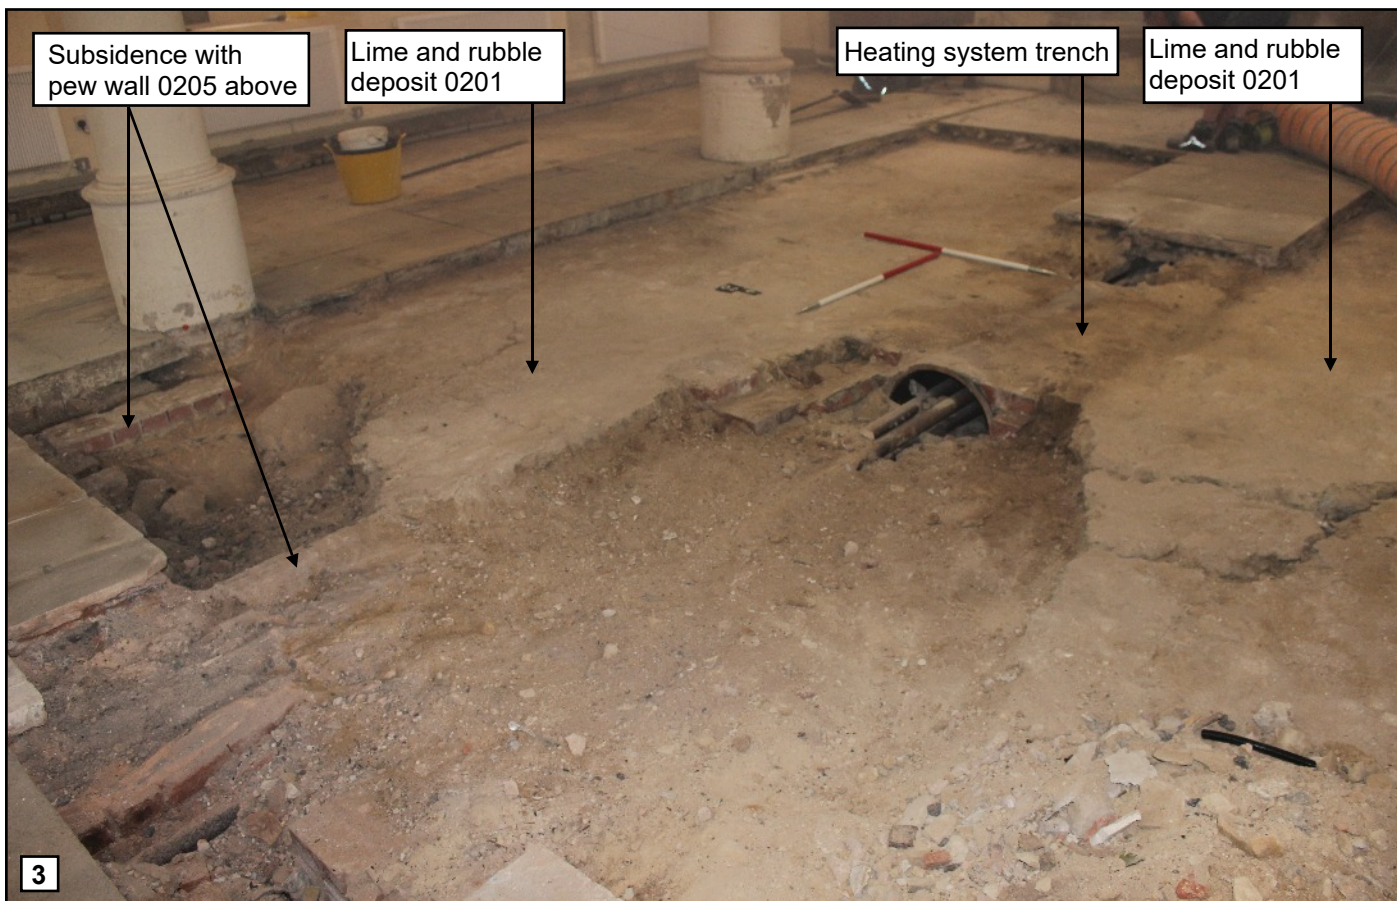
**Plate 1:** Lime mortar and sandstone deposit 0102 exposed in Area 01, the north aisle, viewed looking west.  
**Plate 2:** Lime mortar and sandstone deposit 0201 exposed in Area 03, the south aisle, viewed looking east.  
**Plate 3:** General post excavation view of Area 02 within the nave, viewed looking north-east.

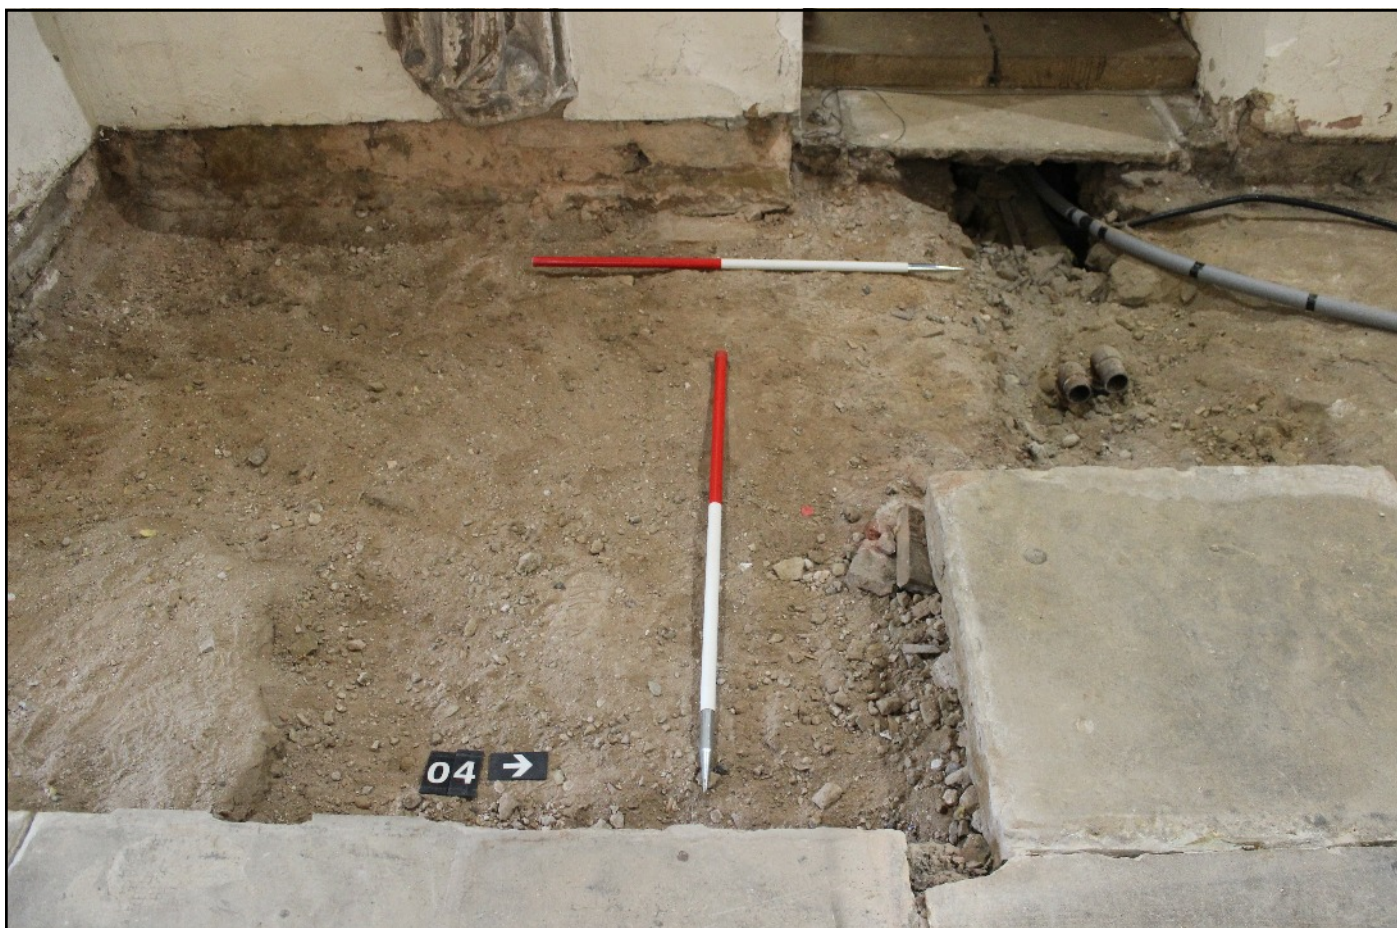
difference in bricks and bonding indicates different phases, possibly an upgrade or repairs due to subsidence. The pipework continues into Area 04 where the trench 0402 is neither brick lined nor the pipes held within a ceramic pipe, the trench being capped by the flag floor (Figure 4).

**Plate 4:** Continuation of the pipework of the heating system into Area 04 within the nave which extends into the tower and presumably to the boiler house abutting the west elevation of the tower, viewed looking west.

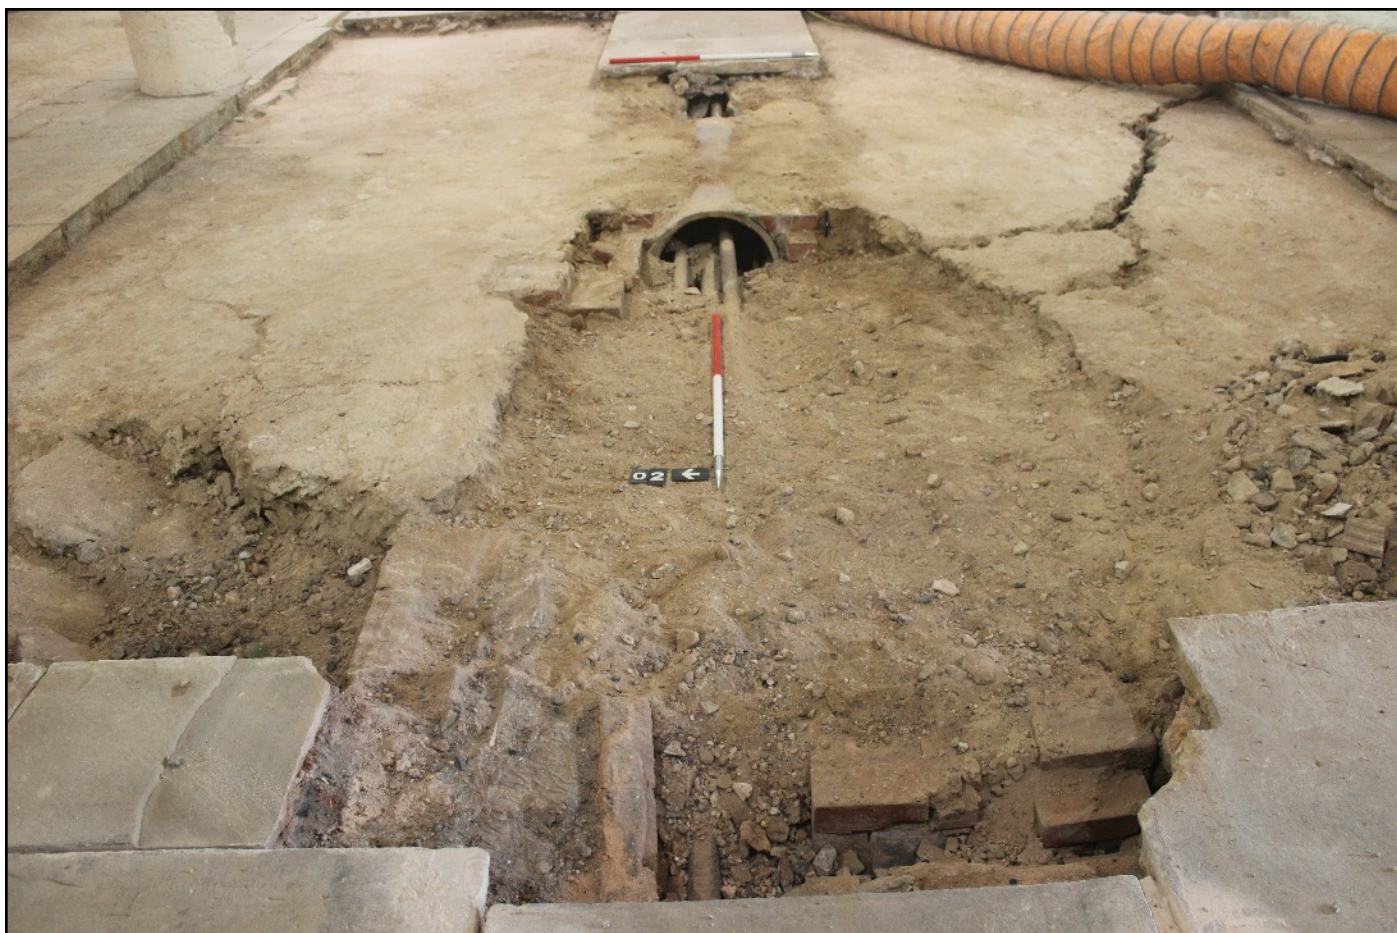
- 5.2 In Area 02 (Plate 3), extending west to east at the east end, was a 1.10m wide trench 0202 infilled with 0203 comprising a ceramic pipe encased in brickwork which held three metal pipes of the heating system and backfilled with loose brown silt loam. The bricks were 9 x 4 x 3 inches and bonded with a very hard white lime mortar. A total length of 5.10m was exposed and it exceeded 0.3m in depth. Stratigraphically it cannot be established if the mortar and sandstone deposit 0201 was shuttered during construction creating the trench for the heating system or whether 0201 was laid in full and subsequently, within only a few years, truncated for the heating system. At the west end of the trench there was further brickwork though of a different nature. It was two bricks thick and housed metal heating pipes. The bricks were 9 x 4 x 3 inches and stamped STAVERLEY a local brick company that first produced bricks in 1929 (Fretwell 2015). A very pale brown cement mortar has been used to bond the bricks. The

**Plate 5:** Heating pipe and trench in Area 02, the nave, viewed looking east. The brickwork in the foreground is later than that in the mid and background, a likely repair required due to subsidence which can clearly be seen in the lower half of the photograph.

| Context | Area Description | Interpretation |
|---|---|---|
| 0206 | Brick walling 2 bricks thick housing metal heating pipes, bricks 9 x 4 ½ x 3 inches, bonded with cement mortar 10YR 8/2 very pale brown, four course exposed. Brick are frog type stamped STAVELEY | Repair to the heating system, likely following issues with subsidence. Staveley brickworks at Barrows Hill, Staveley was built in 1929 and produced bricks |

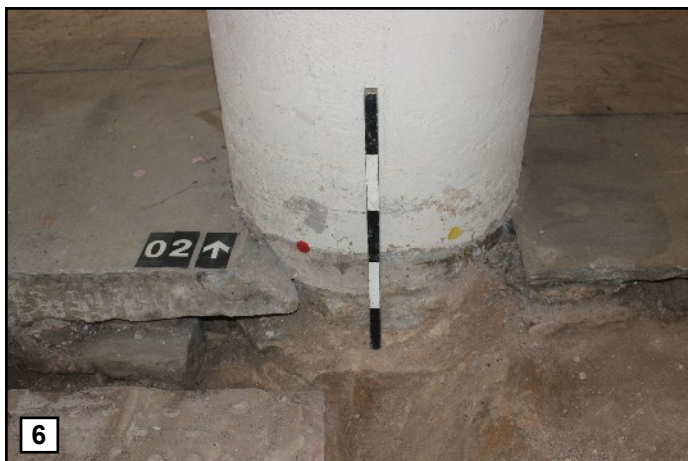
- 5.4 A single course of foundations for the c. 1250 circular piers in Area 02 were encountered. The westernmost example 0209 comprising a single stone slab 0.08m thick with 0.44m in length revealed (Plate 6). A void in the section beneath the flag floor exposed the slab further suggesting that it could potentially be hexagonal. The western pier foundation 0211 comprised three unmortared stones exceeding 0.15m thick (Plate 7). To the south, the easternmost foundations of the hexagonal pier 0210 were also partially exposed (Plate 8) and were again unbonded. All foundations were overlaid by 0208 and 0201.

**Plate 6:** Western circular pier and foundation 0209 in Area 02, viewed looking north.

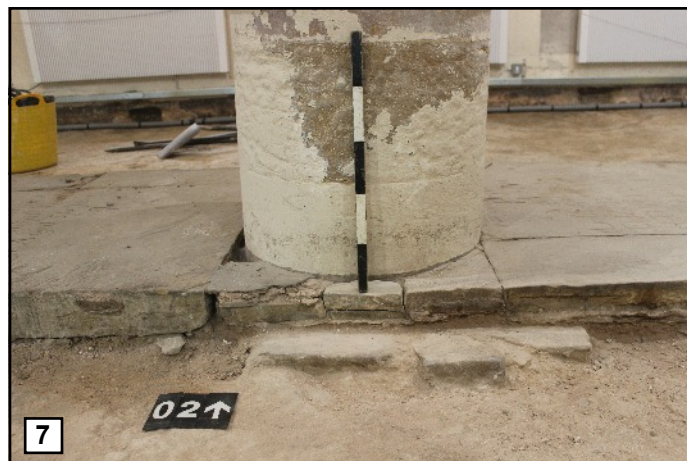
**Plate 7:** Eastern circular pier and foundation 0211 in Area 02, viewed looking north.

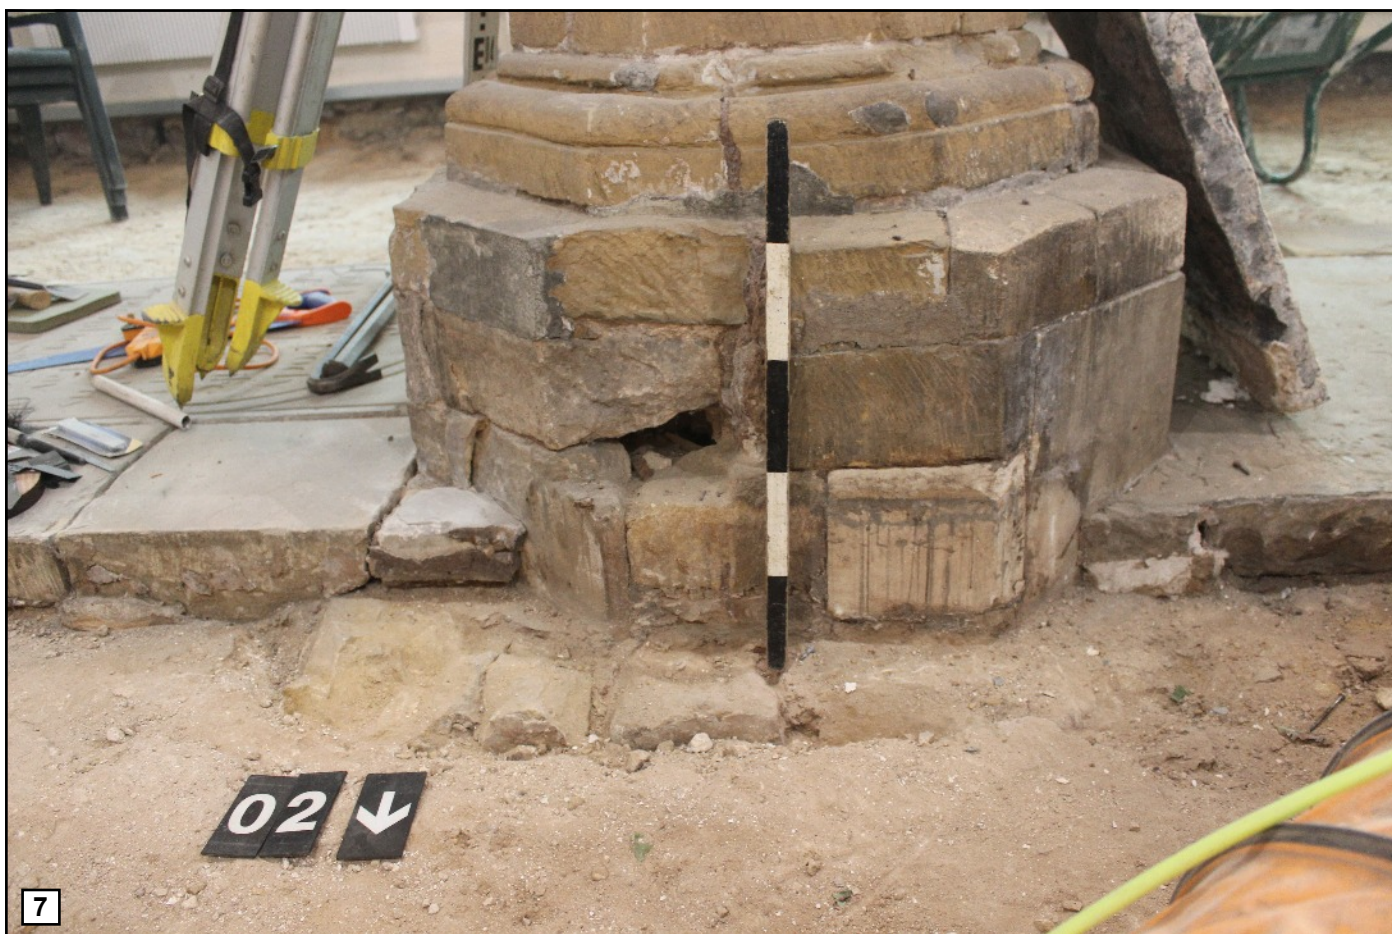
**Plate 8:** Eastern hexagonal pier and foundation 0210 in Area 02, viewed looking south.
