**CHURCH OF ST. LAURENCE, NORWELL,  
NOTTINGHAMSHIRE:  
ARCHAEOLOGICAL EXCAVATION  
WITHIN THE CHURCHYARD**

**Project Code: SLC  
Report Number: 002/2018**

- During 2018 Matt Hurford Historic Buildings and Archaeological Services was commissioned by Dr Elizabeth Jones on behalf of Norwell Parochial Church Council to carry out an archaeological excavation prior to the extension of a drainage gully along the north wall of the chancel at the Church of St Laurence, Norwell, Nottinghamshire.

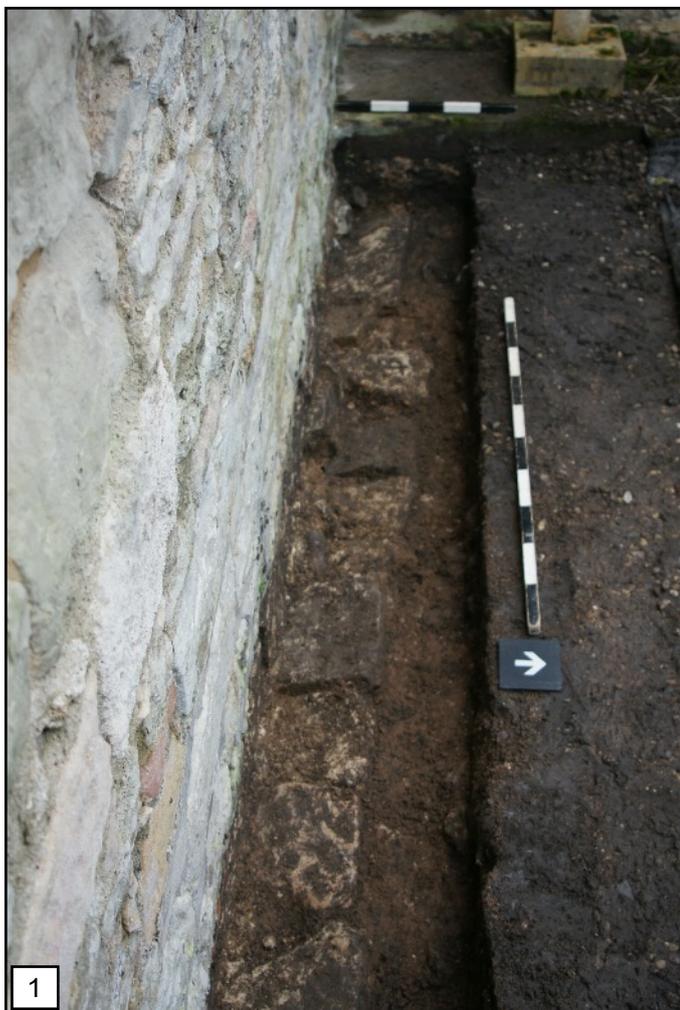
**Plate 1:** Area 01 with 0003 exposed, viewed from the east looking west.

5.3. Orientated west to east and extending along the full length of Area 01 was 0003, either a former wall or foundation. It was built of well-dressed angular pieces of skerry of up to four courses, with a single fragmentary piece of tile present, bonded with firm strong brown sandy clay. It was overlaid by the chancel wall and the modern brick foundations for the low cast iron railings of the private burial plot. Of particular note the feature is on a slightly different alignment to the chancel wall.
