CHURCH OF ST.MARY'S THE VIRGIN NOTTINGHAM

ARCHAEOLOGICAL RECORDING DURING
ALTERATIONS TO THE FLOOR LEVELS
2013

Project Code: NSM3/Report Number: 062/2013

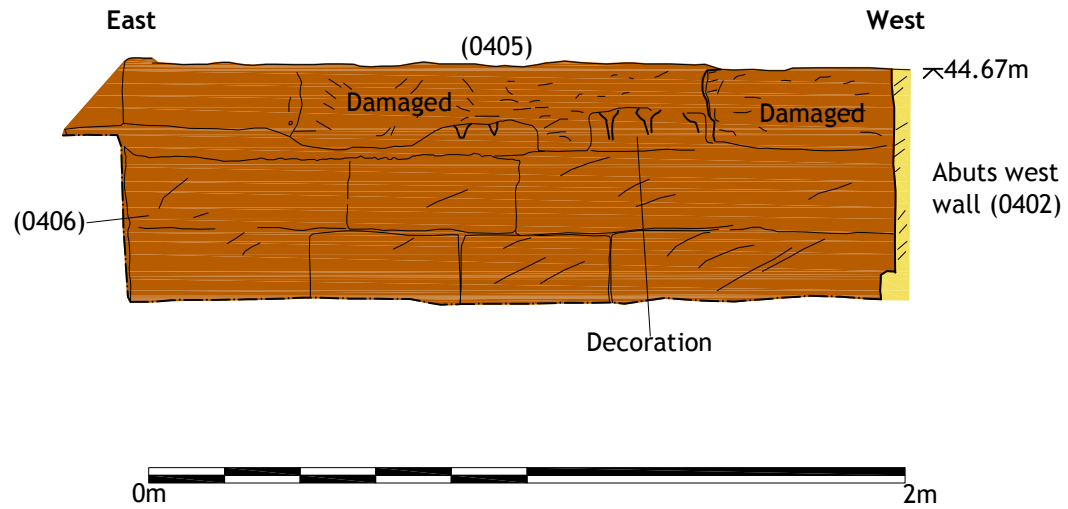
Figure 12: North facing section of south transept, Area 14 showing 0405 and 0406

5.2.5. Above, 0401 was capped by 0415 a course of small ashlar c.0.22m x 0.14m in size. The level of this course lay above that of 0400 to the north. This also capped two courses of foundation 0402 exposed to the south, which abutted foundation 0401 (Figure 10; Plate 7). Foundation 00402 was in-turn abutted by the east-west running foundation of the transept's south wall 0406.

5.2.6. The south wall foundation 0406 stepped out some 0.34m from the wall courses above. This foundation (which abutted the west wall foundation 0402) was exposed to a depth of only 0.6m revealing three rough courses of stone up to c. 0.45m x 0.20m in size. The top course included a heavily damaged slab-like stone c 1.1m x 0.22m in size, with some surviving panel-like ornamentation on the face set 0.1m apart (Figure 12, Plate 8). This stone (and the stones to the side of it) extended south to form the lower

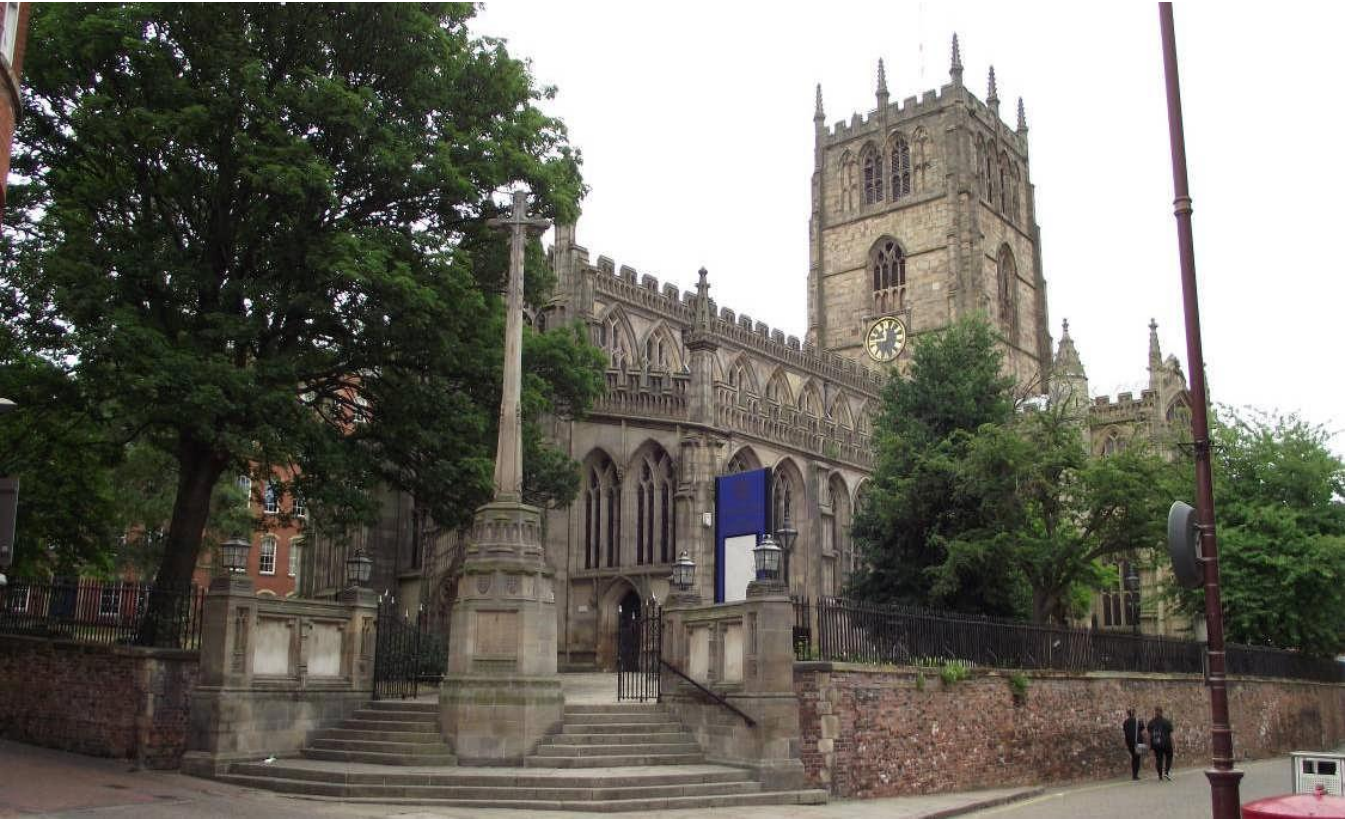
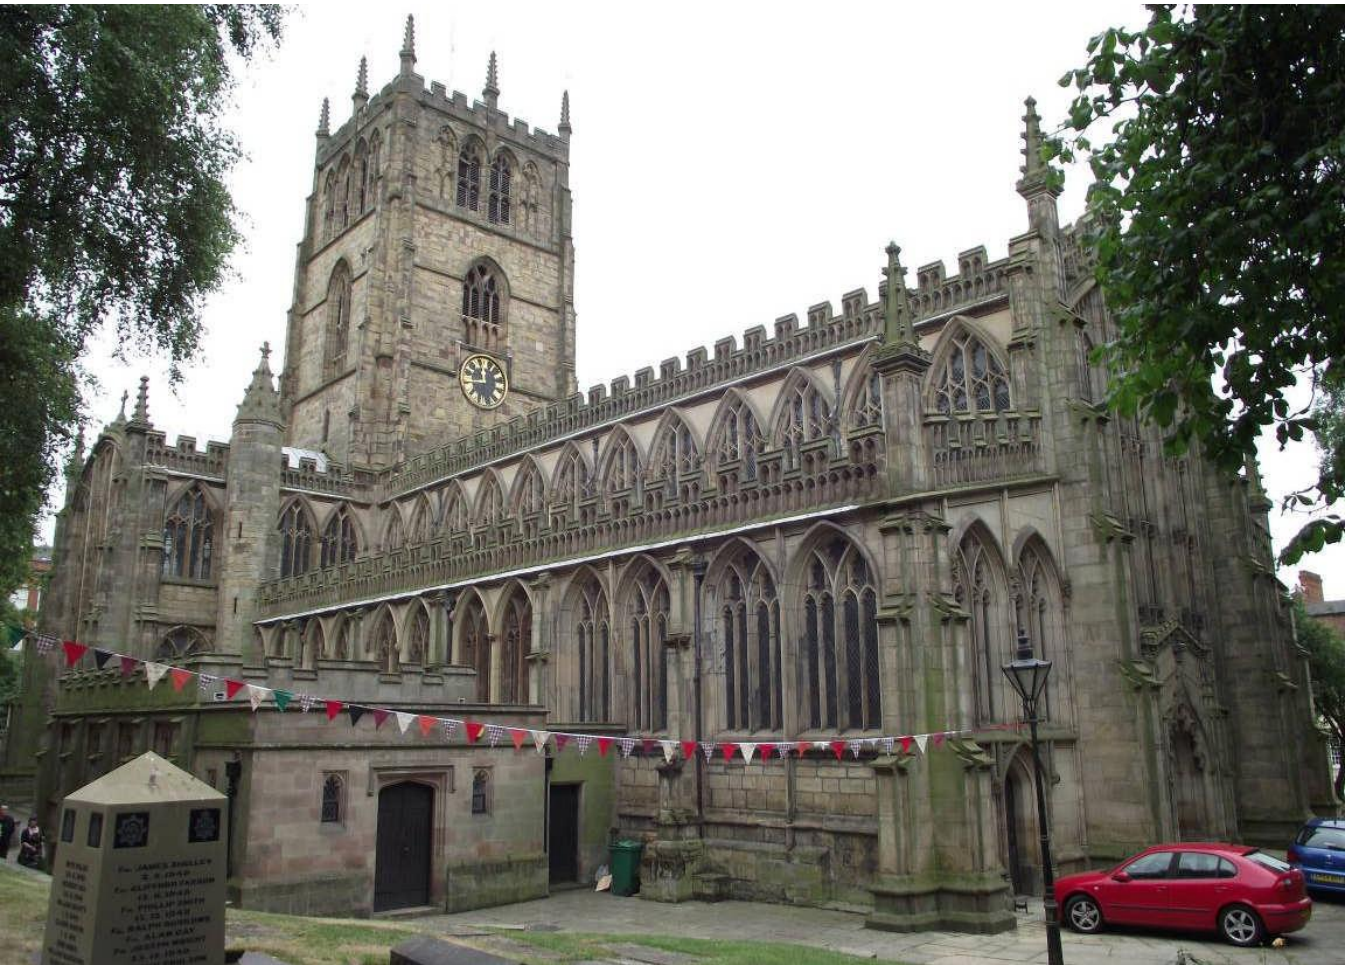
Plate 1: Church of St. Mary's from the west end, looking south-east and north-east.

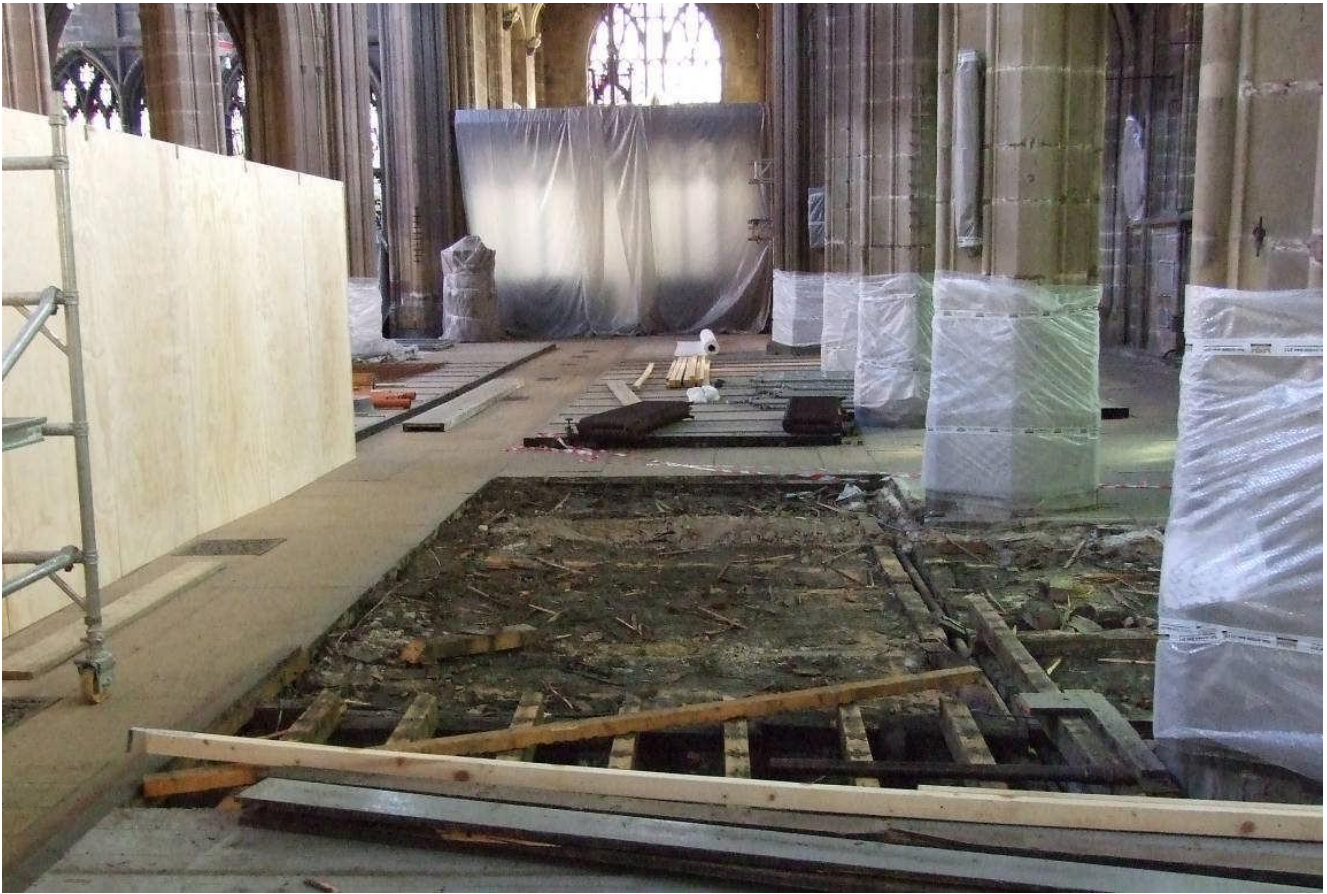
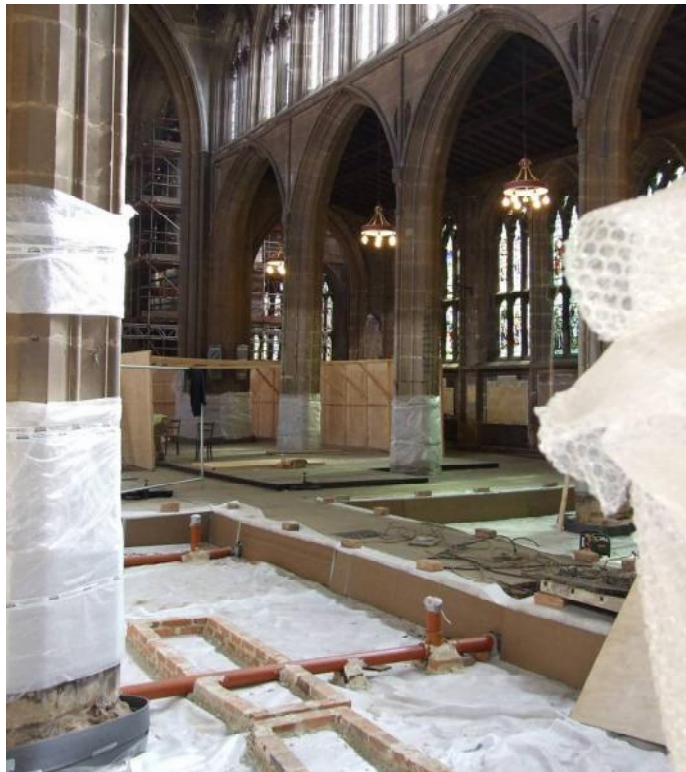
Plate 2: View of nave groundwork in progress. Upper showing removal of raised floorboards. Lower showing shallow depth of groundwork.

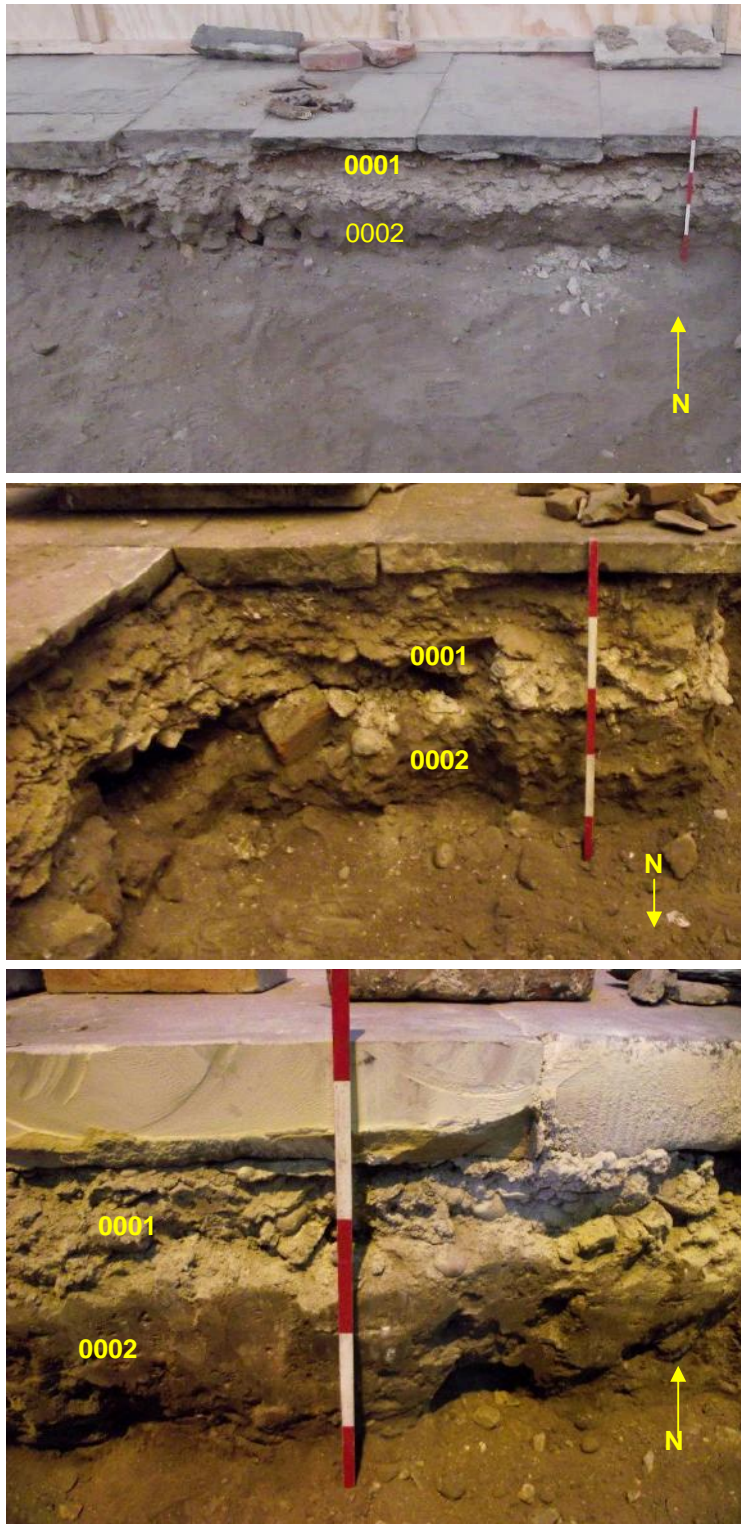
5.1.2. Beneath this within the nave and both transepts the exposed surfaces were found to comprise the same basic stratigraphy of two layers, 0001 above 0002, as encountered during the evaluation. (Plate 3).

Plate 3a-c: Sections of exposed stratigraphy showing 0001 crushed mortar, plaster etc above mixed grave-earth 0002. From top, nave (10), south transept (14) and north transept (15).

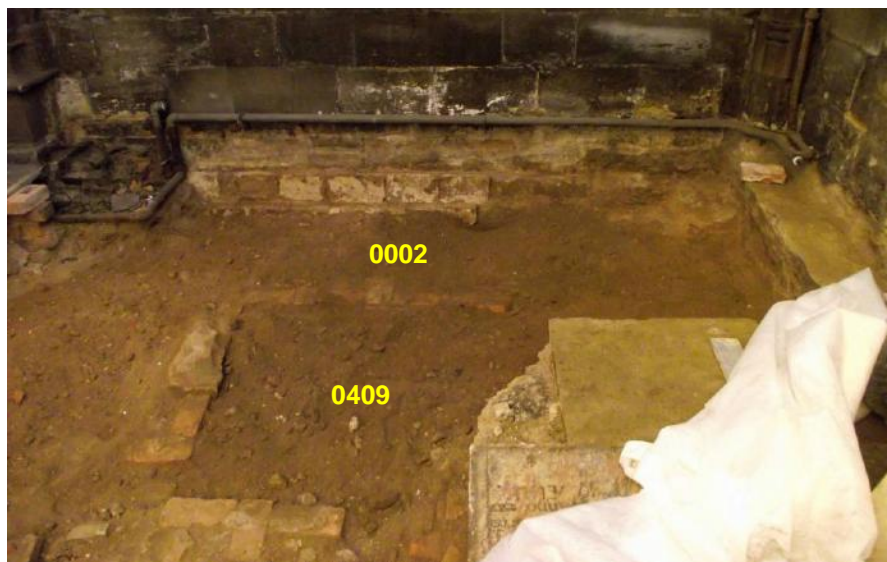
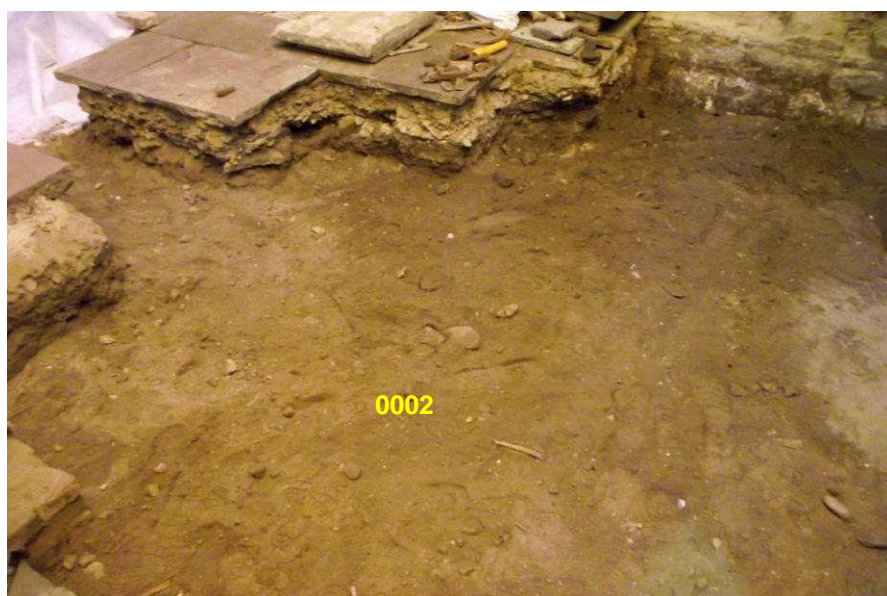
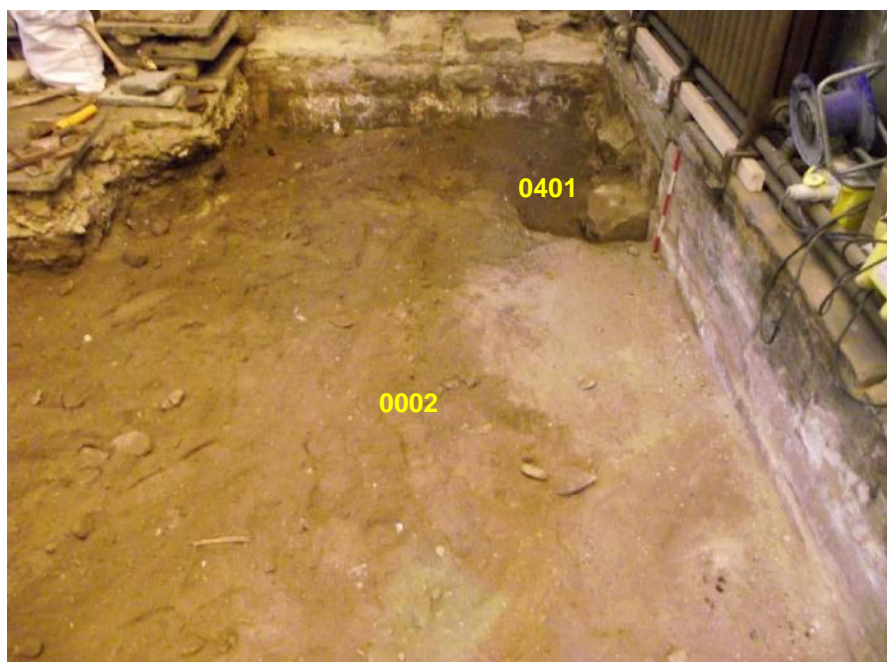
Plate 4a-c: South Transept floor during groundwork. From top looking east, middle looking south-east, bottom looking south

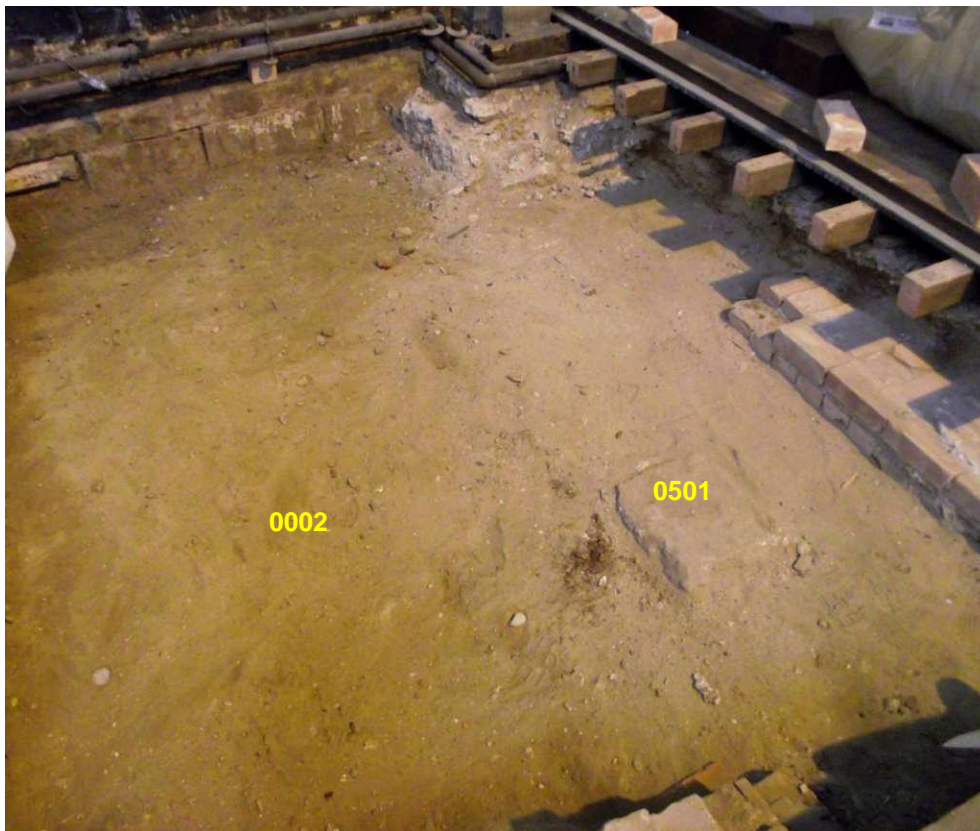
Plate 5a-b: North Transept floor during groundwork. Upper (16) looking south, bottom (15) looking south-east.

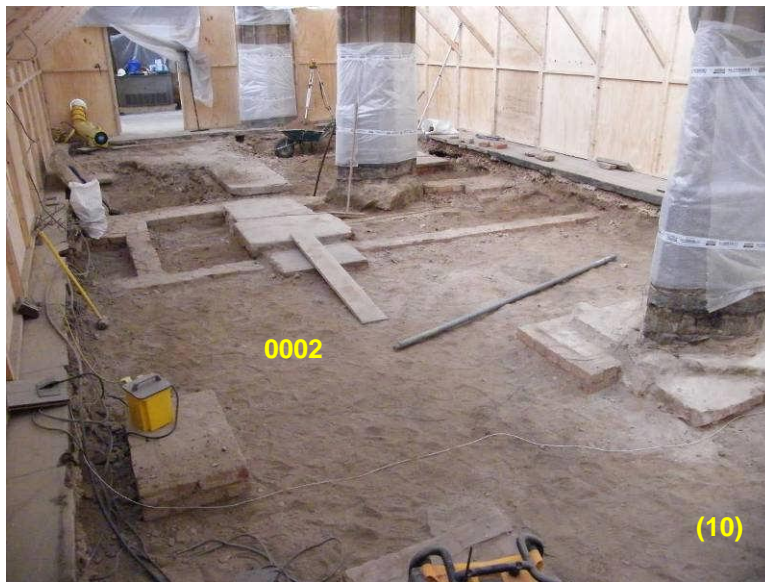
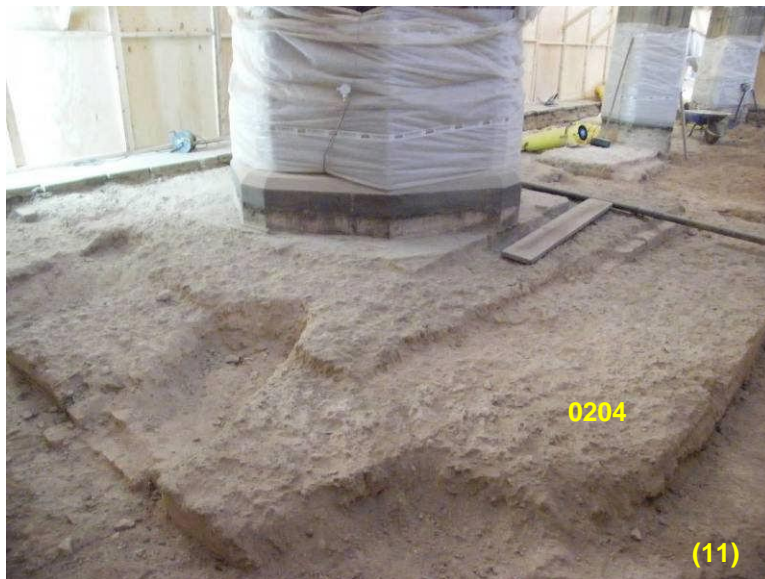
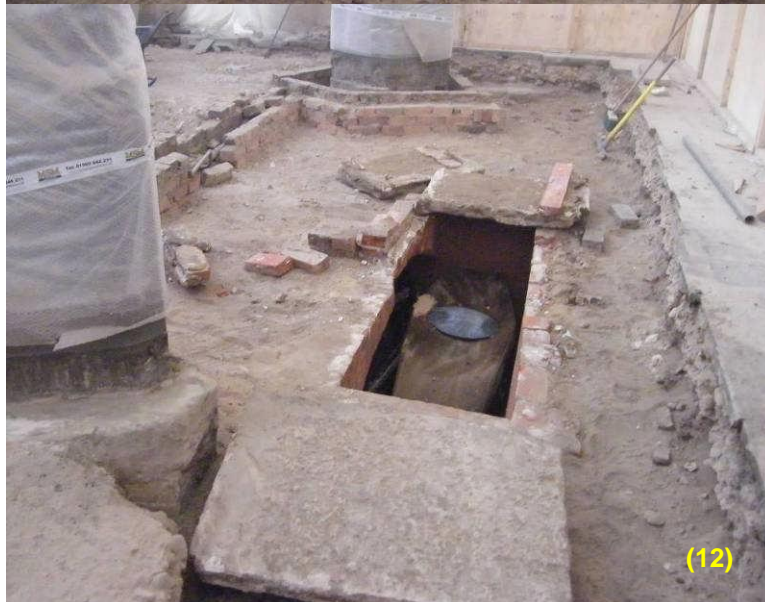
Plate 6a-c: Deposits within the nave, all looking west. Top (10) layer 0002 cut by brick burial shafts. Middle (11) 19th century concrete around south-west pier of crossing. Bottom (12) 0002 cut by brick burial shaft 0301.

5.1.7. Within the junction of the east end of the nave and crossing, substantial concrete deposits were present beneath the floor board voids at depths of 180mm to 220mm (Figures 3, 6 & 7.; Plate 6). These appeared to represent the concrete deposits supposedly used to fill burial vaults and stabilize the tower foundations during the 19th century as described by Glover (see 3.3.11). When constructed these deposits were reportedly several feet thick. Although the true depth is unknown the surface area covered by the concrete exposed by the groundwork around the crossing piers included a 6 m x 5.5m area in 12 and a 6.5mx 5.5m area in 13.

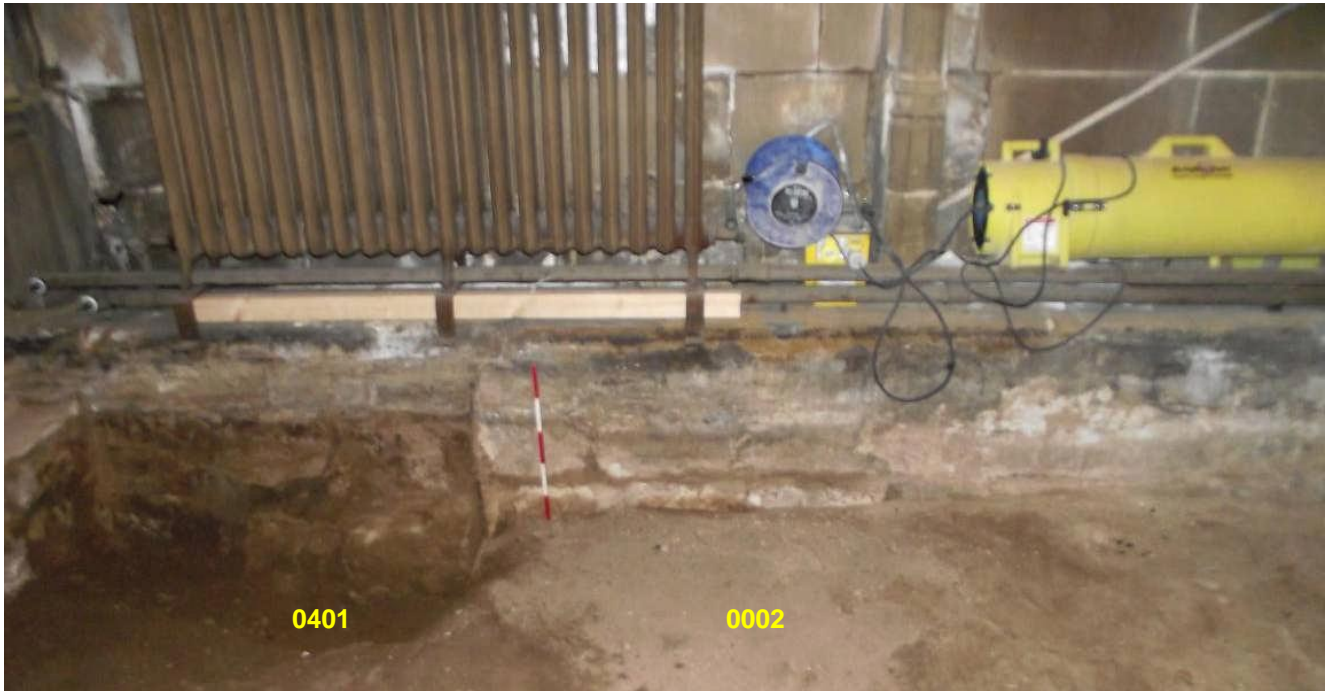
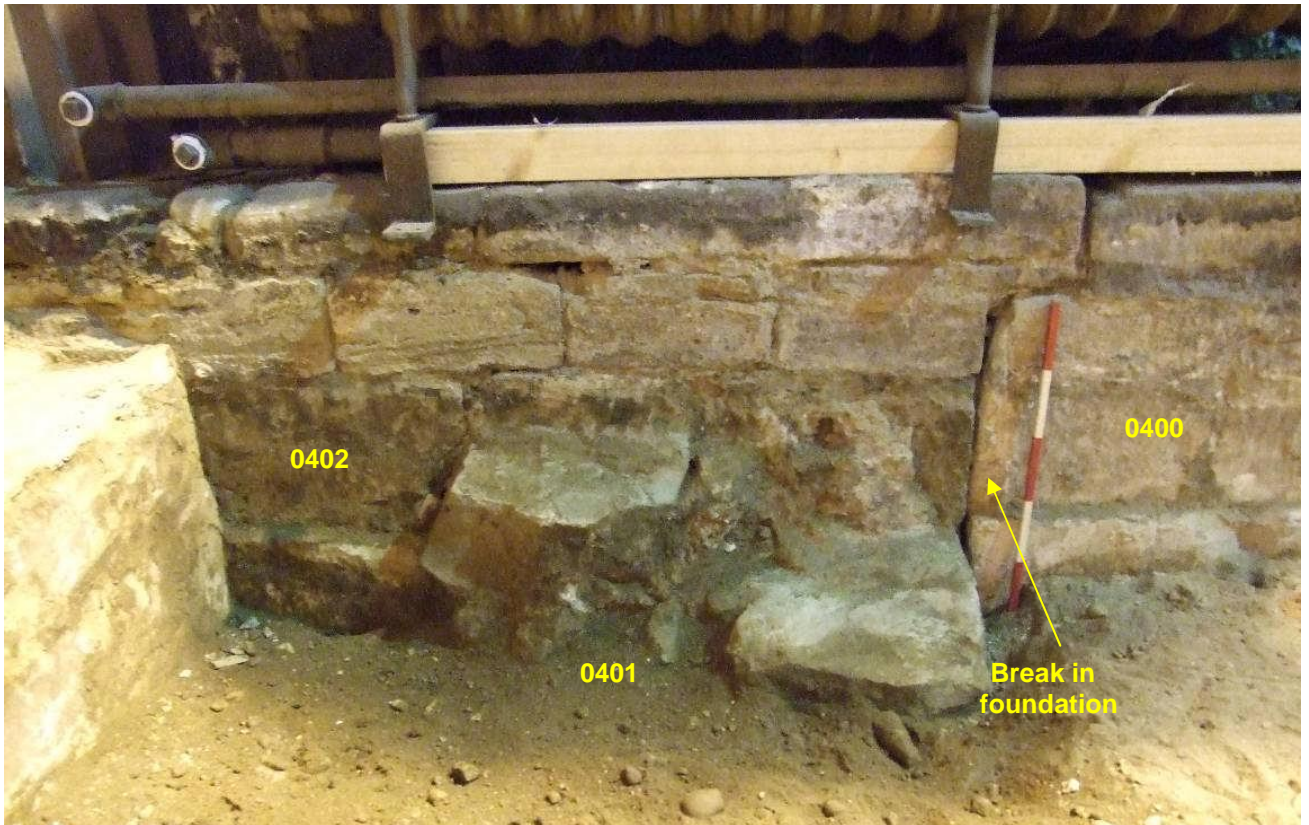
5.2.3. Within the south transept the west wall (east facing) foundation extended south from the crossing c.3 m as 0400. It comprised a course of large sandstone ashlar up to 0.66m x 0.45m in size (Figure 8, 18; Plate 7). Below, the top of a further course could be seen stepped out c.0.03m from the ashlar above.

5.2.4. At its southern end foundation 0400 appeared to abut the remains of an apparent 0.72m wide east running foundation 0401 (Figure 10; Plate 7b). This comprised facings of worked stone with an apparent rubble core. Unfortunately this was completely truncated after extending east for only 0.26m (within the shallow limits of the groundwork). Whether this represented an internal division within the transept related to one of the pre-reformation chapels or a truncated former external wall foundation is therefore unclear with its true extent and function remaining unknown.

Plate 7a-b: South Transept west wall foundation 0400 looking west.

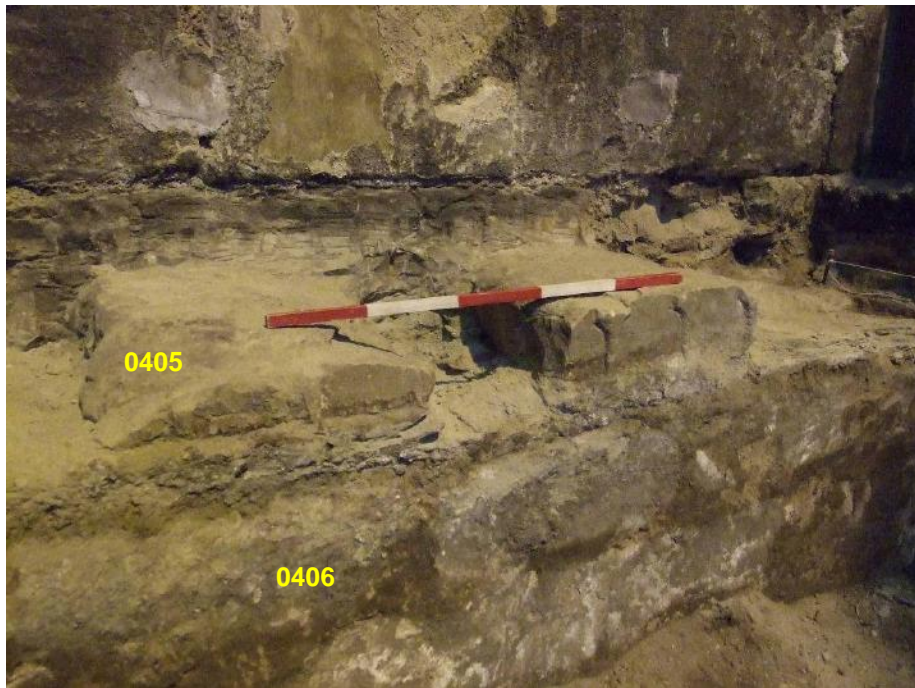
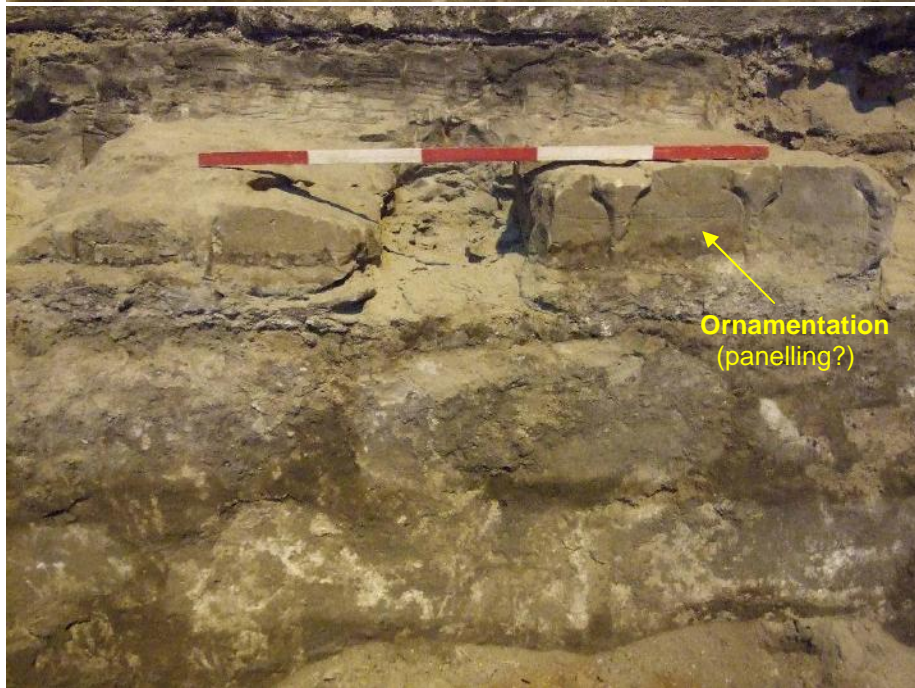
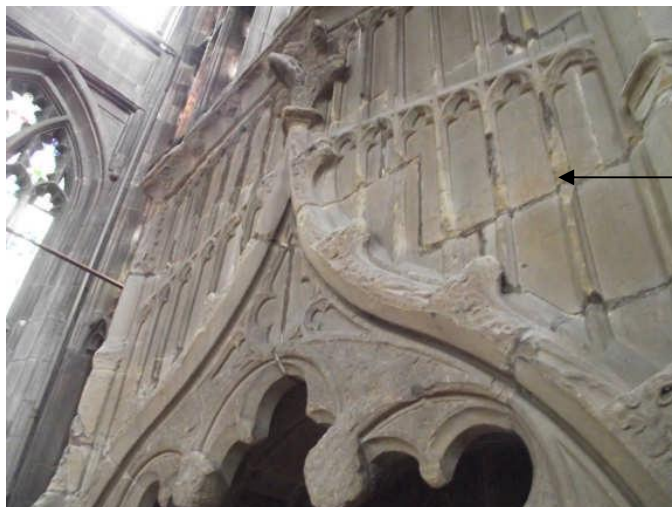
Plate 8a-c: South Transept south wall foundation 0400 looking south. Samon Tomb with decorated face of panel tracery immediately to east of 0400.

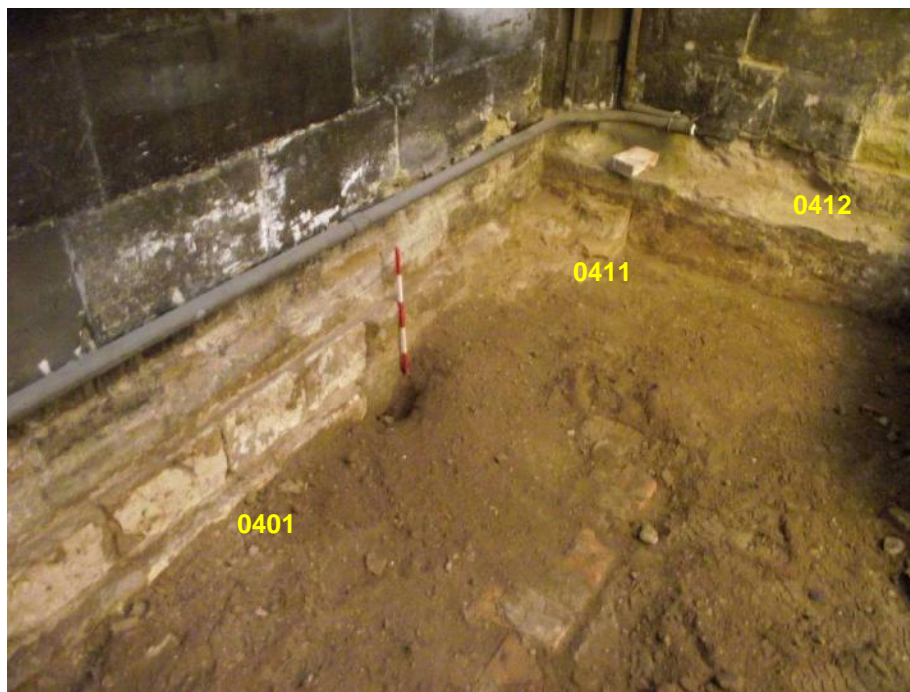
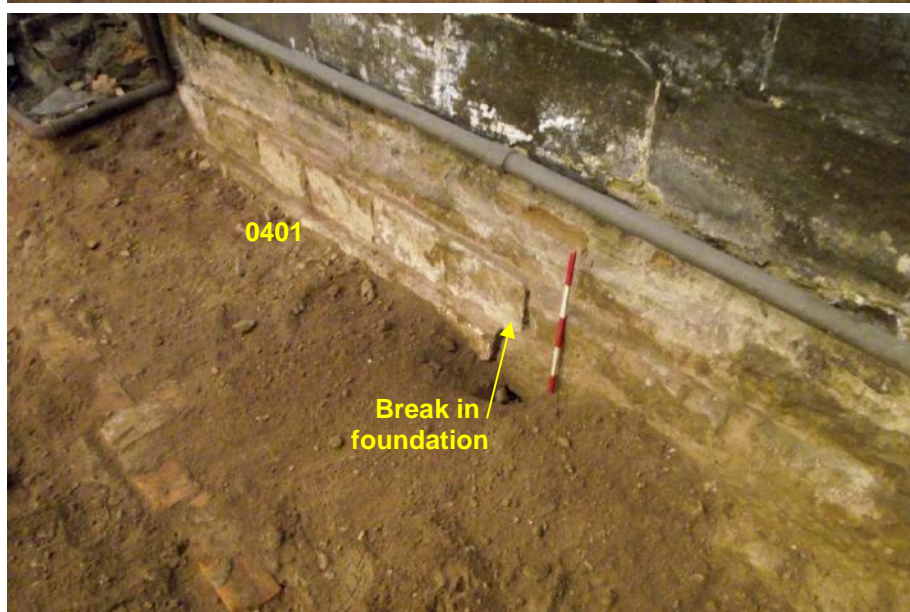
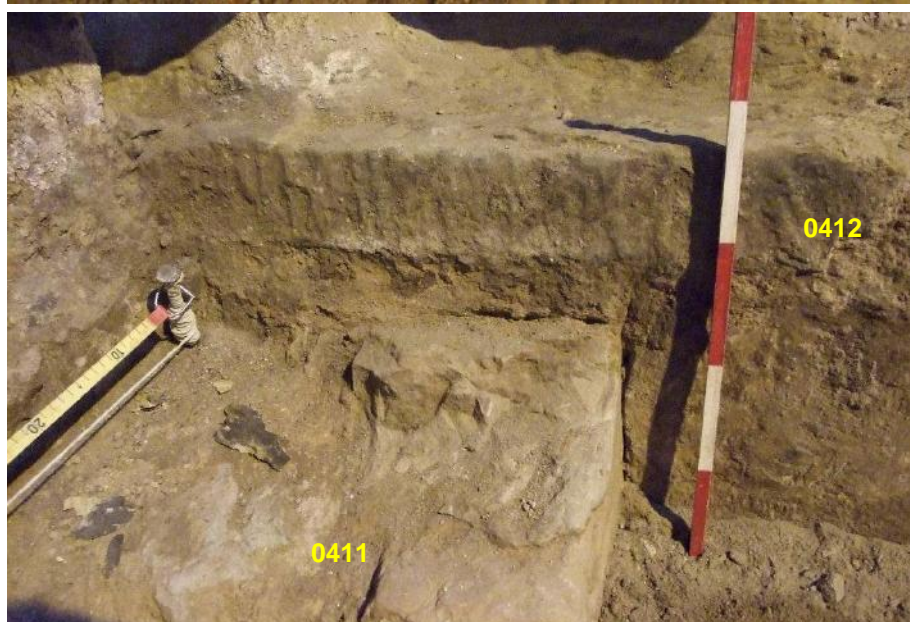
5.2.7. Within the south transept the east wall (west facing) foundation extended south from the crossing c. 2.5m as 0410. It comprised an exposed course of large sandstone ashlar up to 0.43m x 0.22m in size (Figure) which stepped out 0.03m from the wall course above. Below, the top of a further course could be seen stepped out c. 0.06m to 0.05m from the ashlar above. Both courses were white washed obscuring surface detail.

5.2.8. At its southern end wall foundation 0410 had a noticeable break with the remaining foundation to the south including a 0.8m long damaged section of wall foundation 0411, which projected out westwards 0.45m from the wall above (Figure 11; Plate 9). Unfortunately the heavy damage and shallowness of the excavation prevented further definition of the nature of 0411. To its south 0411 appeared to be overlain by the south wall foundation 0412.

5.2.9. South wall foundation 0412 stepped out 0.28m from the wall above (Figure 13; Plate 9c). Unfortunately, due to heavy damage and the presence of a surface wash individual stones and coursing could not be discerned. In addition the ornamented course seen on 0405 appeared to have been removed (hewn away) leaving it only as a damaged course at the base of the south wall (similar to that found at the west end).

Plate 9a-c: South Transept east wall foundation 0410 and south wall foundation 0412 and earlier foundation 0411.

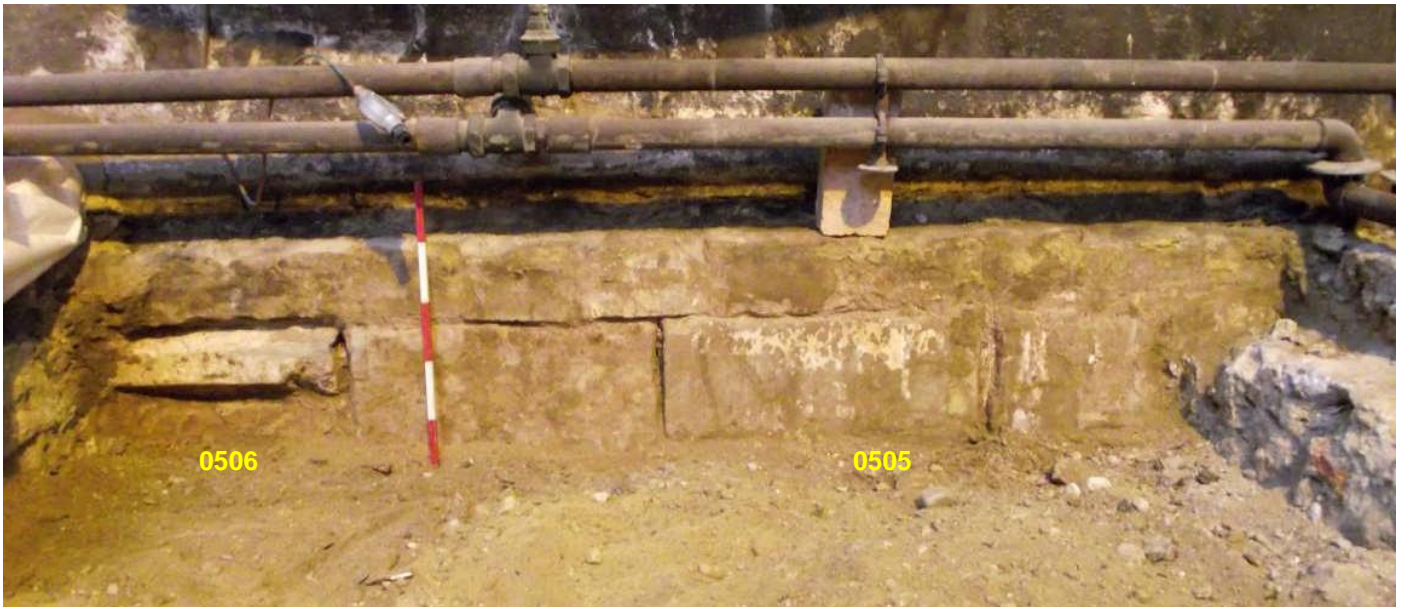
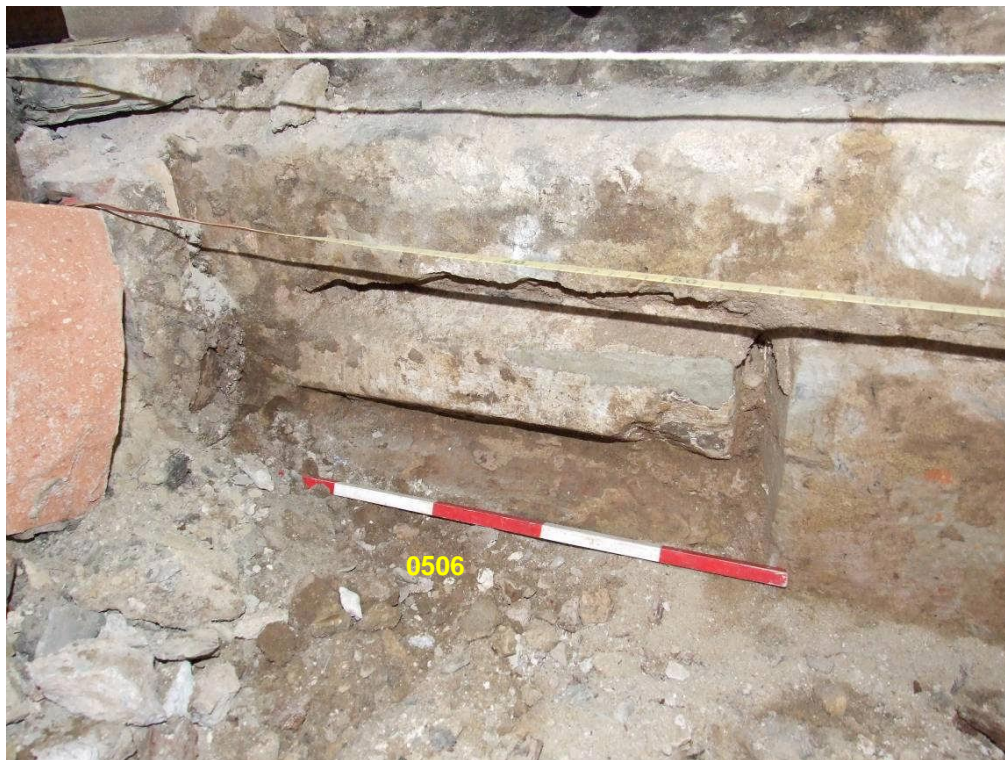
The south end of the foundation was masked by 19th century concrete. At the north end there was a change to a more random foundation 0506, comprising part of a stone window mullion (c.13th/14th century in date), lying upon a roughly-worked reddish grey stone. The stone mullion which was covered by a white wash was at least 0.5m long, with its true length extending outside the excavation area.

Plate 10 a-b: North Transept (15) east wall foundation 0505 (west facing) plus close up of 0506 containing window mullion.

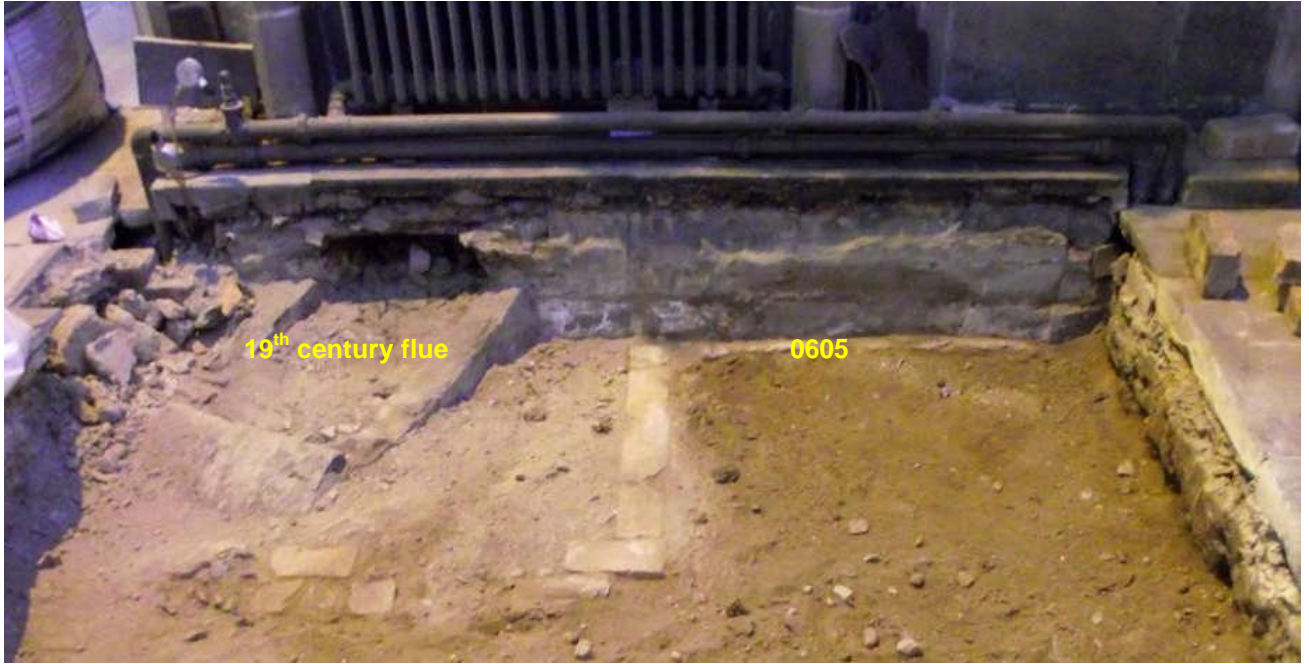
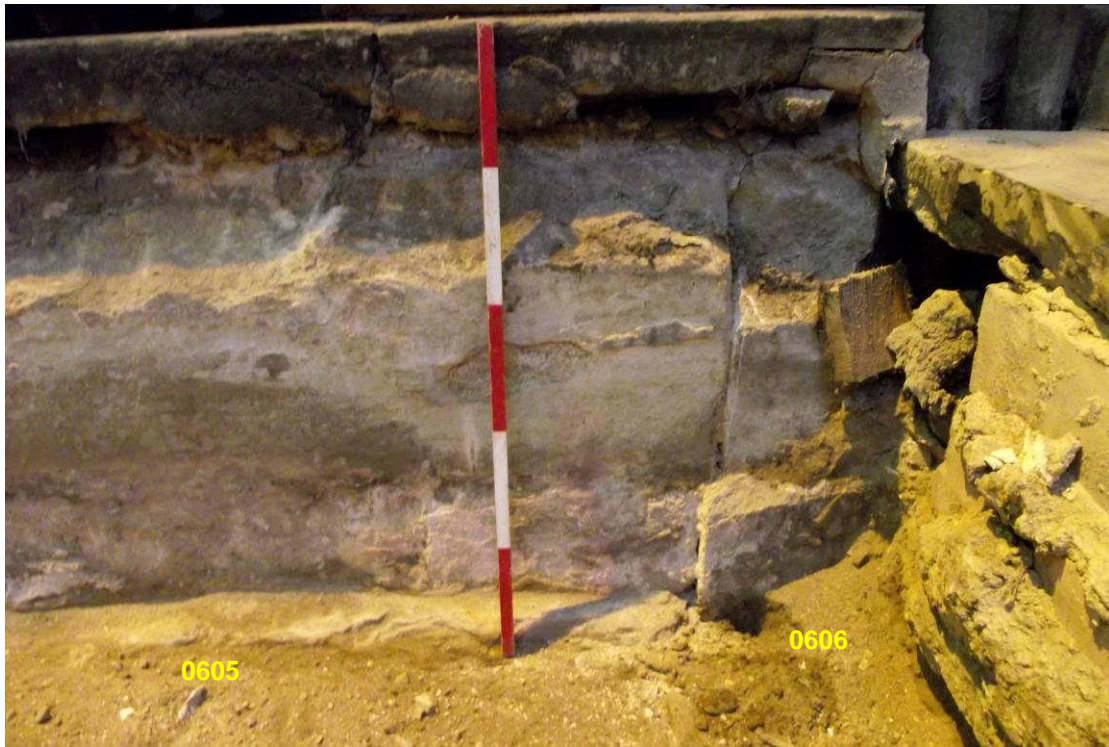
The exposed west wall (east facing) foundation 0605 of the north transept extended north from the crossing c.2.4m. It comprised a course of large sandstone ashlar up to 0.76m x 0.24m in size (Figure 14: Plate 11). The surface was whitewashed in places. Below, a further thin course c.0.13m thick appeared to be present but no detail could be distinguished due to the presence of a whitewash. Below this was the apparent top of a further course stepped out c.0.05m from that above.

5.2.4. At its southern end wall foundation 0605 had been truncated and punctured by a large brick flue for the 19th century heating system. To the north of 0605 there appeared to be a sharp vertical break with course 0606 lying further north, which stepped out c. 0.02m to 0.04m from 0605 (Figure: Plate). Unfortunately only a c.0.14m section of foundation 0606 was exposed (projecting from the north section) within the confines of the excavation area, preventing any further investigation

Plate 11 a-b: North Transept (16) west wall foundation 0605 (west facing) plus close up of break in foundation with 0606 to the north.

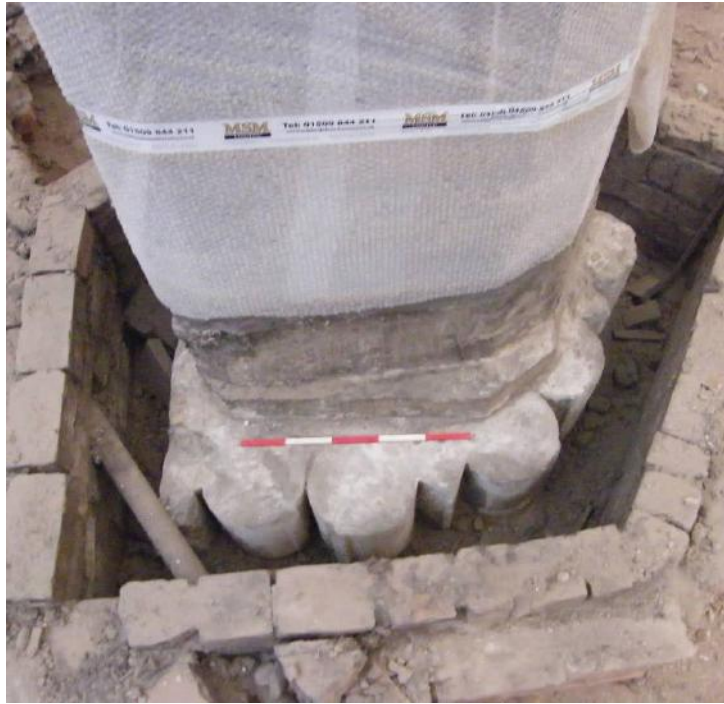
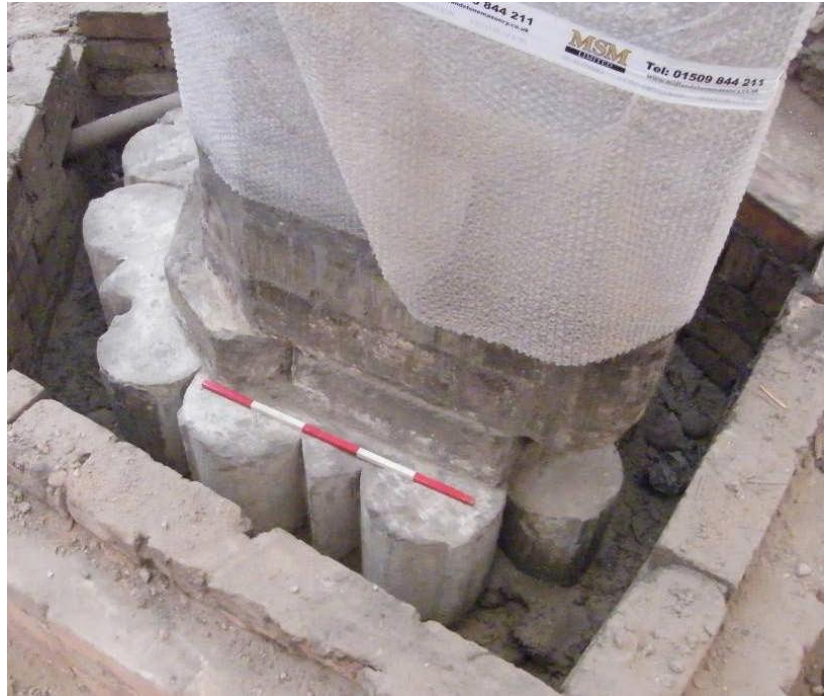
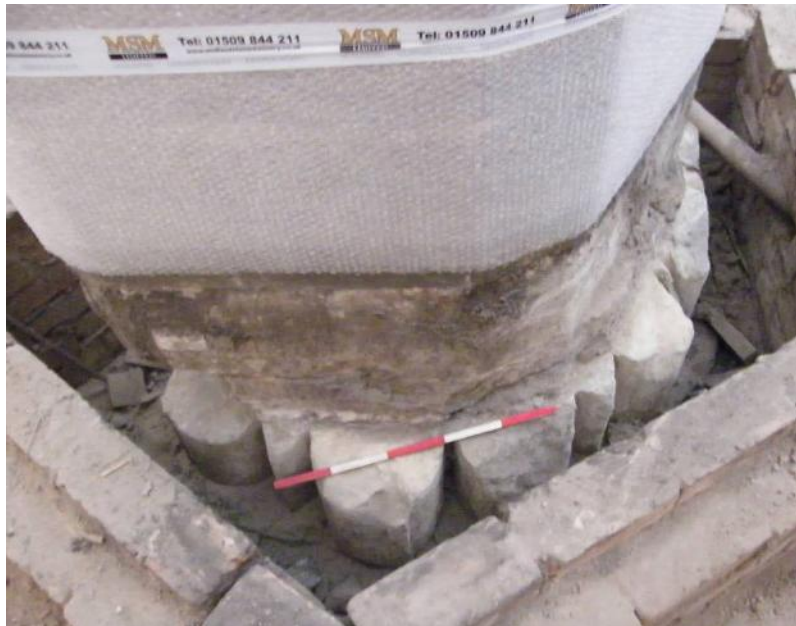
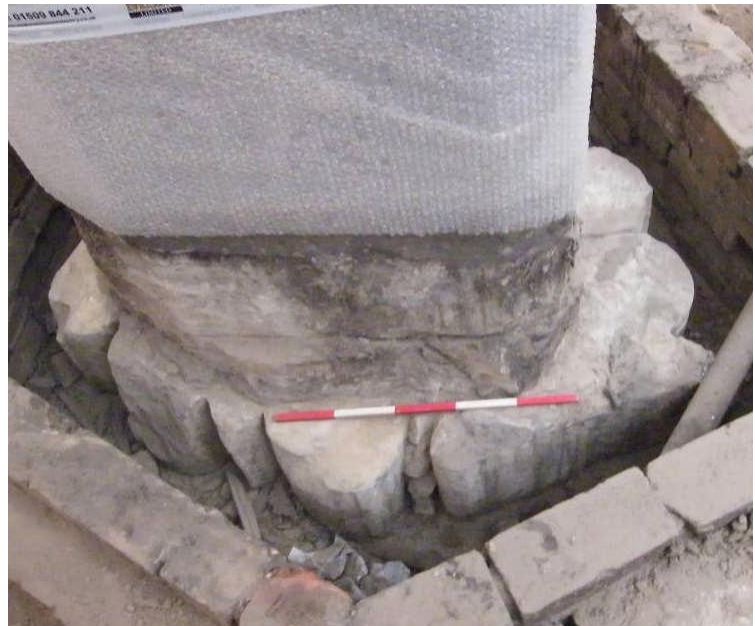
5.3.3. In plan the pier foundation comprised a cluster of nine roll mouldings together covering an area of c 1.3m x 1m (Figure 17; Plate 12). These were found to comprise four pairs of roll mouldings with fillets. The remaining section of the ninth roll moulding was obscured under the later pillar. No base mouldings were present as the roll mouldings lay directly upon a foundation of plain irregular shaped random course of foundation stones (Plate 13c).

Plate 12a-d: Four views of several fragments of roll mouldings re-used under the north arcade pier.
