CHURCH OF ST.MARY'S THE VIRGIN NOTTINGHAM

ARCHAEOLOGICAL RECORDING DURING
ALTERATIONS TO THE FLOOR LEVELS
2013

Project Code: NSM3/Report Number: 062/2013

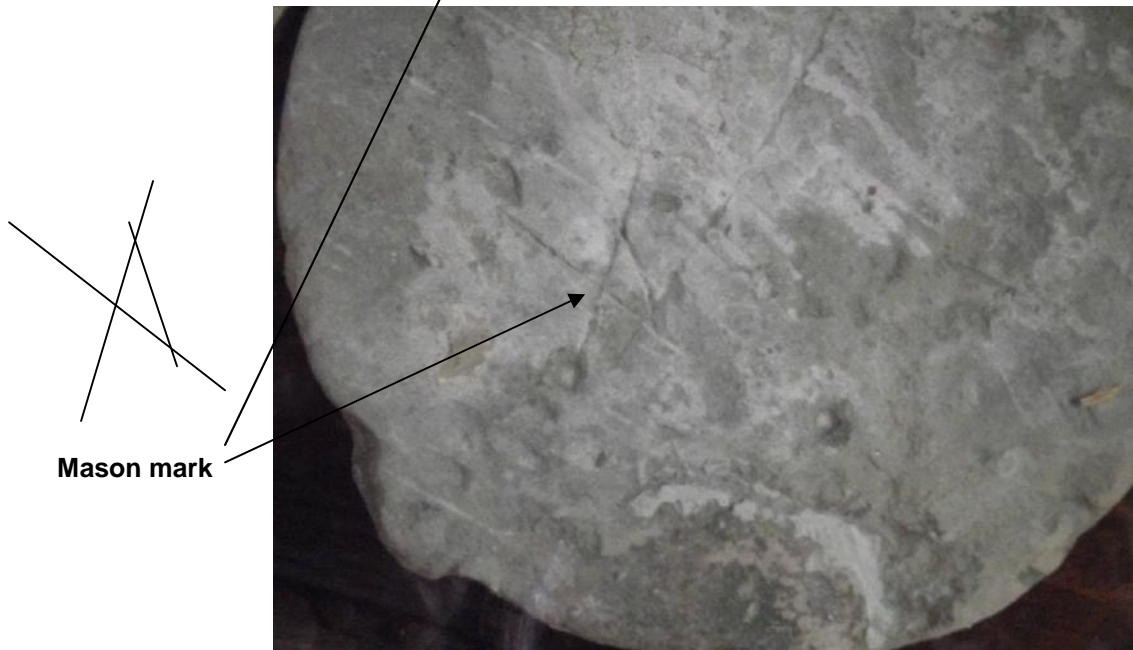
5.3.4. On the west side the pier had suffered some damage. Also present running vertically to the side of one roll moulding was four fragments of heavily damaged ornamentation, possibly dogtooth, although the damage was too great to confirm this with any certainty. At least one apparent mason mark was visible at the end of one roll moulding (Plate 13a-b).

Plate 13a-c: Detail views of the fragments of roll mouldings re-used under the north arcade pier. Upper, showing two roll mouldings with fillet. Middle, showing mason mark. Lower, showing absence of base moulding.

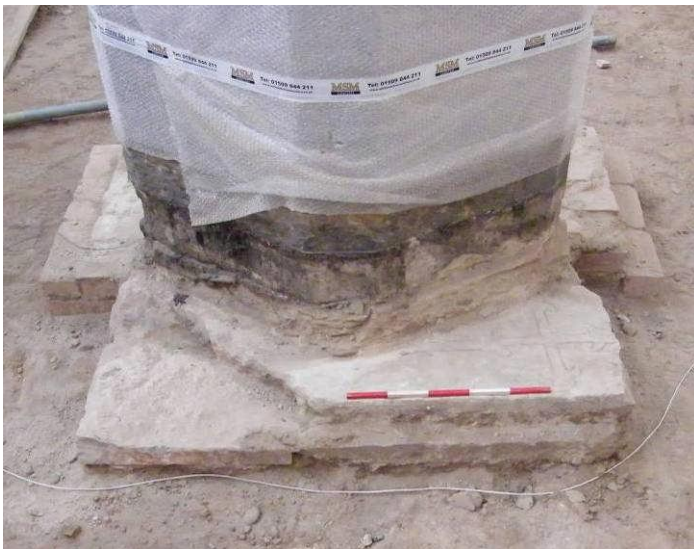
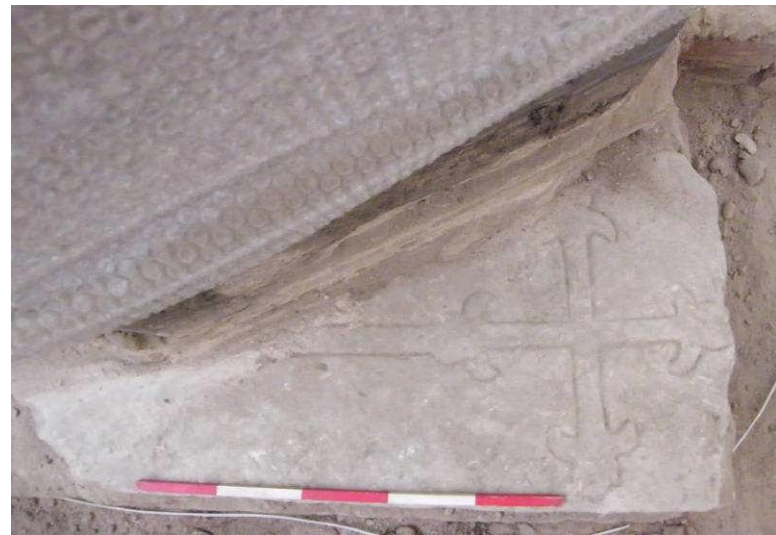
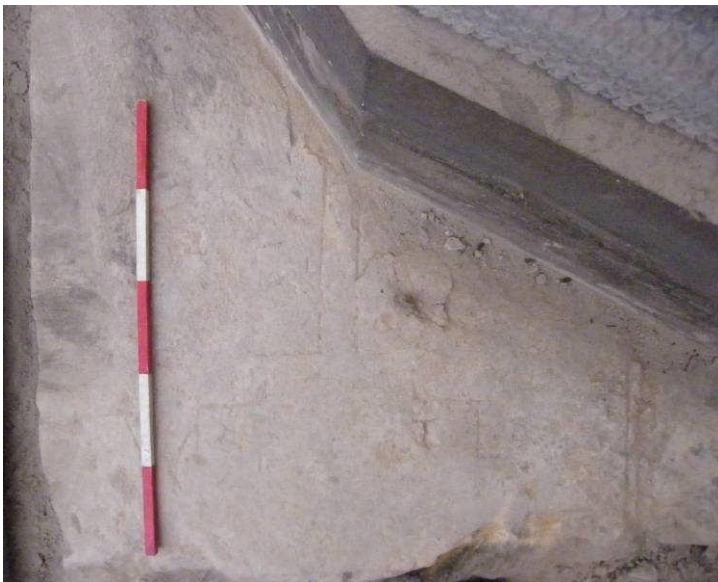
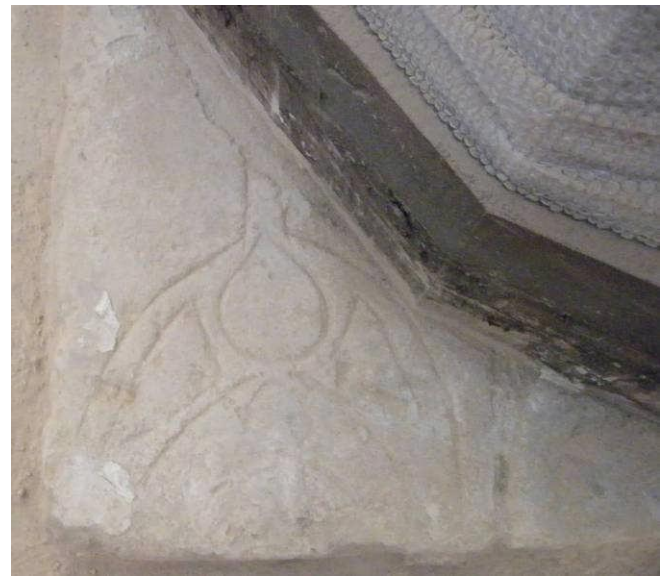
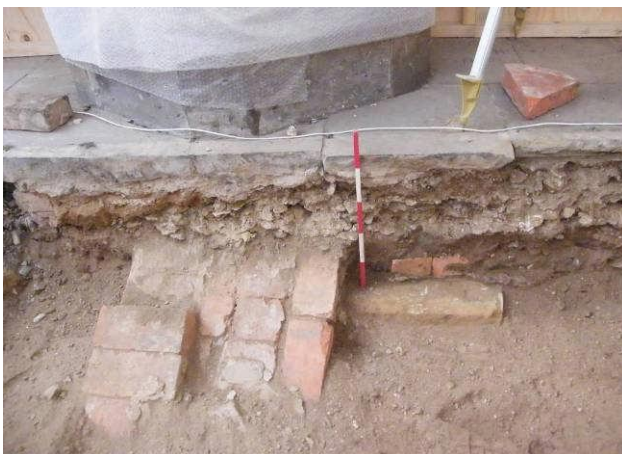
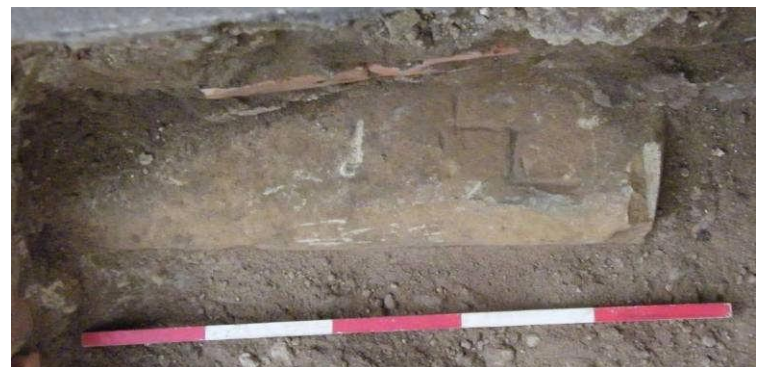
Plate 14 a-d: Medieval cross-slab fragments beneath piers of north arcade.

5.4.1. A number of re-used medieval stone cross-slab grave-cover fragments were exposed incorporated into the base of some of the north arcade piers in areas 10 and 13 (Figures 4 & 7).

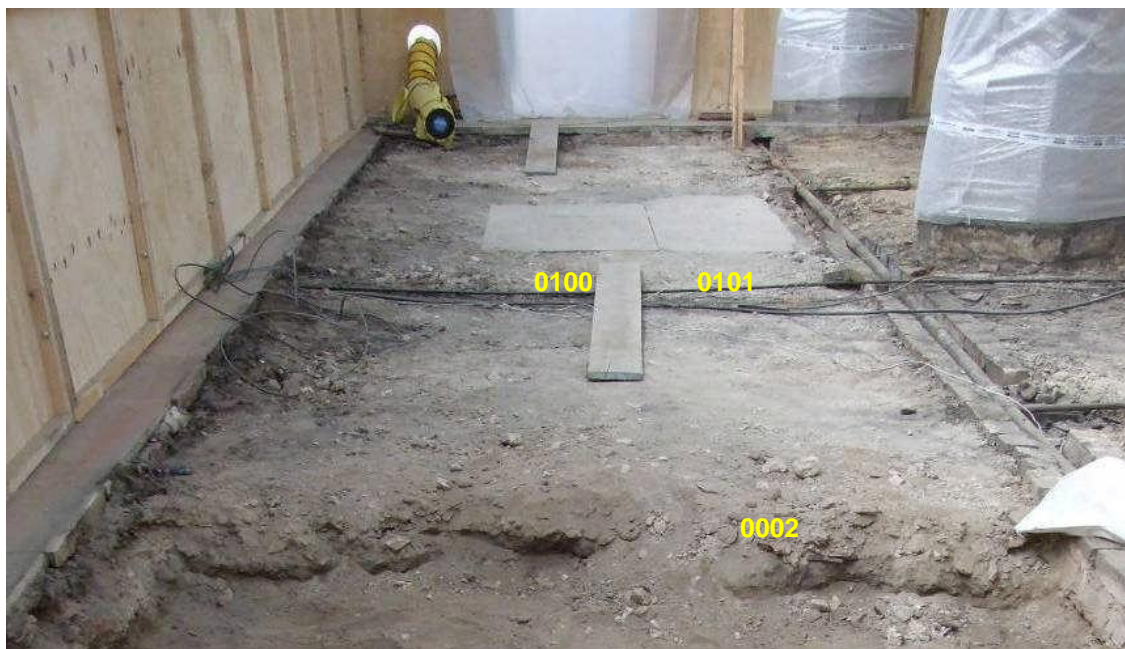
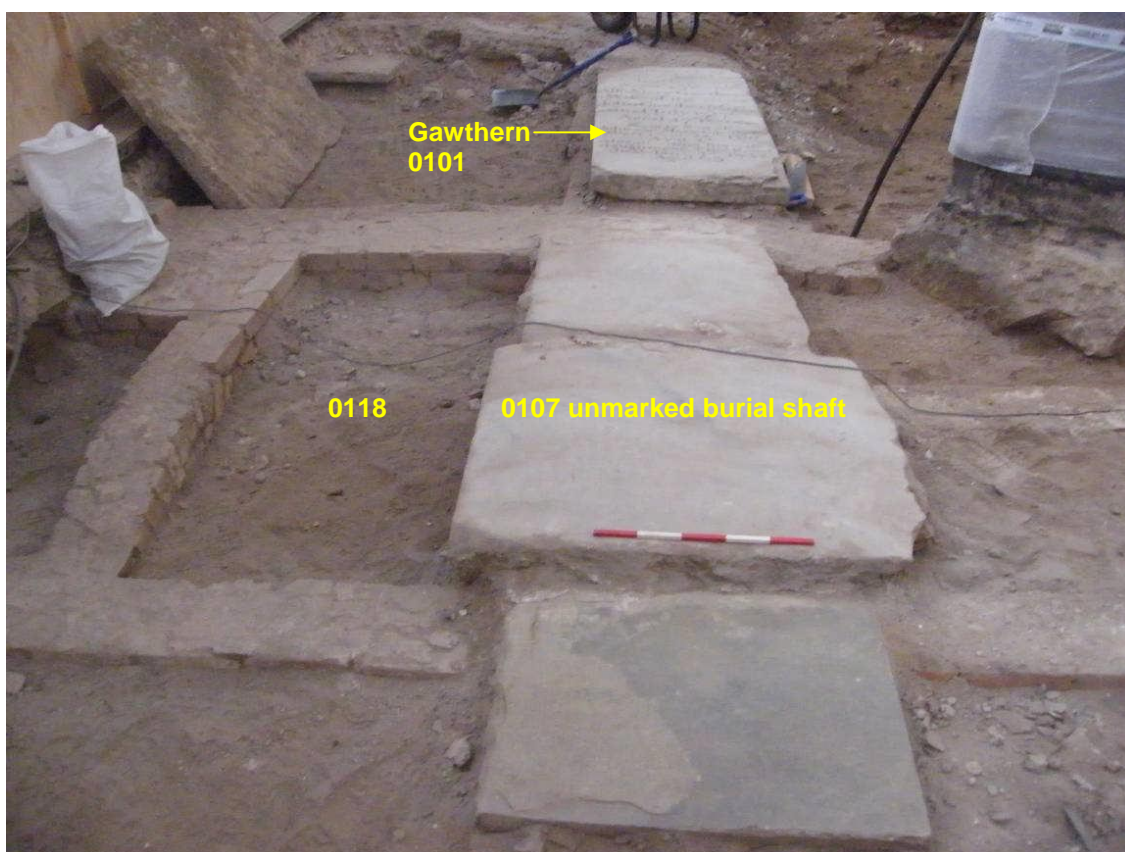
Plate 16a-b: Top showing two ledger stones 0100 and 0101 in the nave (10). Bottom showing brick burial shafts with stone-slab covers below following lowering of 0002 and removal of ledger stone 0100. Looking west.

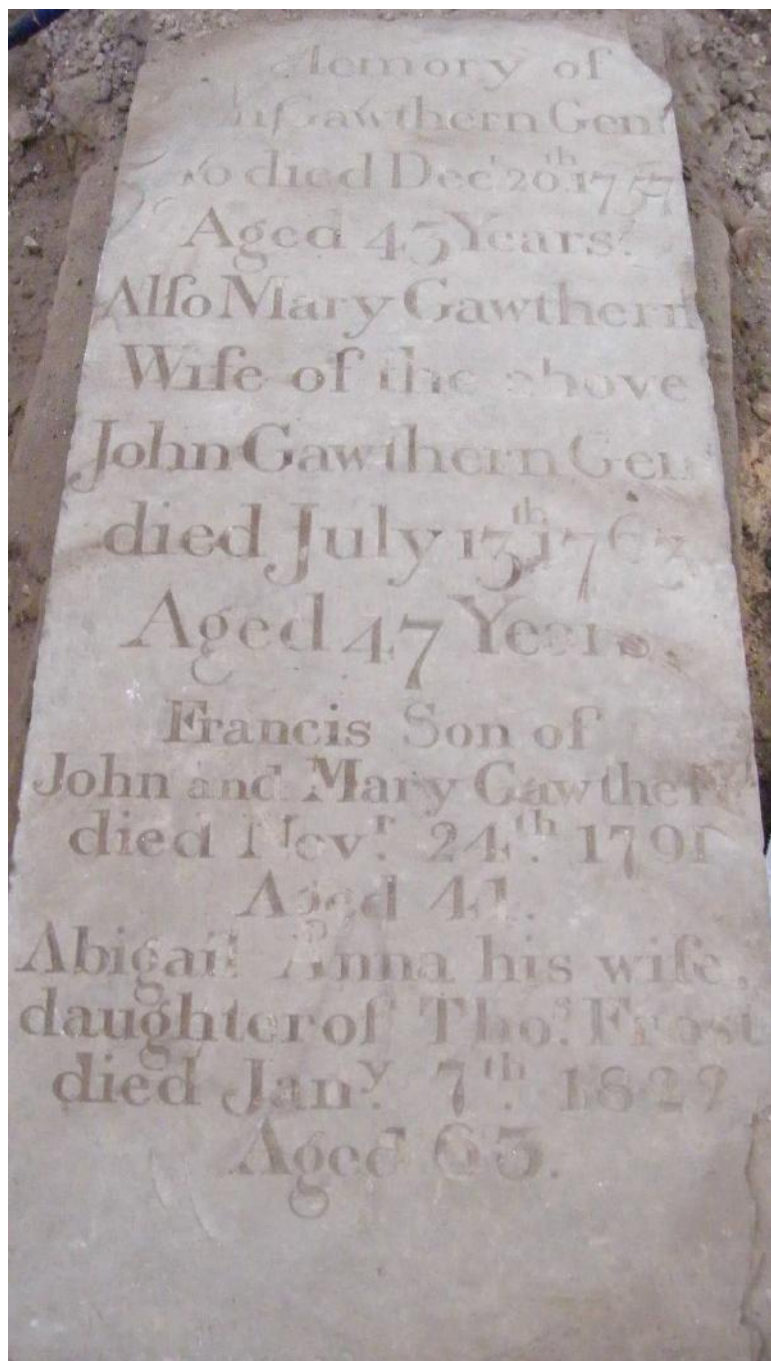
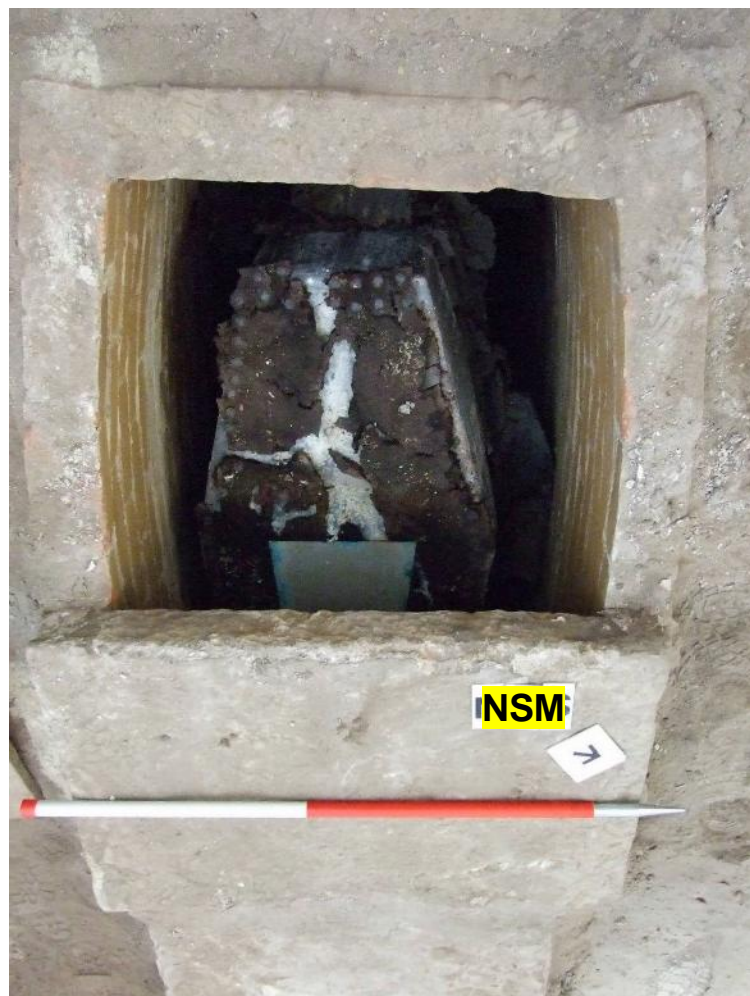
Plate 17 a-b: Showing ledger stone (0101) for Gawthern family in the nave (10), with brick burial shaft 0102 containing shouldered coffins 0103-0106. Looking west.

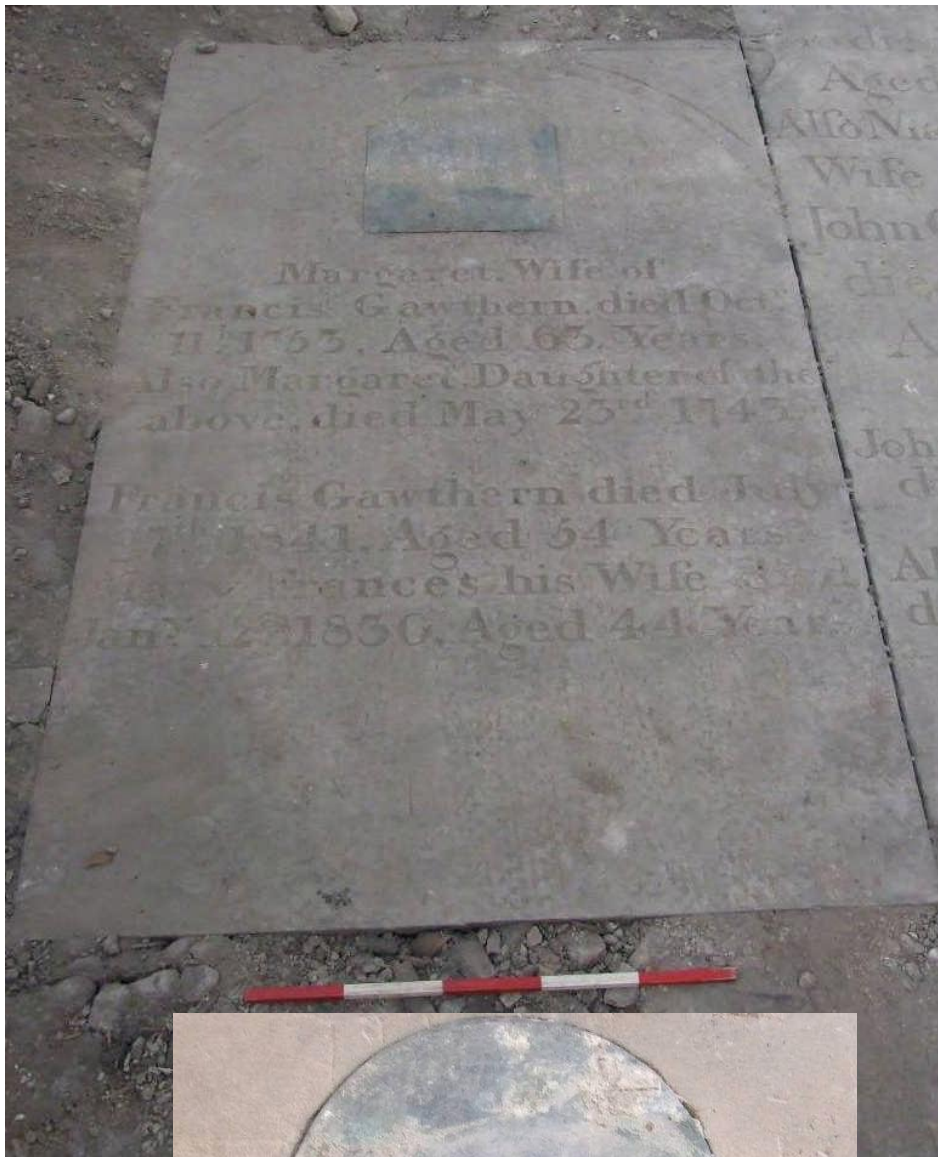
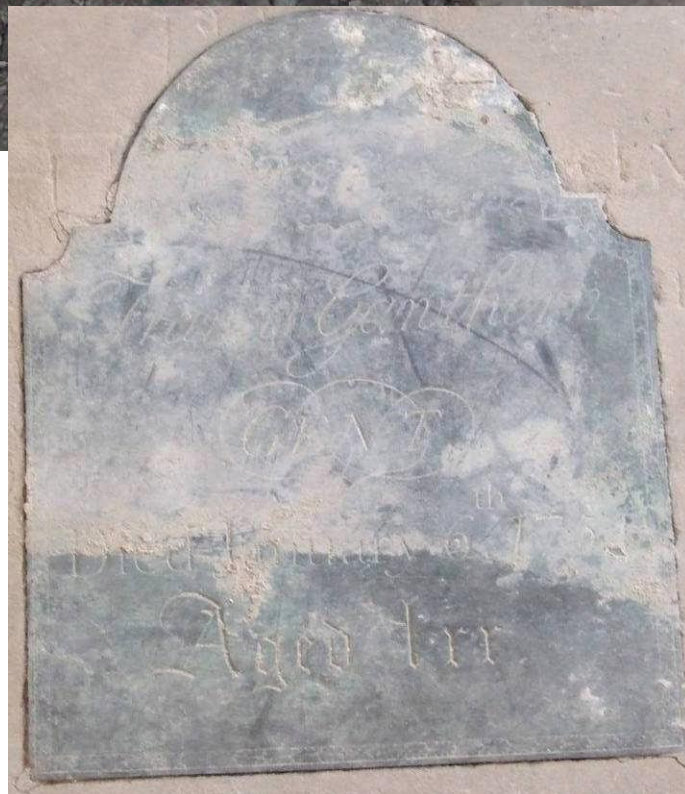
Plate 18a-b: Showing ledger stone 0100 and detail of plaque for Gawthern family in the nave (10). Looking west.

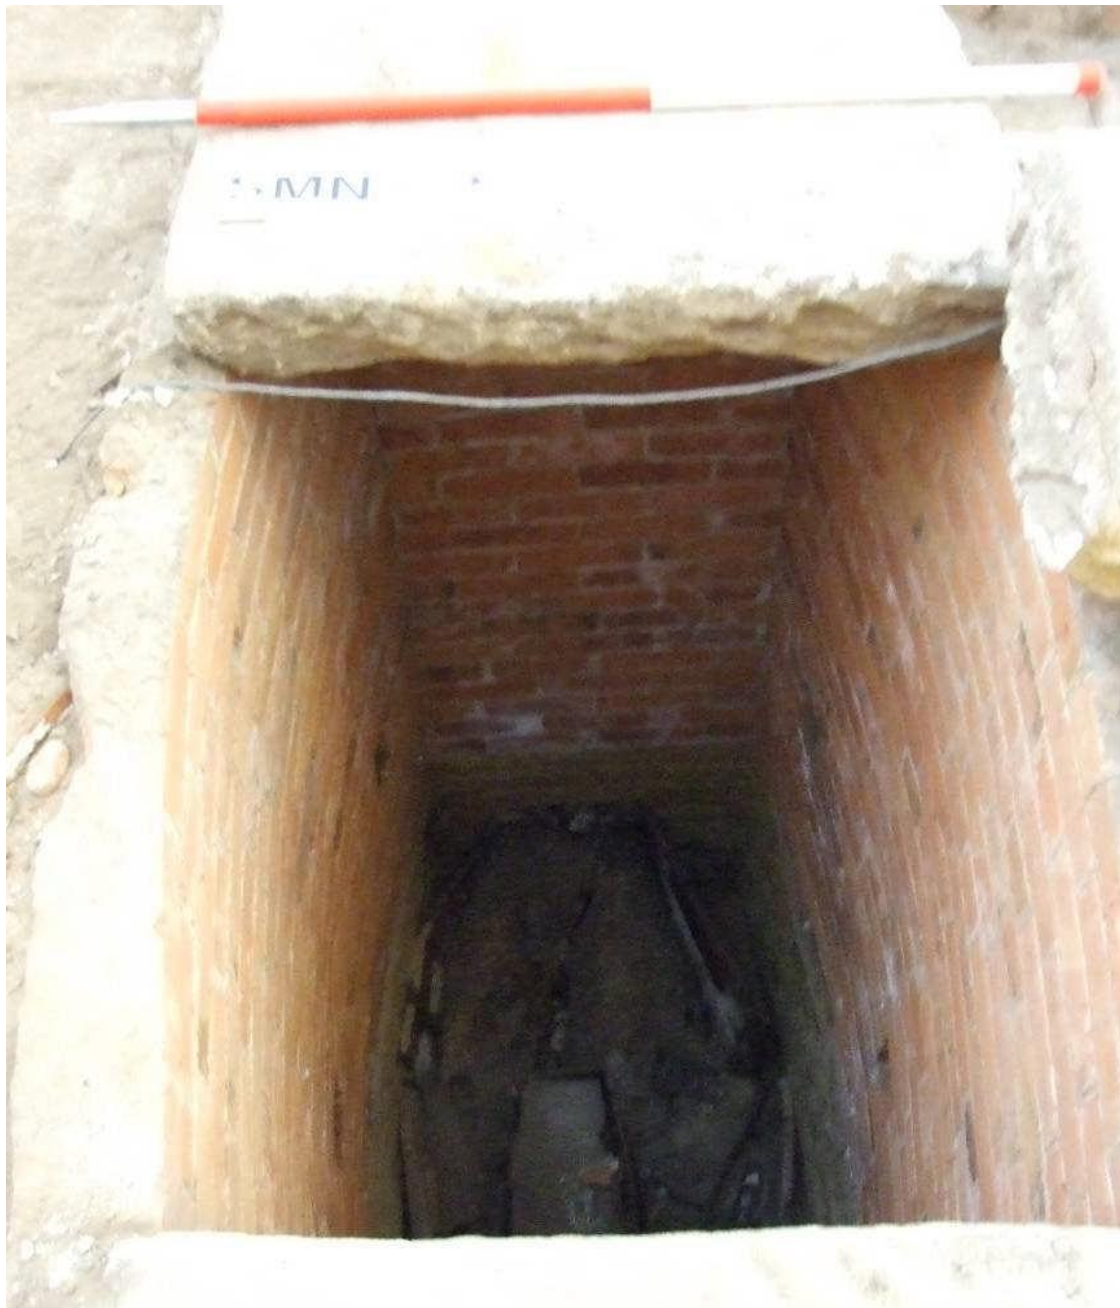
Plate 19: Unmarked brick burial shaft 0107 after removal of covering stone slab showing shouldered coffins within including adult 0108 and child 0109.

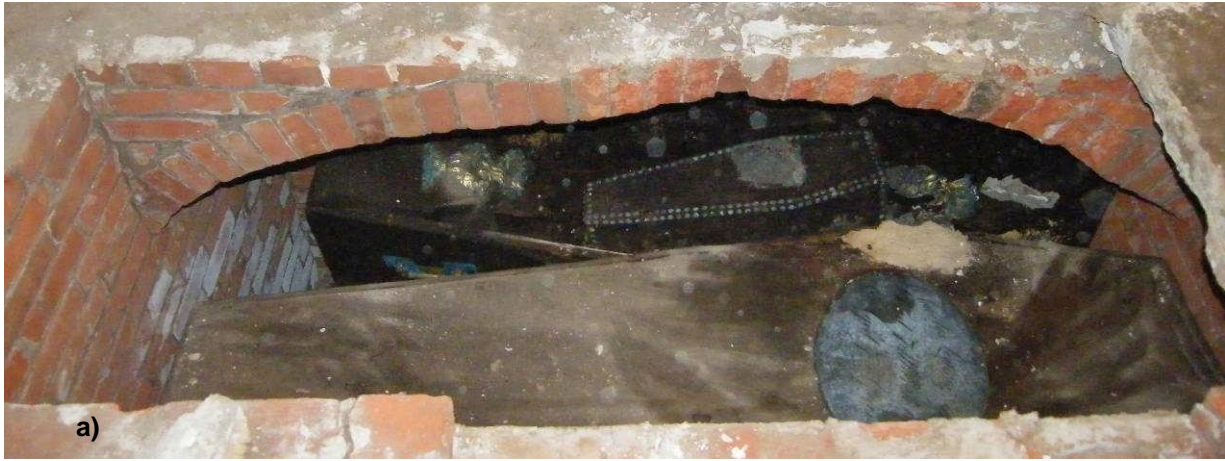
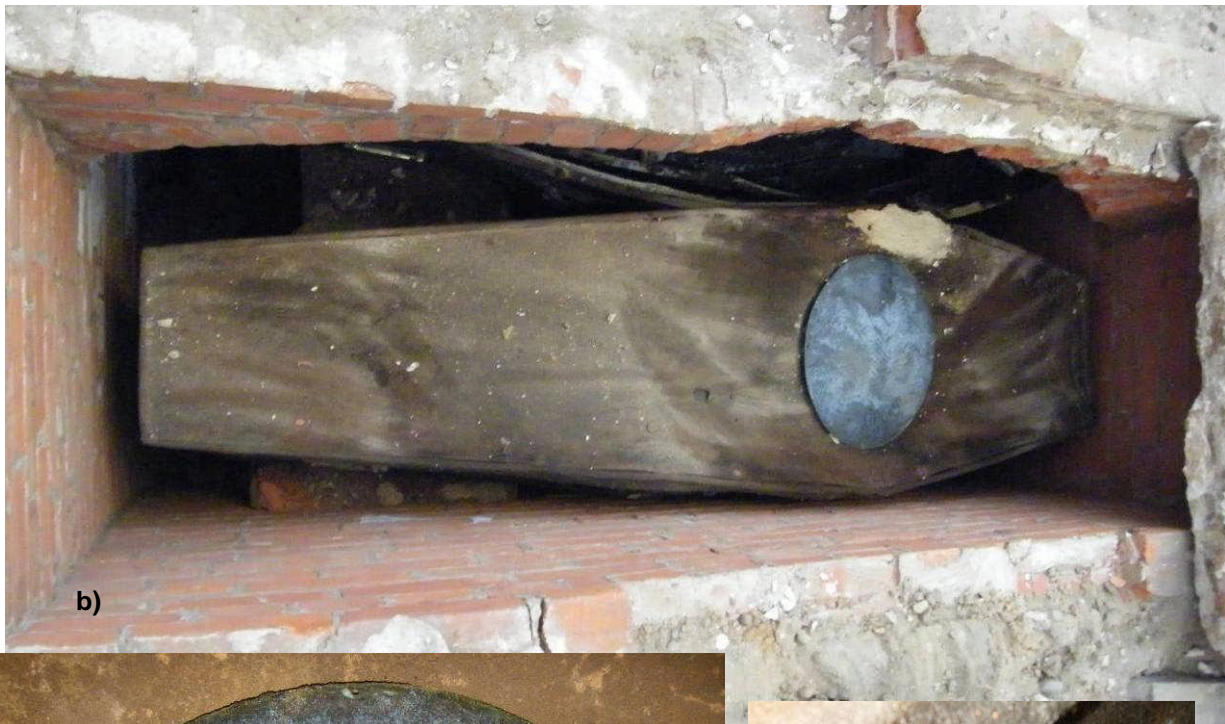
Plate 20a-d: Double brick burial shaft (0301) after removal of covering stone slabs showing shouldered coffin of Charles Lomas Morley died 7th March 1839 aged 73 years. Copper alloy breastplate and coffin grip (c-d).

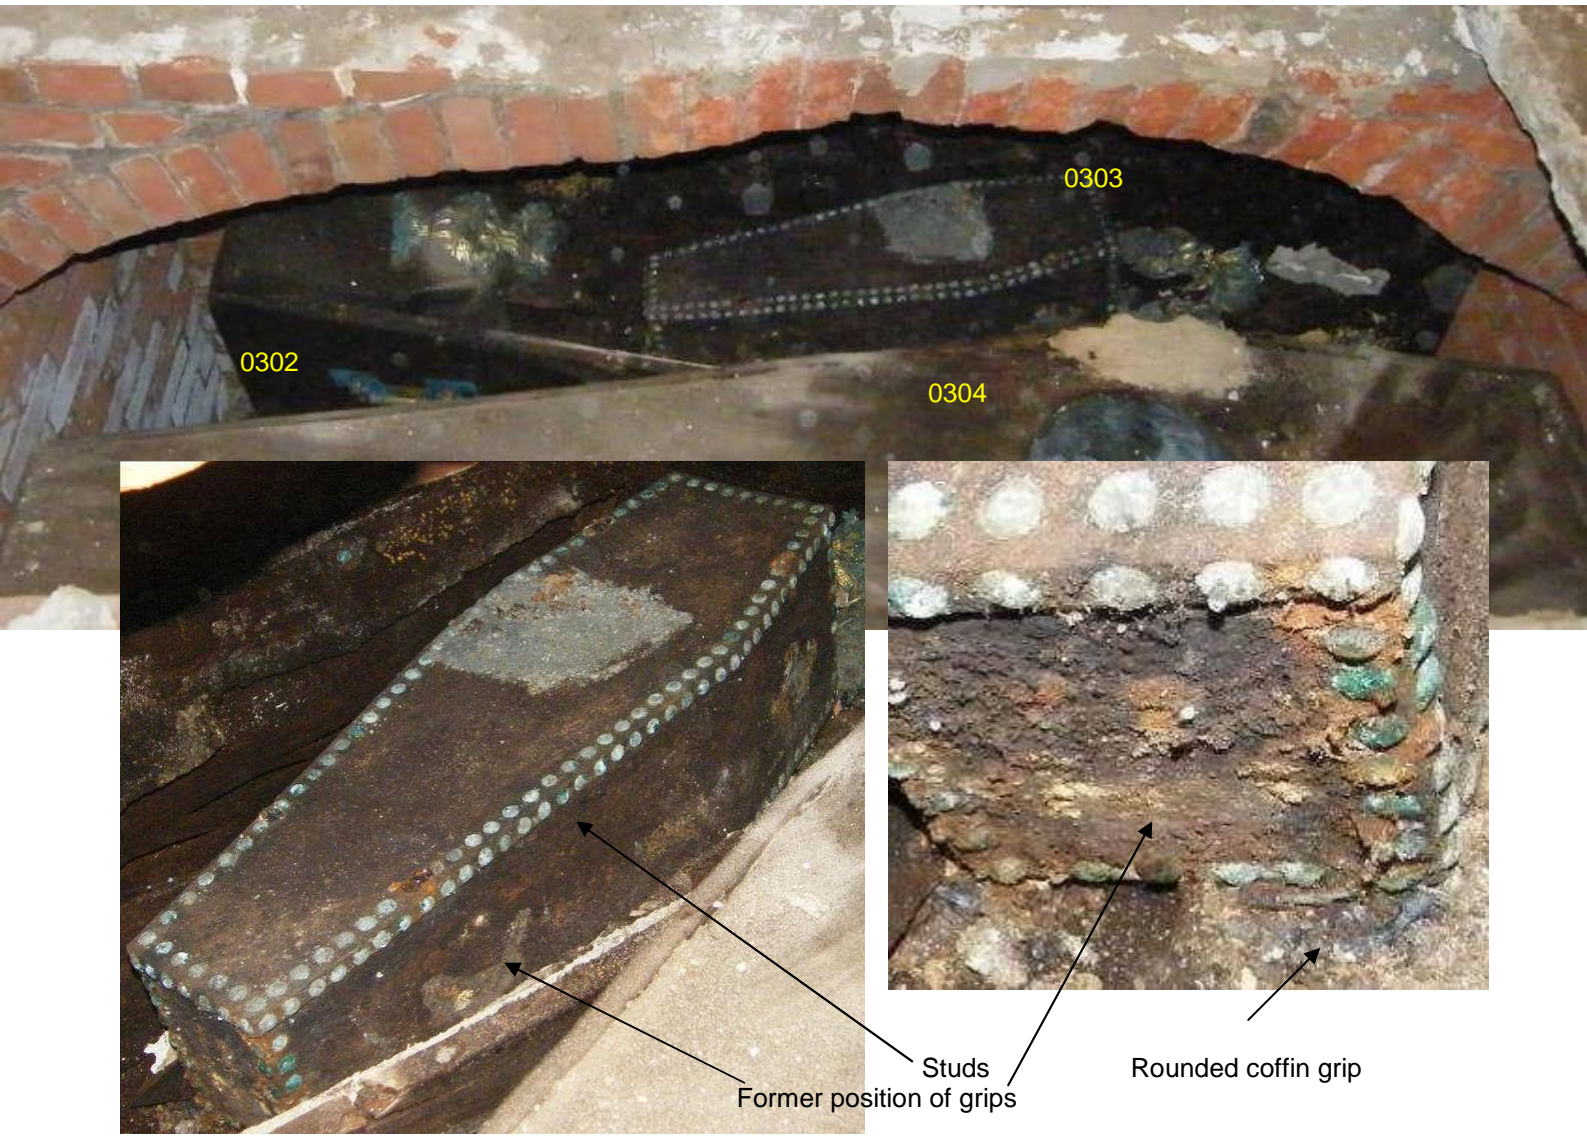
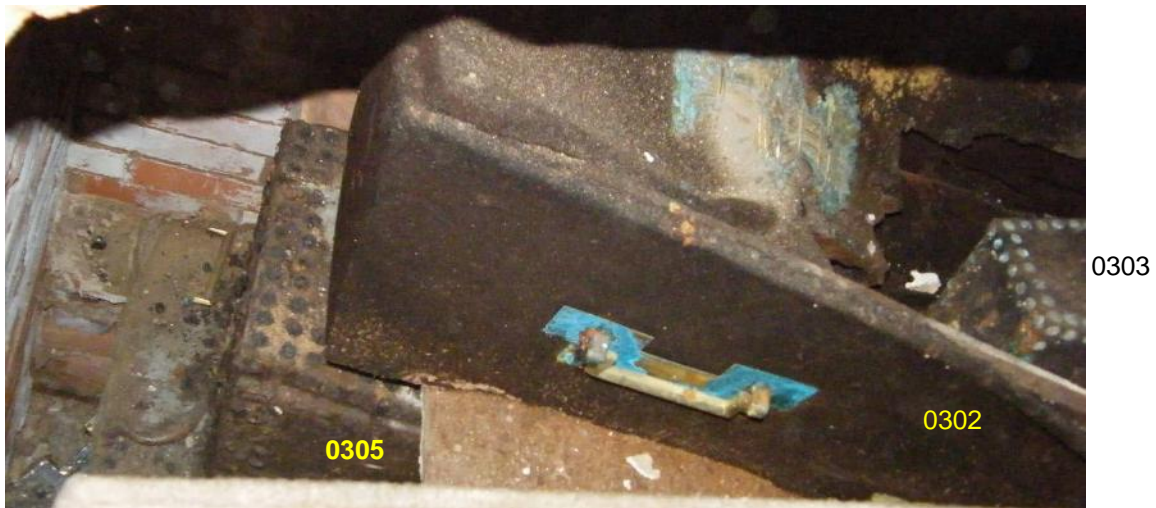
Plate 21a-d: Double brick burial shaft (0301) showing three visible coffins on south side. Child coffin 0303 with studs, adult coffin 0302 with gilded motifs, and adult coffin 0305 with studs below. Child coffin 0303 appears to have been replaced on the south side to facilitate the placement of Samuel Morley's coffin 0304 within the vault.

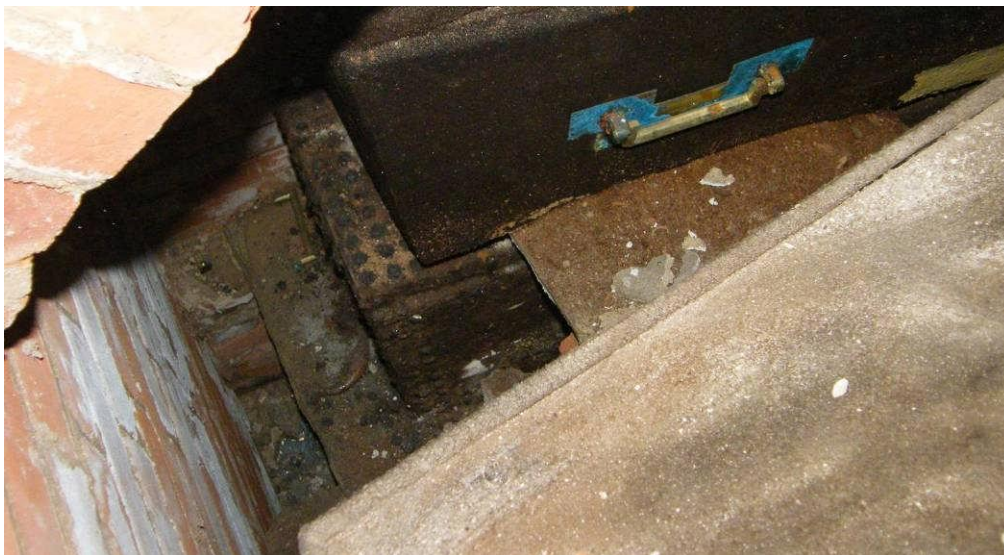
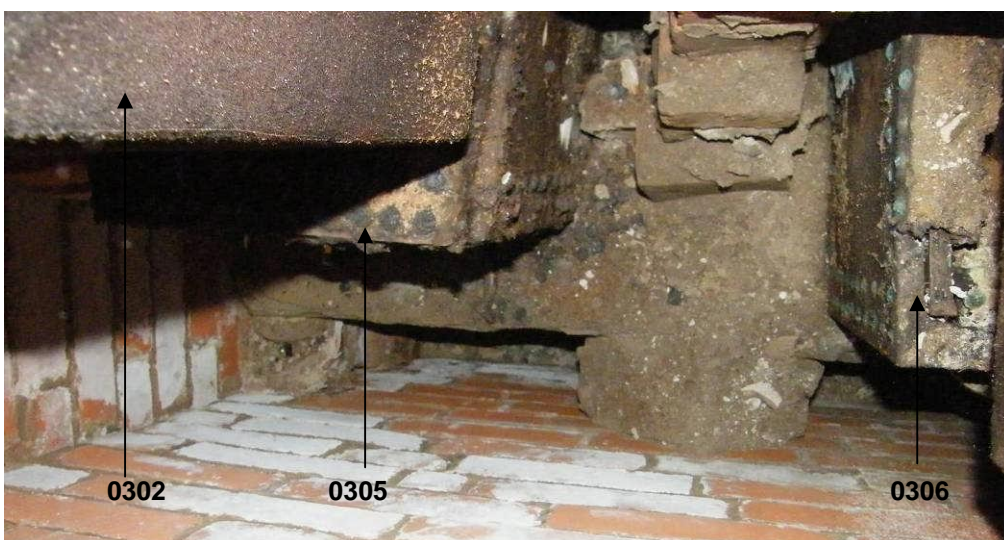
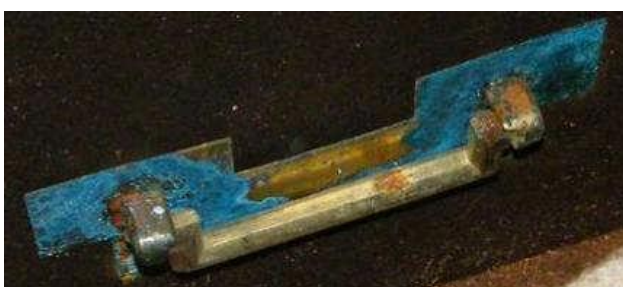
Plate 22a-e: Double brick burial shaft (0301) showing stacked coffins on south side and further studded coffin 0306 on north side below that of Samuel Morley (0000). C-e show examples of coffin grips.

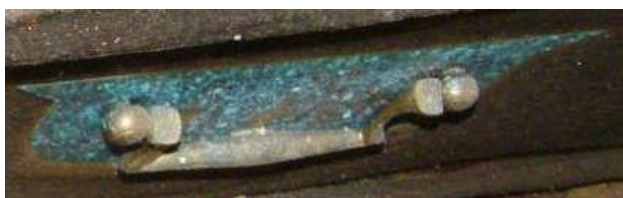
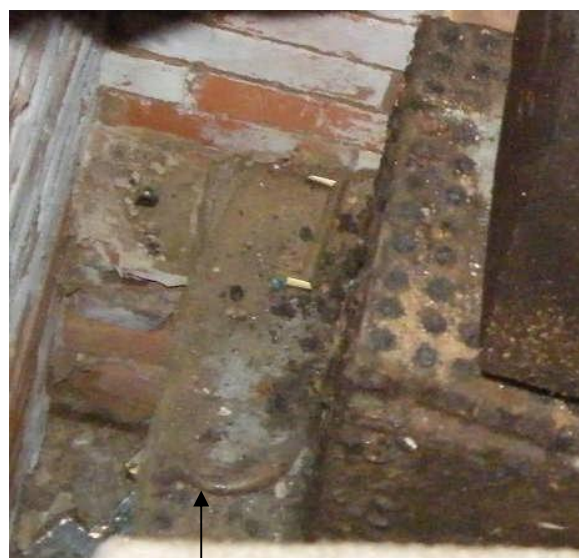
Coffin grip for 0304

Rounded coffin grip from 0305

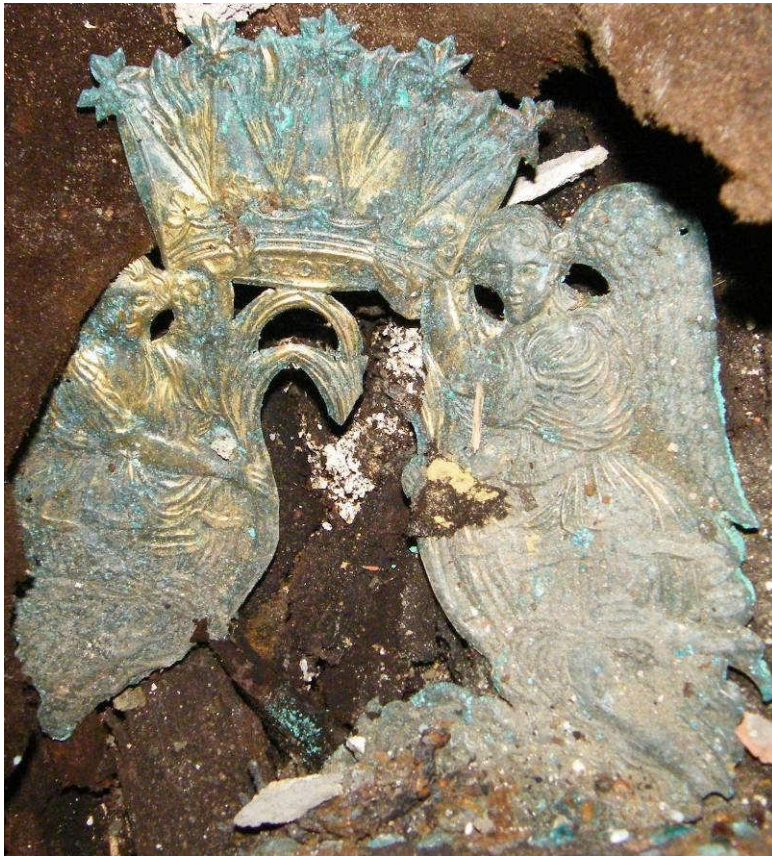
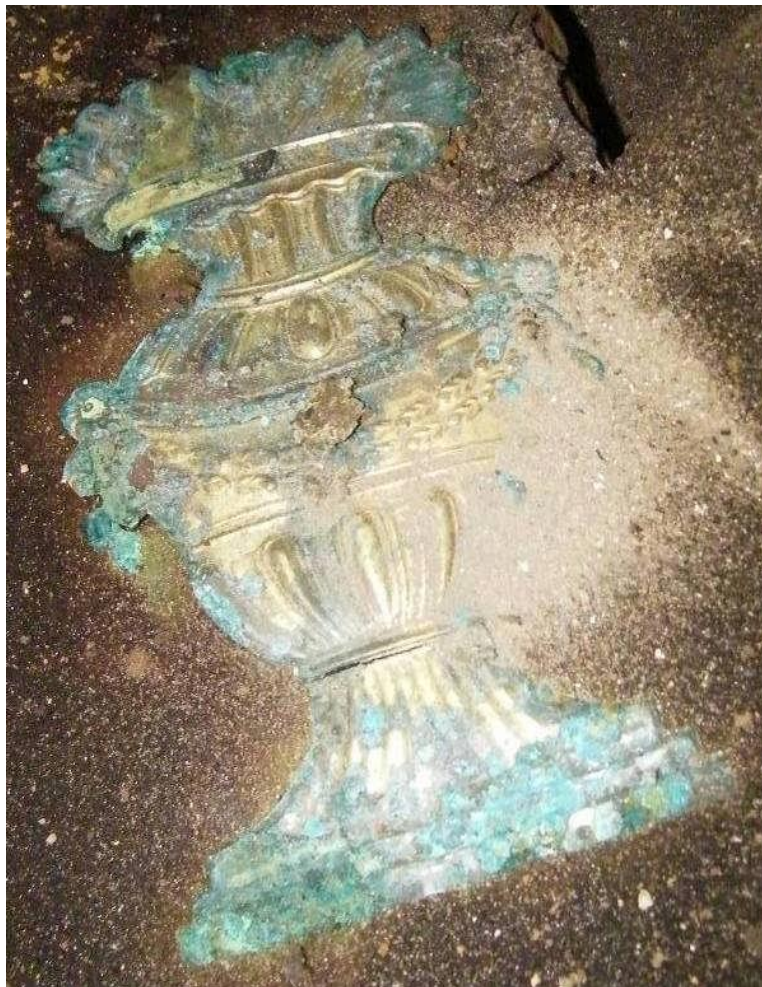
Plate 23a-b: Gilded pressed metal motifs from coffin 0302, including angels with celestial crown and urn.

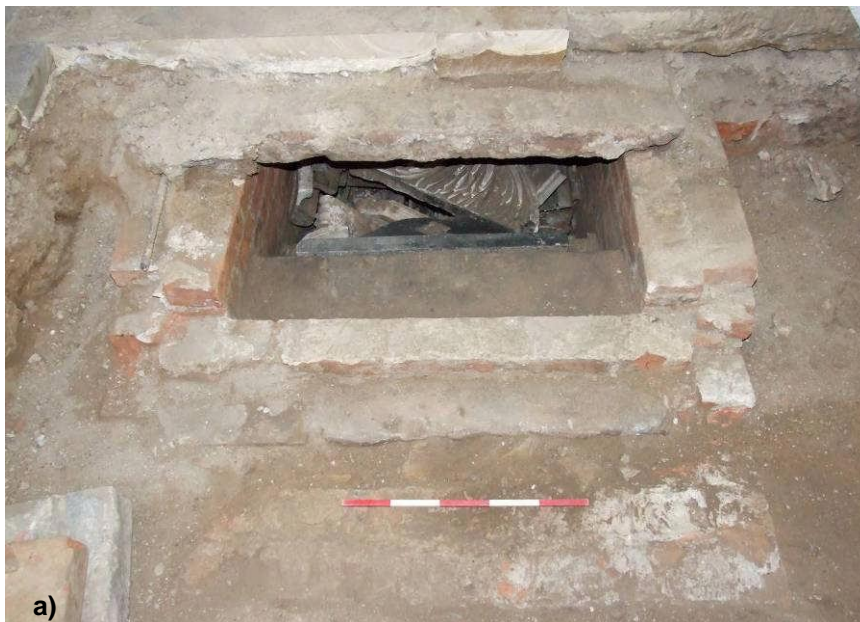
Plate 24a-c: Entrance in Plumptre Vault.

- a. Showing stone steps and brick walling looking east.
- b. Showing external brick vaulting over steps down looking west.
- c. Showing internal brick vaulting over steps down looking east.

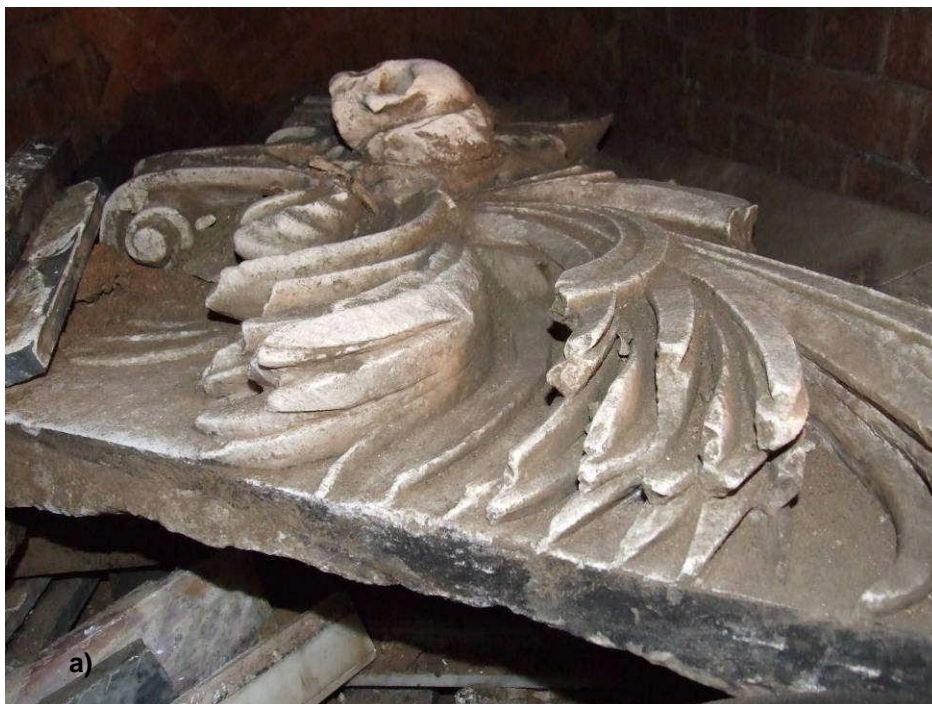
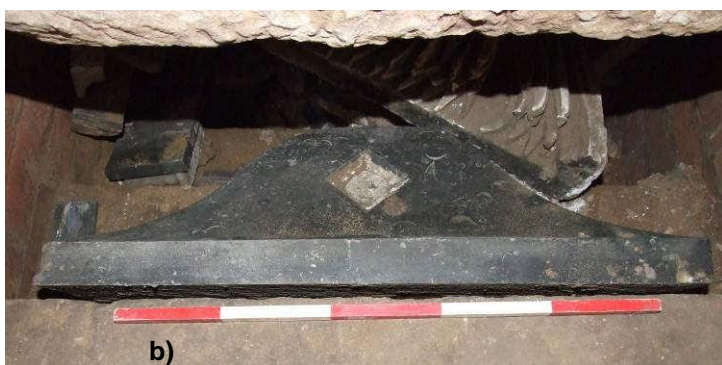
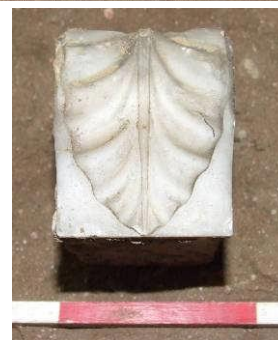
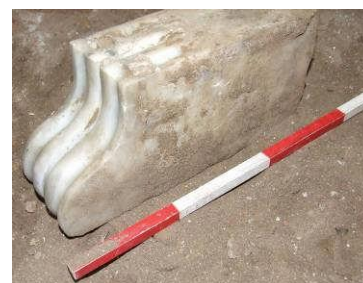
Plate 25a-g: Monument fragments lying across steps within the Plumtre Vault. Some at least appear connected to the Wright family (d-e). Stylistically some elements appear 17th to 18th century in date e.g. a.winged skull, b.apron, g. fluted corbel or bracket.

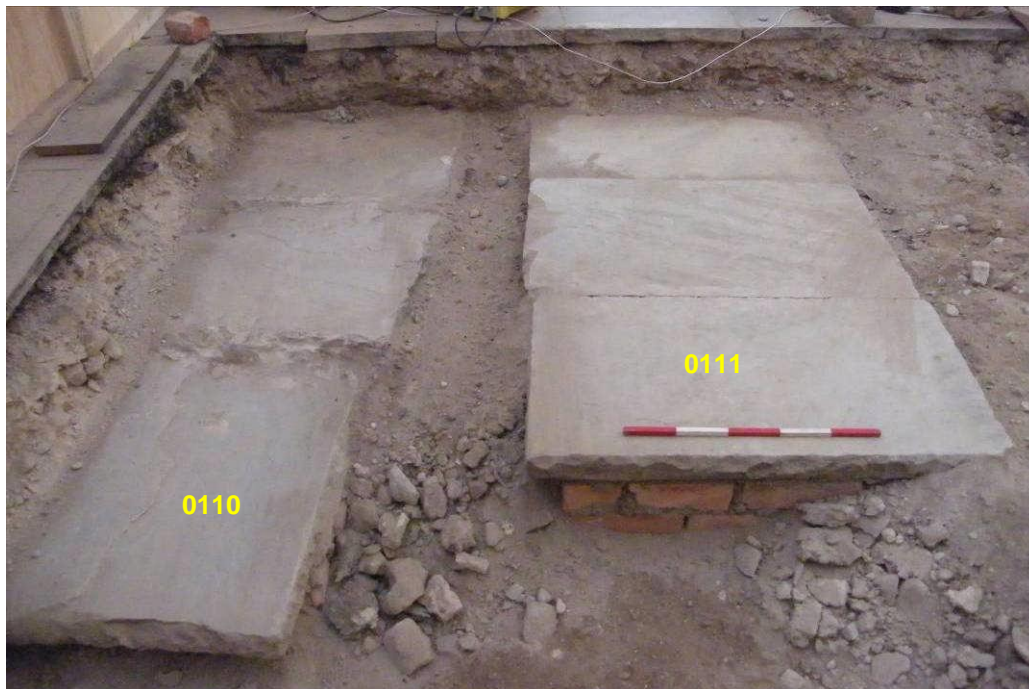
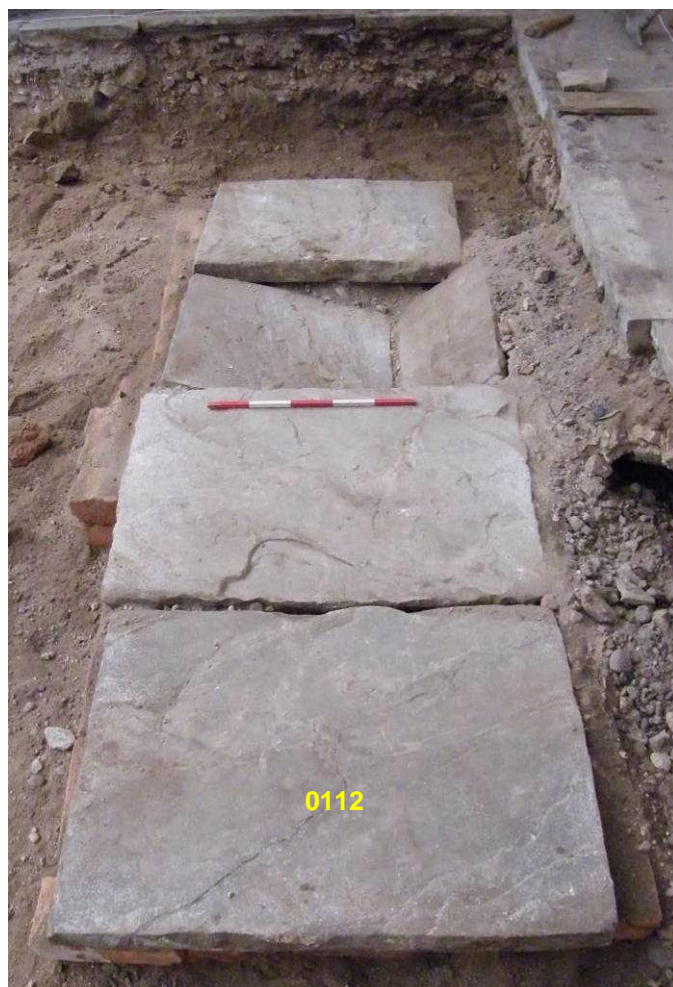
Plate 27: Un-marked brick burial shafts with stone-slab covers in (10) the nave. Top 0110 and 0111, bottom 0112.

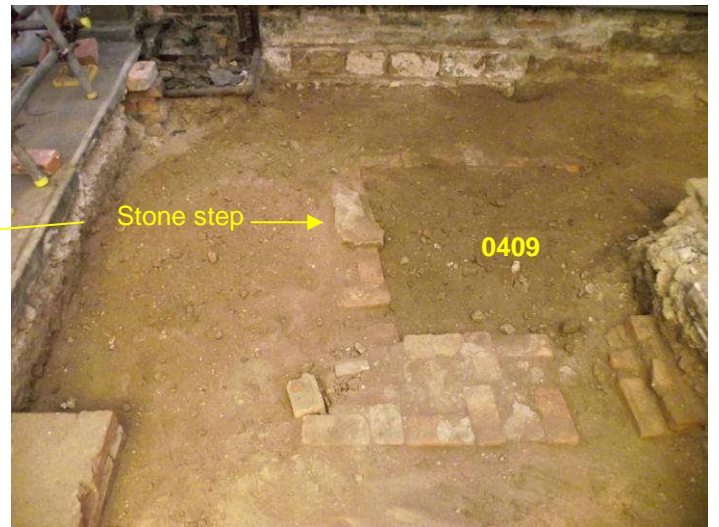
c)

Plate 28a-e: A-d, rectangular brick structure 0409 within the east end of the south transept (14).
 e) The Earl of Clare Tomb formerly located at the east end of the south transept as illustrated prior to its removal in 1804.

5.7.2. No conclusive remains for the tomb were identified below ground during the works. However, the partial remains of a rectangular brick structure were exposed within the corresponding area of the tomb (Figure 8: Plate 28).

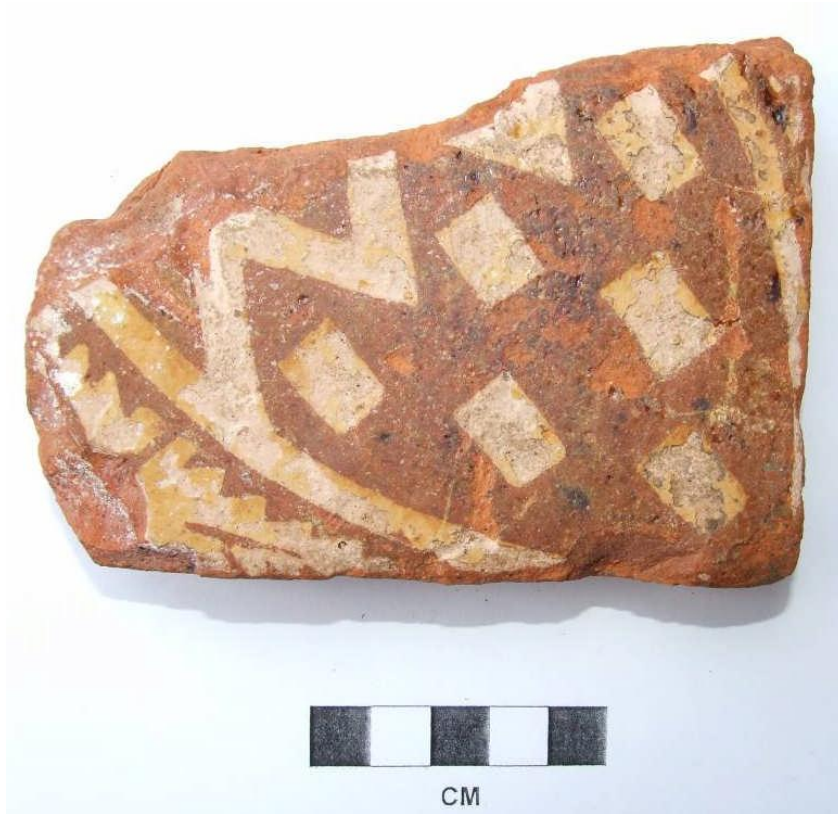
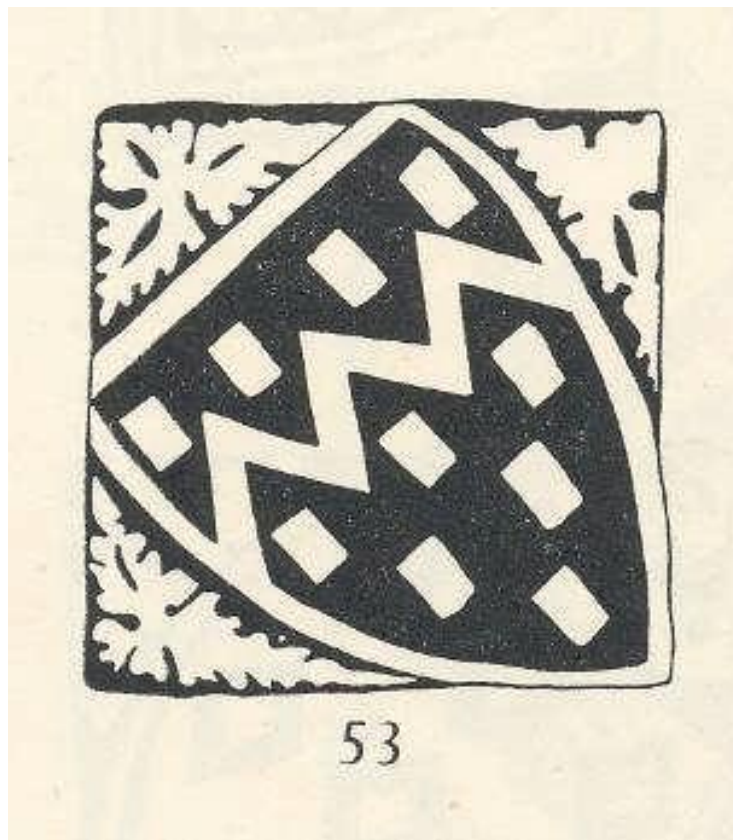
Plate 29: Medieval floor tile BAA and corresponding pattern (after Whitcomb 53).

- BAA – Diagonal shield with partial coat of arms of the D'Eyncourt family (six billets below *fesse dancette*), leaf motif to side. Ralph De Ayencourt founded Thurgarton Priory in 1140-45. Corresponds with Whitcomb 53. Yellow and brown glaze with orange-brown well sorted sandy fabric. 118mm x 20mm thick. Slightly bevelled sides and sanded base (Plate 29).
