CHURCH OF ST.MARY'S THE VIRGIN NOTTINGHAM

ARCHAEOLOGICAL RECORDING DURING
ALTERATIONS TO THE FLOOR LEVELS
2013

Project Code: NSM3/Report Number: 062/2013

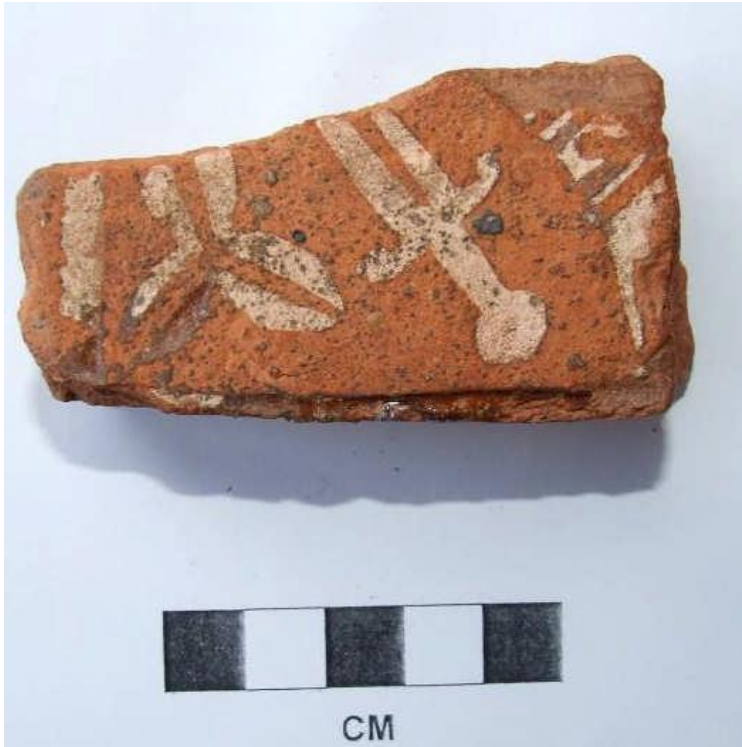
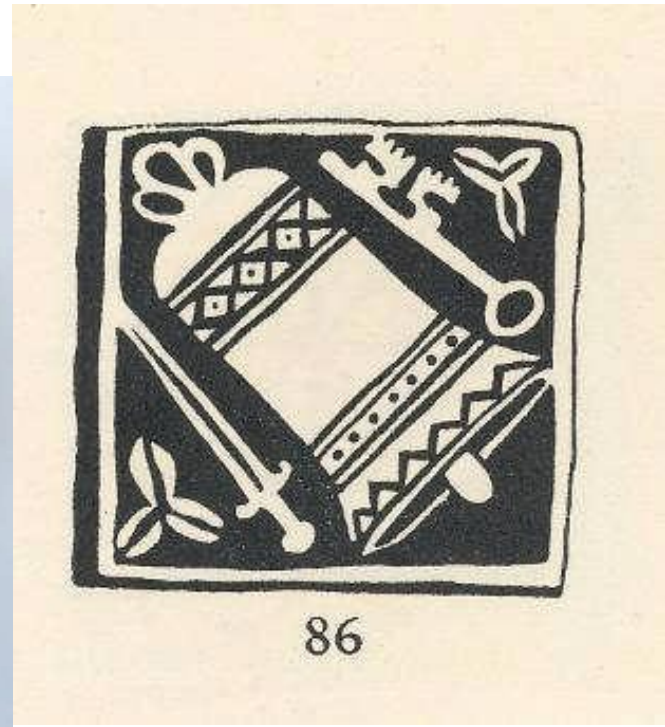
Plate 30: Medieval floor tile BAB and corresponding pattern (after Whitcomb 86).

- BAB- Partial diagonal bell and sword with trefoil in corner. Corresponds with Whitcomb 86. Yellow and brown glaze with light orange-brown sandy fabric. 25mm thick. Slightly bevelled sides and sanded base (Plate 30).

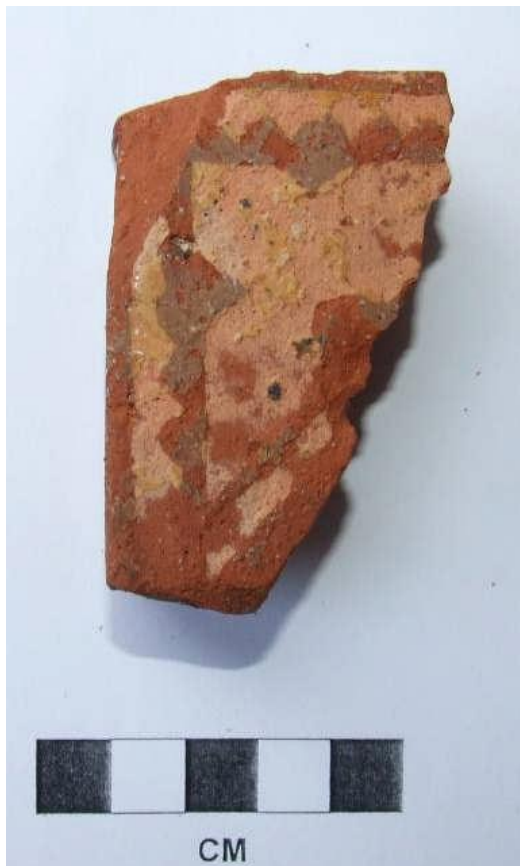
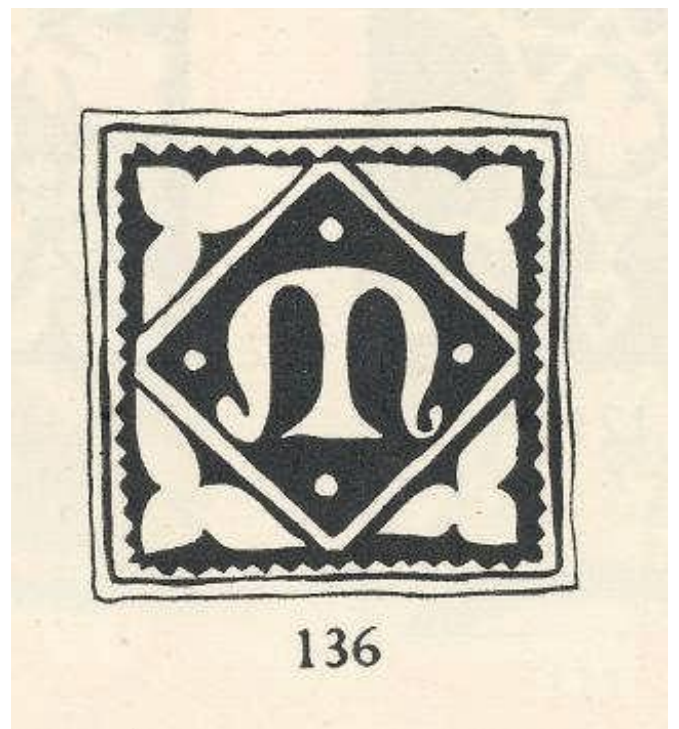
Plate 31: Medieval floor tile BAC and corresponding pattern (after Whitcomb 136).

- BAC- Three-lobed motif in corner with toothed border. Corresponds with Whitcomb 136. Yellow and brown glaze with orange-brown well sorted sandy fabric. 21mm thick. Slightly bevelled sides and sanded base (Plate 31).

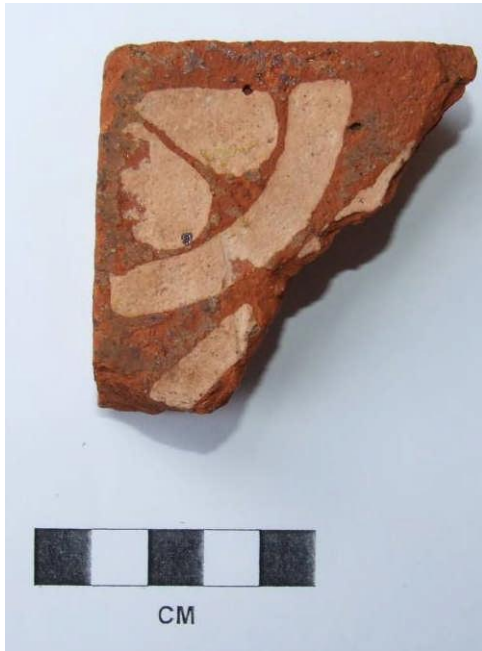
Plate 32: Medieval floor tile BAD and corresponding pattern (after Whitcomb 102).

- BAD- Quadrant of a circle in the corner enclosing two petals of a rosette. Corresponds with Whitcomb 102. Yellow and brown glaze with orange-brown well sorted sandy fabric with occasional dark inclusions up to 2mm in size. 21mm thick. Slightly bevelled sides and sanded base (Plate 32).

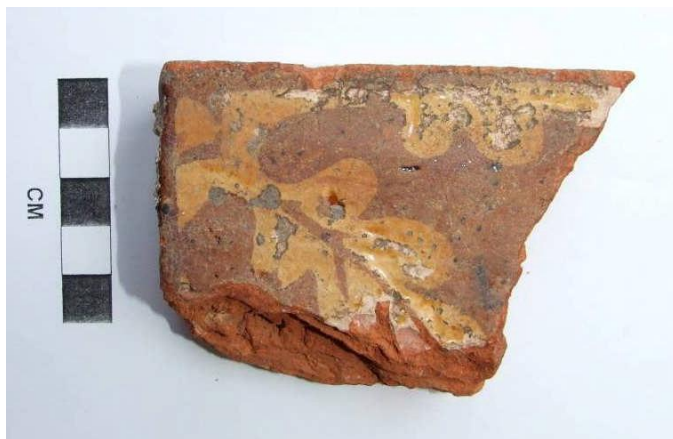
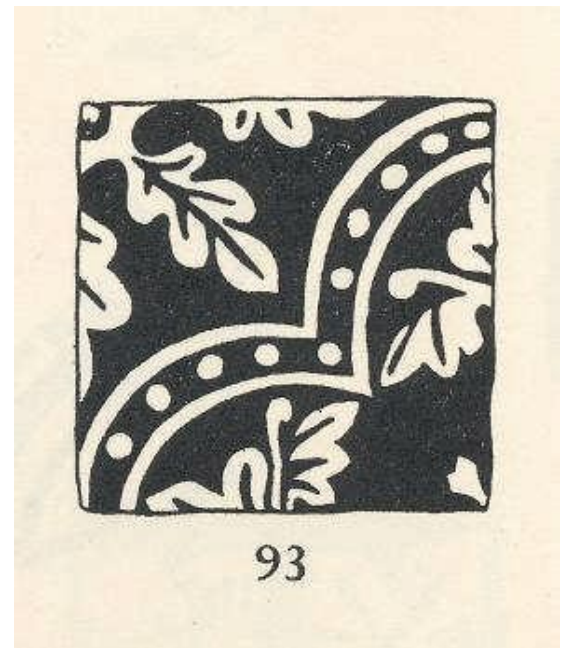
Plate 33: Medieval floor tile BAE and corresponding pattern (after Whitcomb 93).

- BAE – Spray of oak leaf in corner. Corresponds with Whitcomb 93. Yellow and brown glaze with orange-brown well sorted sandy fabric. 22mm thick. Slightly bevelled sides and sanded base (Plate 33).

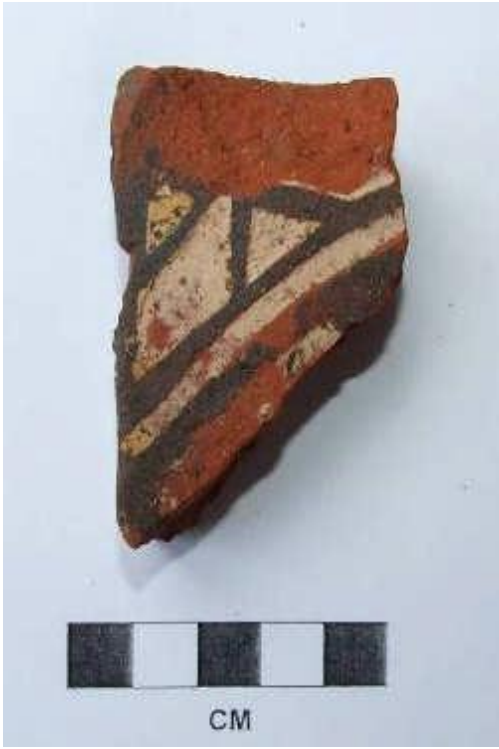
Plate 34: Medieval floor tile BAA

- BAF – Unidentified three small triangles in corner. Yellow and dark brown glaze with red-brown hard fabric. 21mm thick. Slightly bevelled side and sanded base (Plate 34)

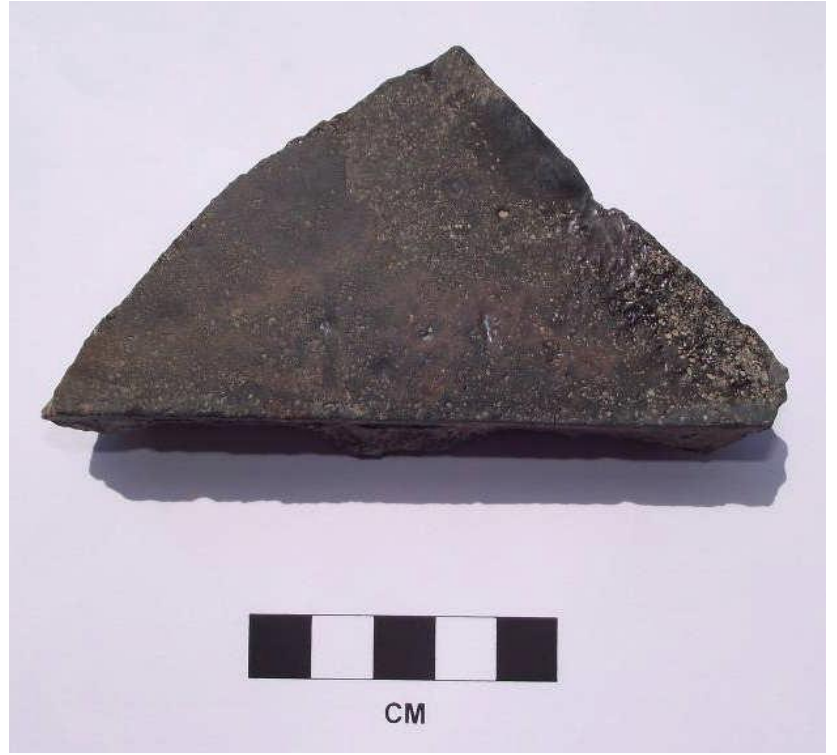
Plate 35: Medieval triangular floor tile

6.2.4. One incomplete triangular floor tile was found (Plate 35). It had a brown to purple-black glazed surface and a hard-fired fabric with dark-red core and dark-grey outer edges, 21mm thick. One side had a sharp bevel, while one had straight cut upper edge and broken lower edge where the former square tile had been split to form two triangular tiles.

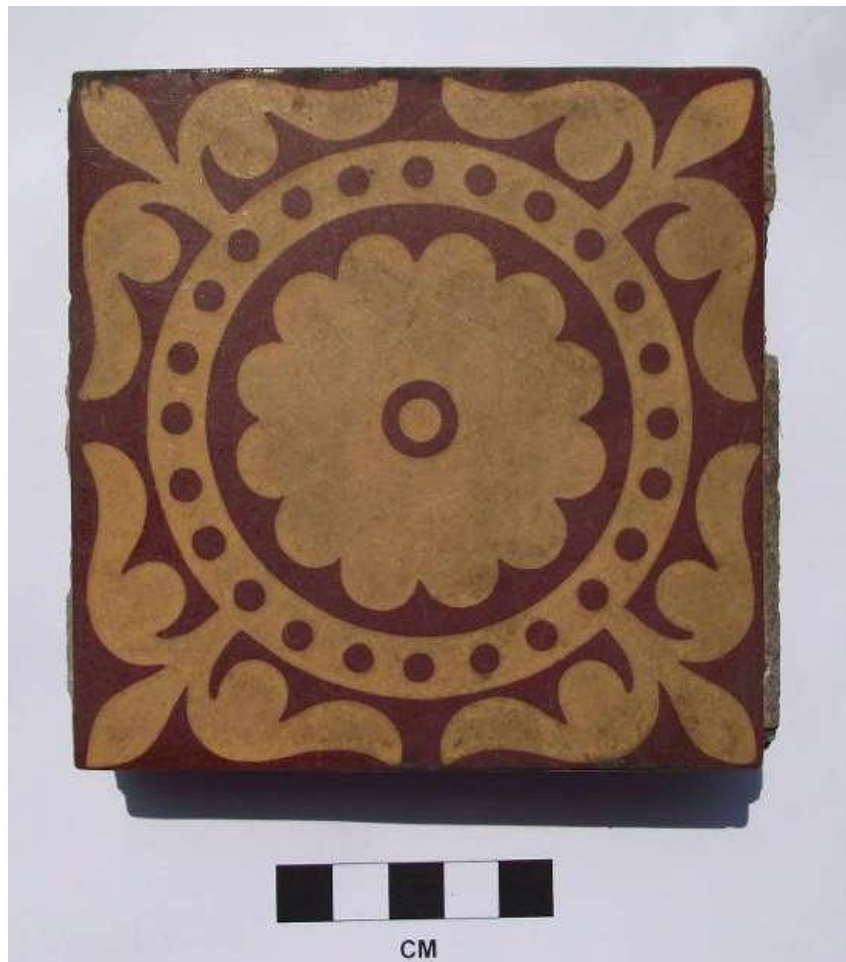
Plate 38: 19th century floor tile (13)

6.3.2. A single complete decorated floor tile of 19th century date was recovered from 0002 in 13 (plate 38). The pattern comprised four foliated fleur-de-lys at each corner with an encircled twelve petal central floral motif. It had a hard fired fabric; across the back were sixteen round holes (to aid firing and later application). Dimensions were 111mm x 111mm x 21mm. The tile probably originates from the mid-19th century re-flooring of the church.

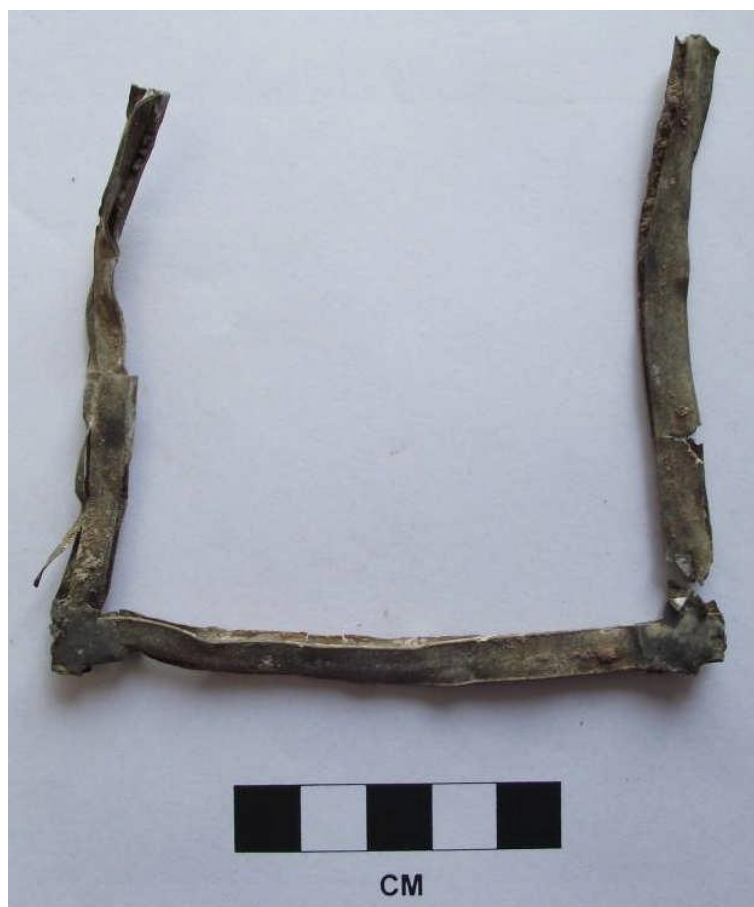
Plate 39: Fragment of window came (14)

6.3.5. Three lengths of joined lead window came apparently forming a square or diamond shaped quarry c. 87mm x 85mm was recovered from 0002 in the south transept (14). The came had a flattened H-shape profile 7mm wide and 2mm thick (Plate 39).

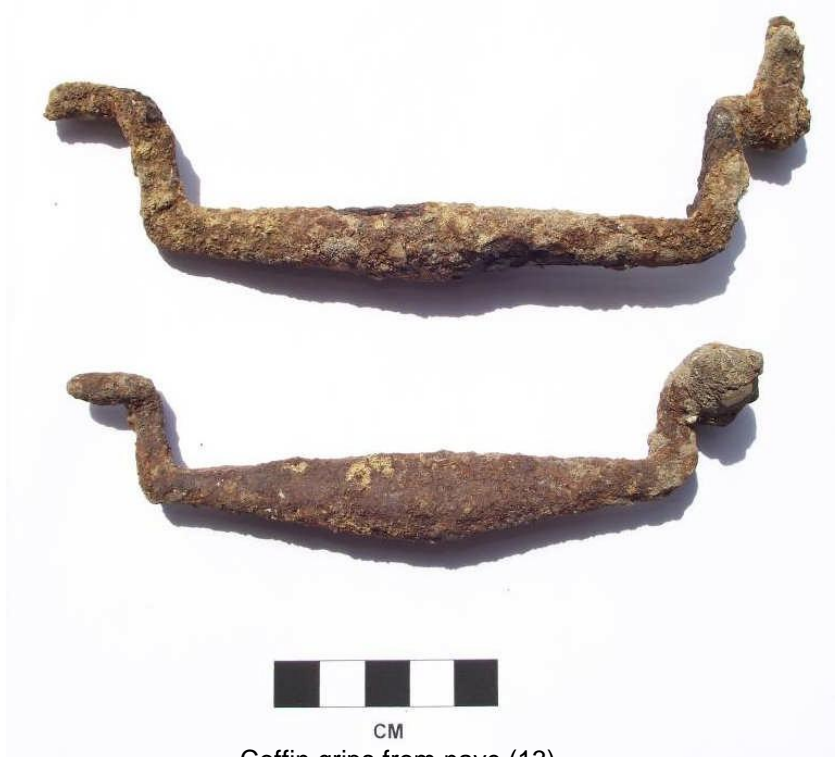
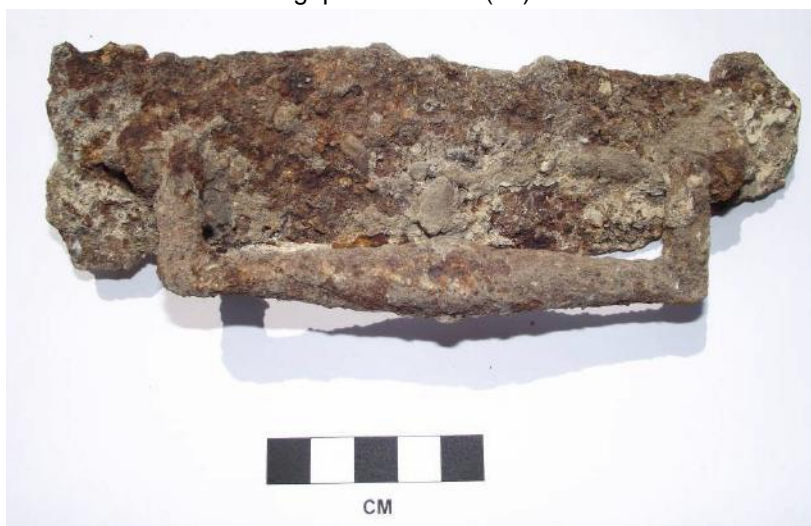
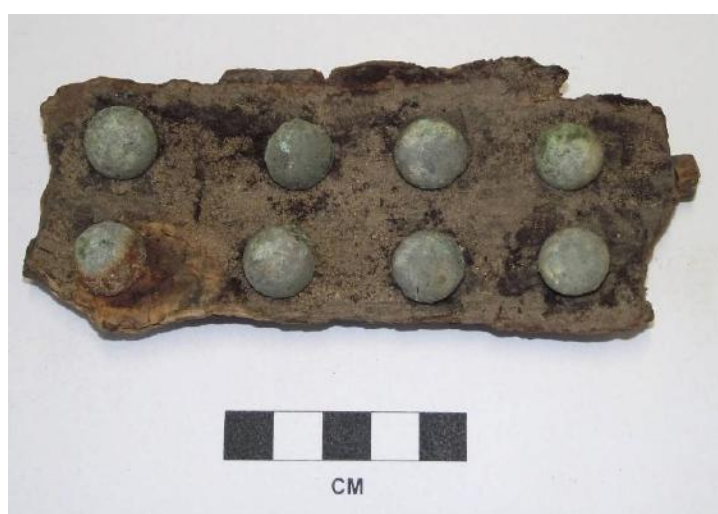
Coffin grips from nave (13)

Coffin Grip and plate from nave (10)

Fragment of wooden coffin shell with studs (10)

Plate 40: Coffin Grips and Coffin Fragment

6.3.6. A total of twelve coffin grips were recovered from 0002 during the groundwork highlighting previous disturbance and redeposition of 18th/19th century burials within the church. The majority were from the north side of the nave. Six grips were from 10 and five from 13 (Plate 40) with only one grip recovered from in the south transept 14. Only one grip was recovered with the attached grip plate (Plate 40). All were of simple none decorated types.
