CHURCH OF ST CATHERINE, COSSALL, NOTTINGHAMSHIRE:

ARCHAEOLOGICAL RECORDING OF GROUNDWORKS WITHIN THE CHURCHYARD

**Faculty Number: 2020-047272
Contractor Project Code: SCC.1
Report Number: 008/2021**

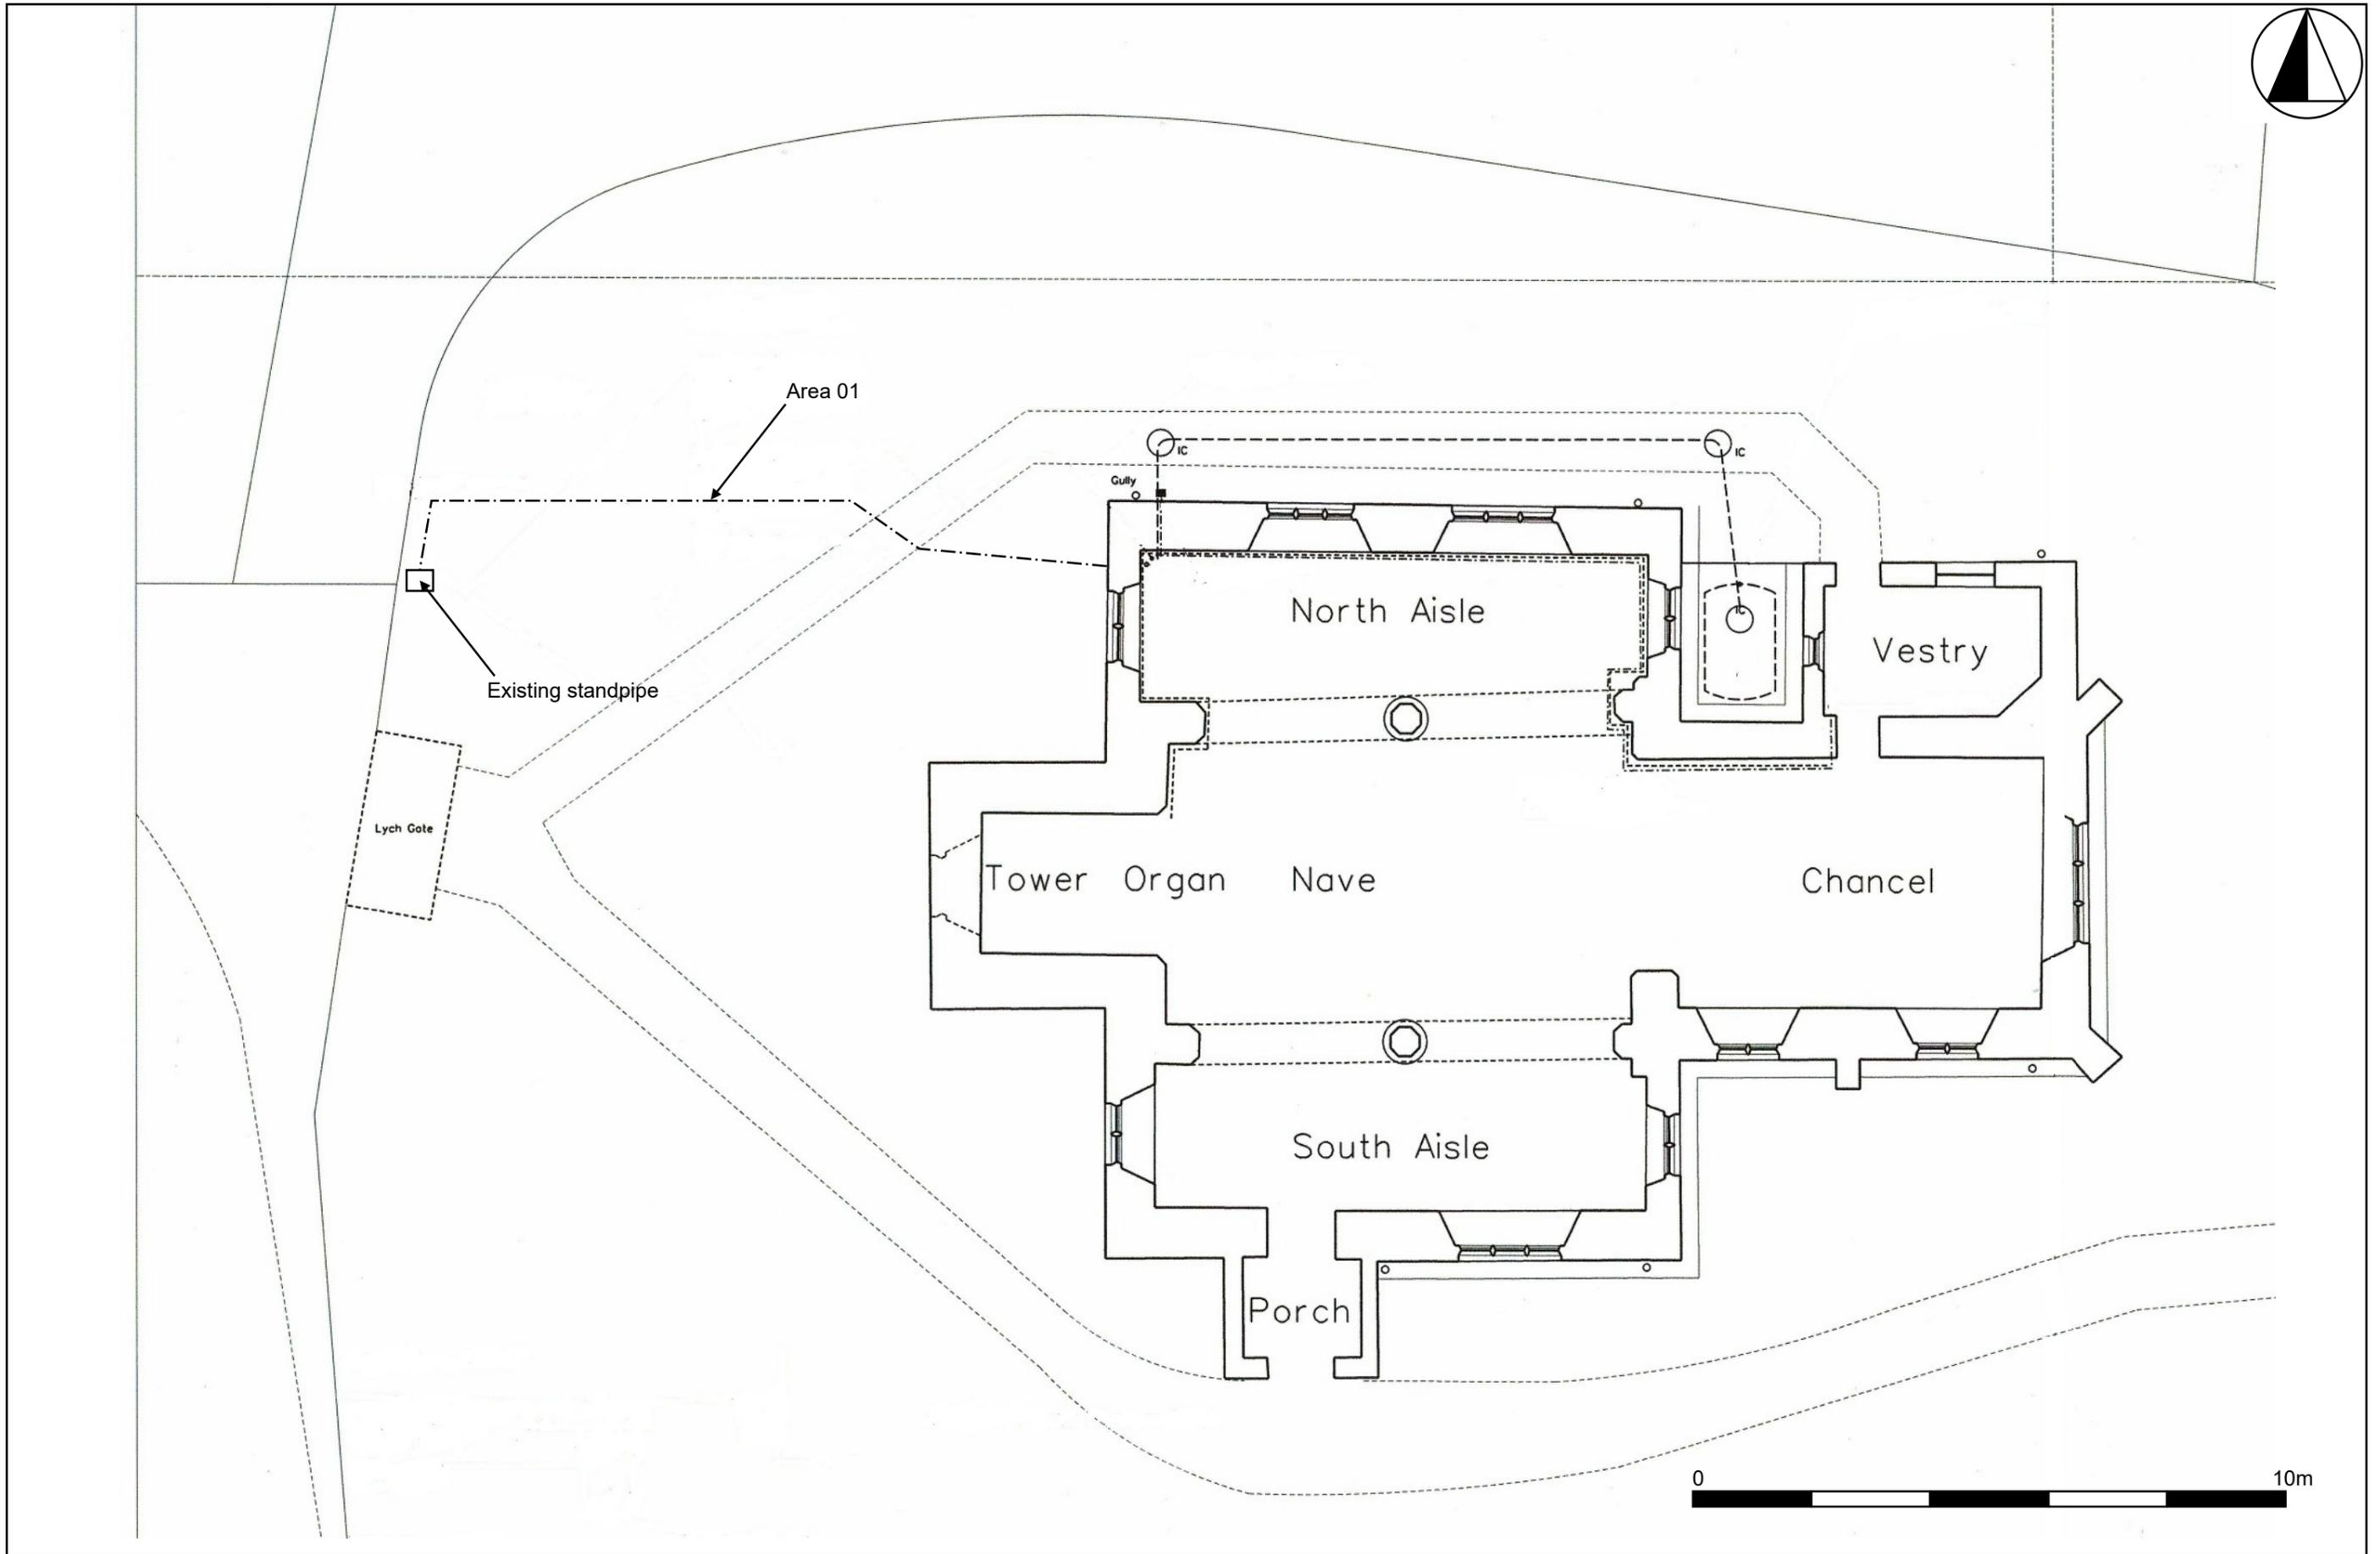
SCC.1 Church of St Catherine, Cossall, Nottinghamshire.
Figure 2: Area 01 location plan.
Scale 1:100 at A3.

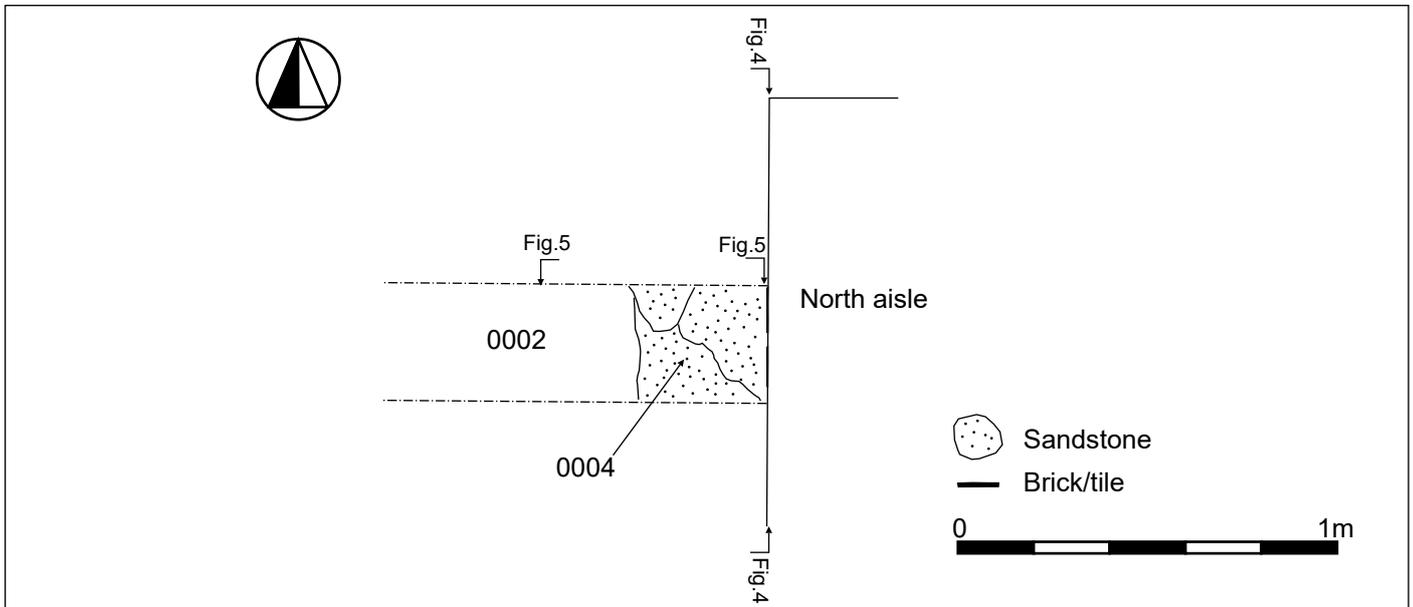
5.2.2. In the east end of the trench the sandstone rubble foundation 0004 for the west wall of the north aisle, dating to 1842-3, was encountered. The very top of 0004 incorporated brick or tile fragments which were probably used to level or strengthen the foundation. The brick or tile was bonded to the wall above and sandstone below with a light brown lime mortar in contrast to the sandstone which used firm brown sandy clay. The foundations reached a depth of 0.26m and extended up to 0.34m from the face of the north aisle wall and were set in a trench 0003 which truncated the natural sandstone 0002 and was partially infilled with firm brown silty clay loam (0005).

SCC.1 Church of St Catherine, Cossall, Nottinghamshire.
 Figure 3: Area 01 east end post excavation plan of 0004.
 Scale 1:20 at A4.

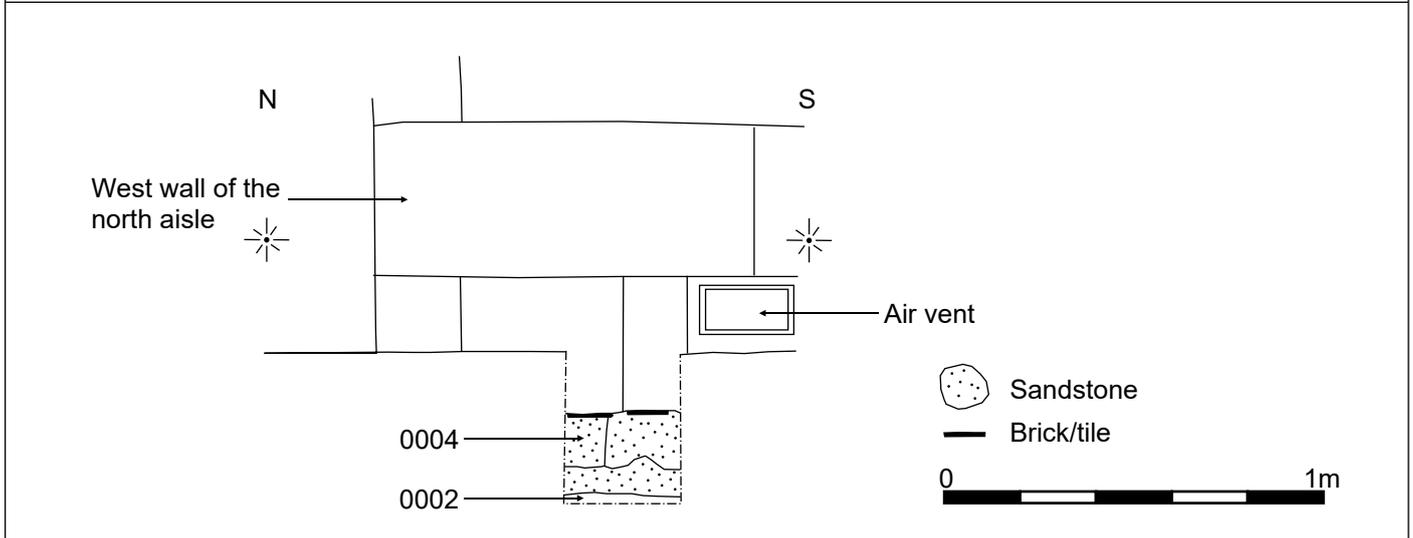
SCC.1 Church of St Catherine, Cossall, Nottinghamshire.
 Figure 4: Area 01 west facing section of 0004.
 Scale 1:20 at A4.

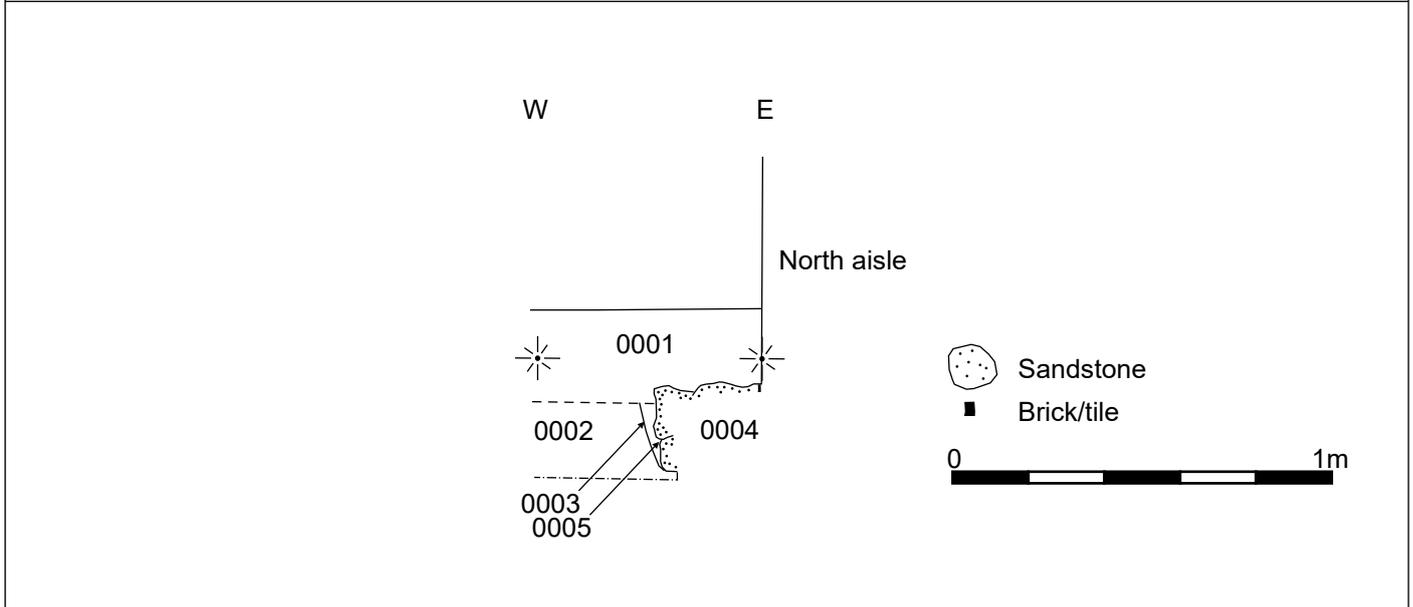
5.2.1. The excavation of Area 01 revealed a basic stratigraphy of two deposits comprising topsoil 0001, and natural bedrock 0002. The topsoil 0001, which extended to a depth of between 0.22m and 0.46m, consisted of a very dark brown silty clay loam with sandstone fragments become increasingly frequent to the west with beds of hard reddish yellow to strong brown sandstone 0002 below.

SCC.1 Church of St Catherine, Cossall, Nottinghamshire.
 Figure 5: Area 01 south facing section of 0001-0005.
 Scale 1:20 at A4.

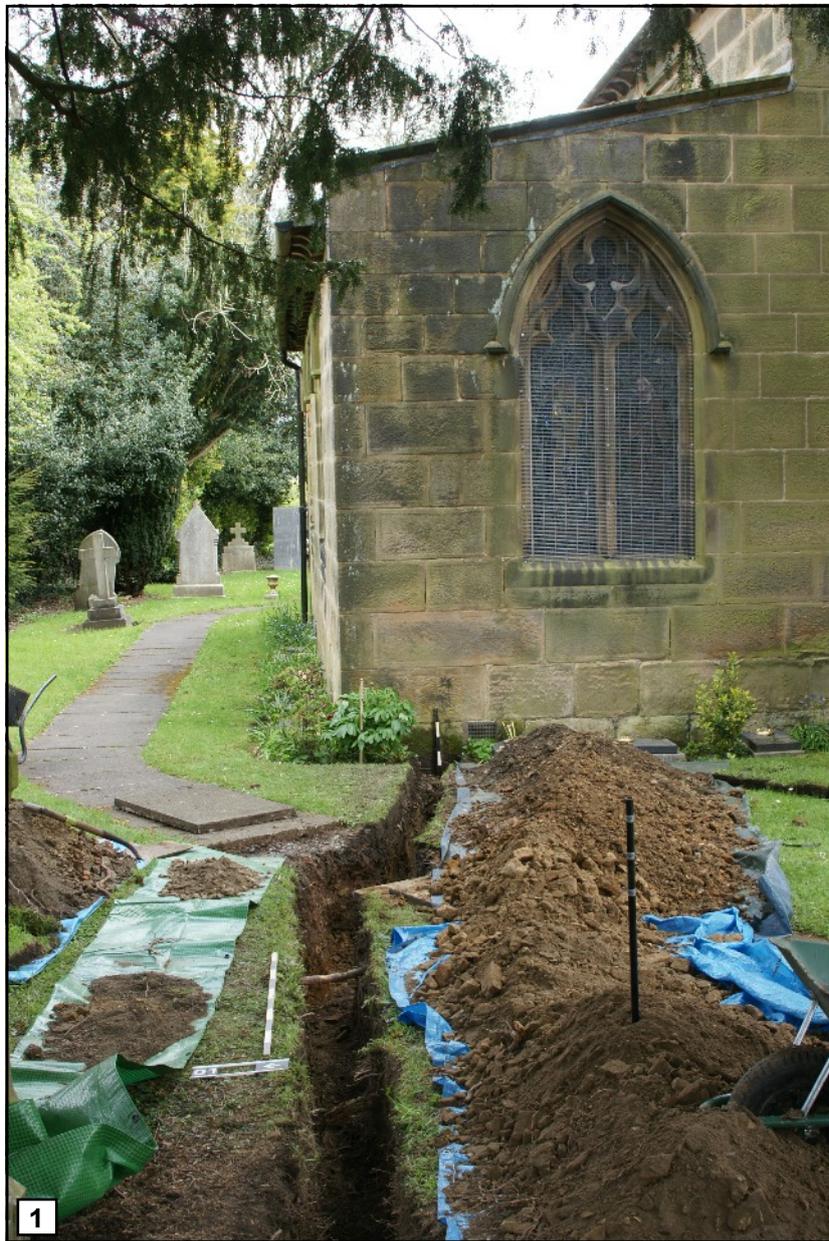
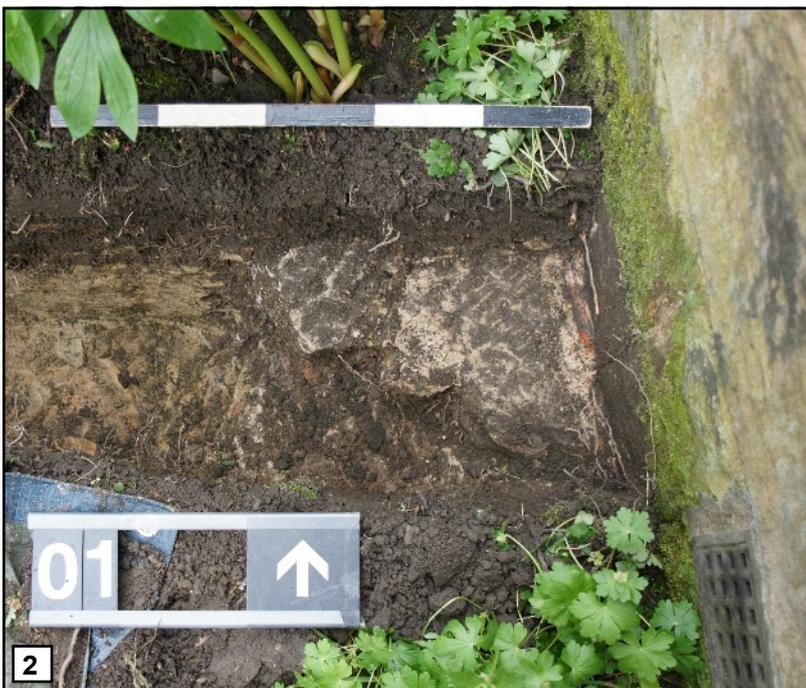
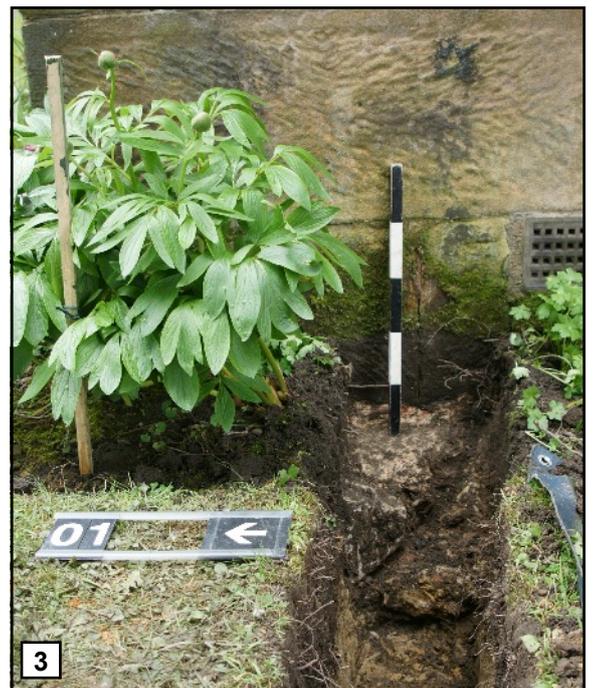
Plate 1: General view of Area 01 with the north aisle in the background, viewed looking east.
Plate 2: Foundations 0004, viewed looking north.
Plate 3: The west face of the north aisle and foundations 0004, viewed looking east.
