ST.GILES CHURCH, OLLERTON

A Report on the Archaeological Watching Brief

Author: L.Elliott, *Trent & Peak Archaeological Unit*

Project code: OSG

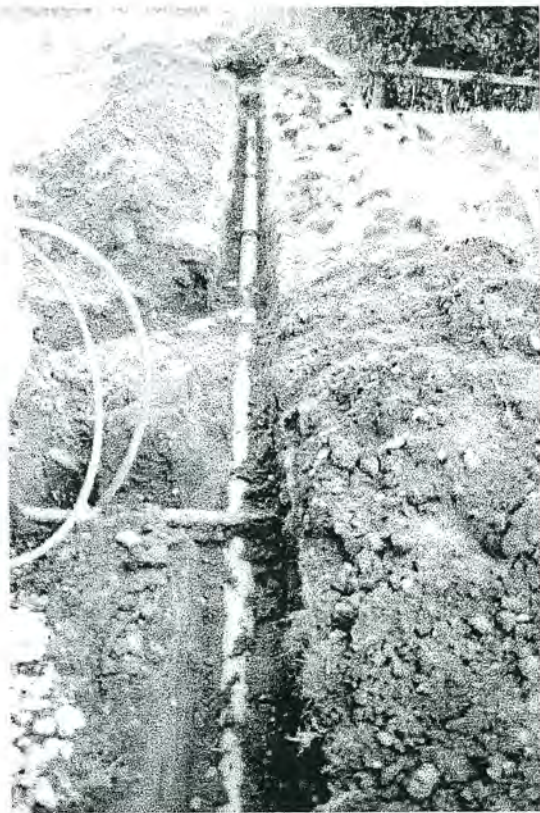
Plate 1: 01, the pipe trench running north-east of the chancel.

The objective of the archaeological work was to observe the contractors excavations, recording as appropriate any archaeological stratigraphy, artefacts or palaeo-environmental remains found to be present. The groundwork comprised the excavation of pipe trenches c.300mm wide and c.400mm deep, at locations along all four sides of the church (Plate.1 & 2), feeding into one existing and three new c.1000mm deep soakaways.

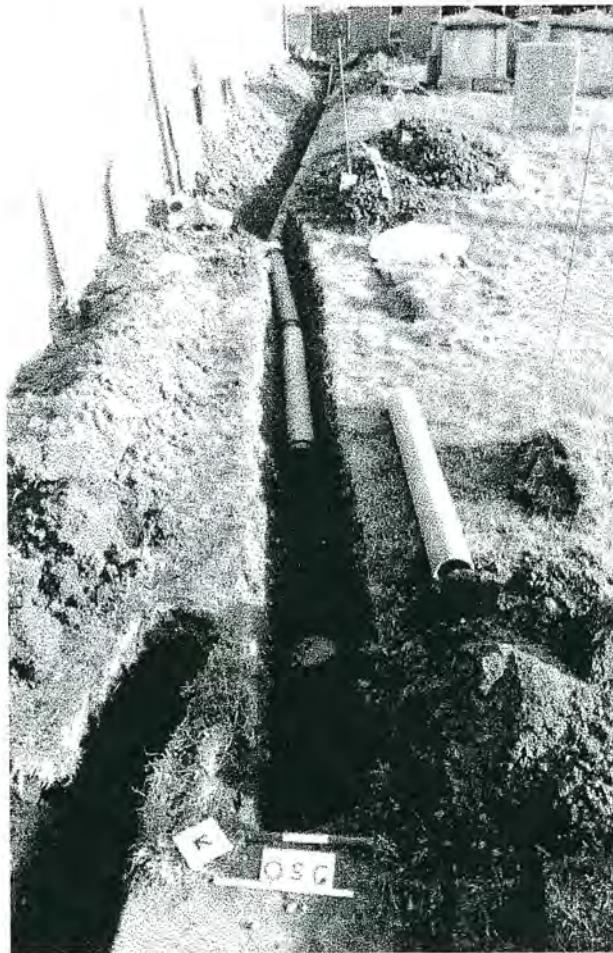
Plate 2: 02, the pipe trench running along the south side of the nave and chancel.

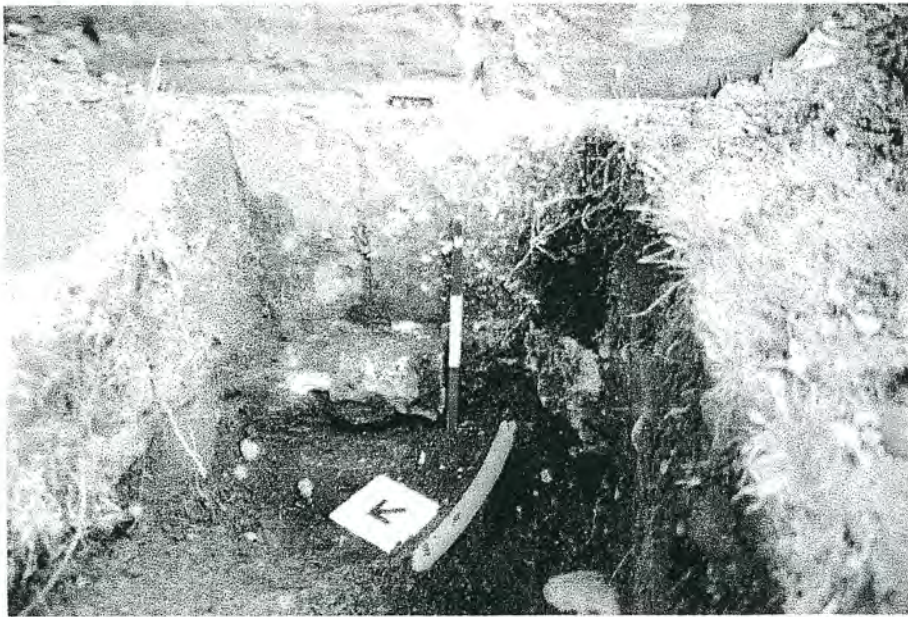
The existing church wall of the nave 02a (Figure.2), and the tower 05a (Figure.3, Plate.3), were exposed to a depth of c.400mm. This was insufficient to reveal anything beyond a further two courses of ashlar in the nave wall, and a single course of ashlar above a slightly protruding stone plinth in the tower wall.

Plate 3: 05a, the partially exposed foundation of the tower with pipe inserted through the wall.

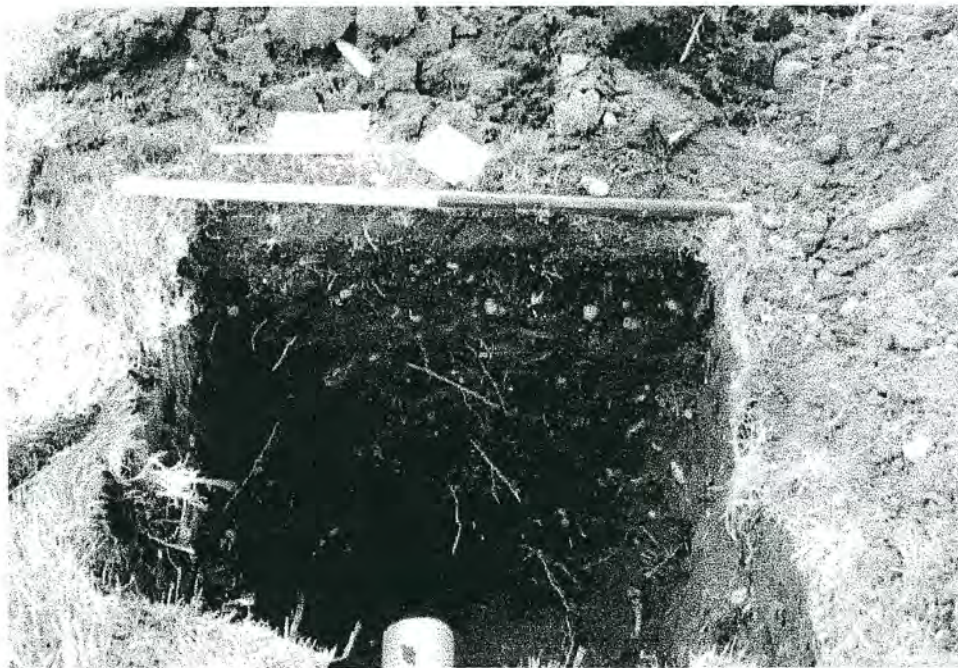
Layer 0002 comprised a mid-brown loamy sand with a variable 5%-15% rounded stone content up to 0.10m in size. It appeared very mixed in nature apparently as a result of burial activity, accentuated in 08 by tree root disturbance (Figure.4, Plate.4). Disarticulated human skeletal material was present throughout 0002 with the greatest concentration found in 06 and 07. This included the articulated remains 0010, comprising pelvis and leg bones, which were left *insitu* in the south-east corner of 06 (Figure.5, Plate.5). Grave-earth such as 0002 is characteristic of churchyards subject to long periods of burial (Rodwell 1981, 146). The limitations of the groundwork concealed the full depth of 0002, however at its base in the deeper soakaways 06 and 07, it appeared to merge into a slightly more greyish-brown layer 0003 (Figure.6). This is unlikely to constitute a truly separate layer, but represents leaching of 0002 by groundwater, indicating little recent disturbance from burial. Overcrowding of the graveyard was recognized in a meeting of 1860, leading to the creation of a new cemetery in 1863 at Forest Road (Bradbury 1985,56).

Plate 4: 08, showing grave-earth 0002 and the presence of root disturbance.

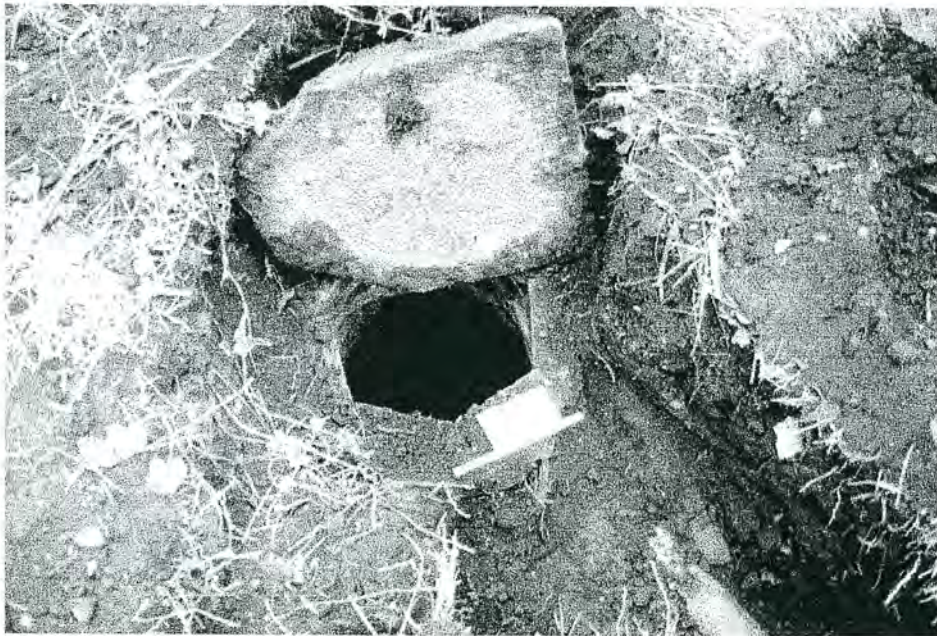
Two soakaways were uncovered, 0004 to the north of the chancel and 0008 close to the south porch. In 01, 0004 consisted of a roughly rectangular 800mm x 600mm capstone, 300mm below ground surface (Plate.6). Removal of the capstone revealed the soakaway to be still functioning, and consist of a six sided brick structure with a bell shaped profile c.2.5m deep (Figure.7). This was re-used for the new drainage system, reducing the need for a fourth new soakaway. In contrast the other soakaway 0008 was more crudely constructed comprising a void randomly filled with brick and stone (Figure.8). The brick present in both soakaways suggests a late 19th/20th century date for their construction.

Plate 6: 01, the capstone of soakaway 0004, lifted to reveal a six-sided brick structure.
