CHURCH OF ST PETER, SIBTHORPE, NOTTINGHAMSHIRE:

**ARCHAEOLOGICAL RECORDING OF GROUNDWORKS
WITHIN THE TOWER AND CHURCHYARD**

Report Number: 013/2019

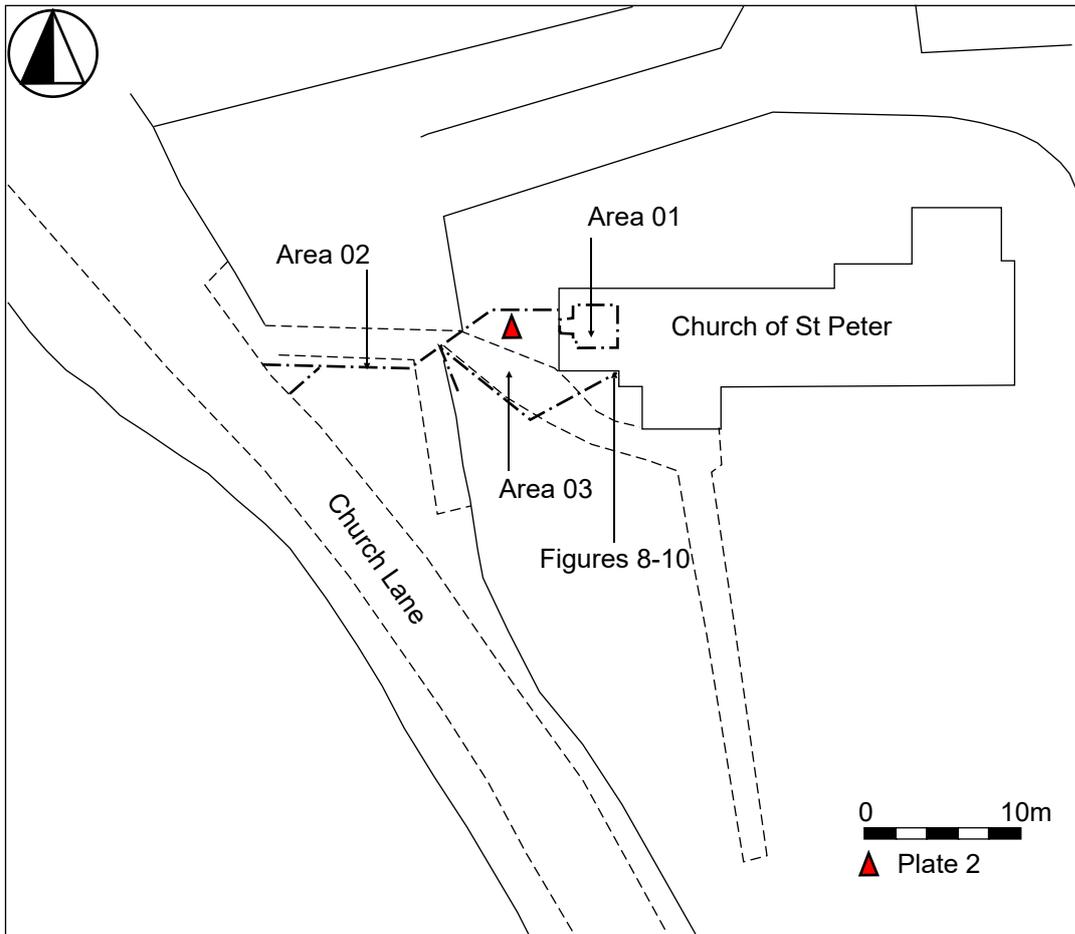
SPS Church of St Peter, Sibthorpe, Nottinghamshire.
Figure 2: Trench location plan.
Scale 1:500 at A4.

5.1. The groundworks comprised excavation of three areas (Figures 2 and 3). Area 01 was located within the tower and entailed the lowering of the floor levels by up to 0.25m with Box 01, measuring 1m x 1m and 0.5m in depth, dug in the north-west corner to facilitate the drilling of a hole through the west wall of the tower for a service pipe. Area 02 was a service trench extending from the west wall of the tower, through the churchyard to Church Lane to the west. It was up to 0.6m in width, 0.75m in depth and 19m in length. Area 03 was also a service trench extending from the south wall of the tower, through the churchyard to connect with Area 02 to the east of the churchyard boundary. It was up to 0.6m in width, 0.45m in depth and 11m in length.

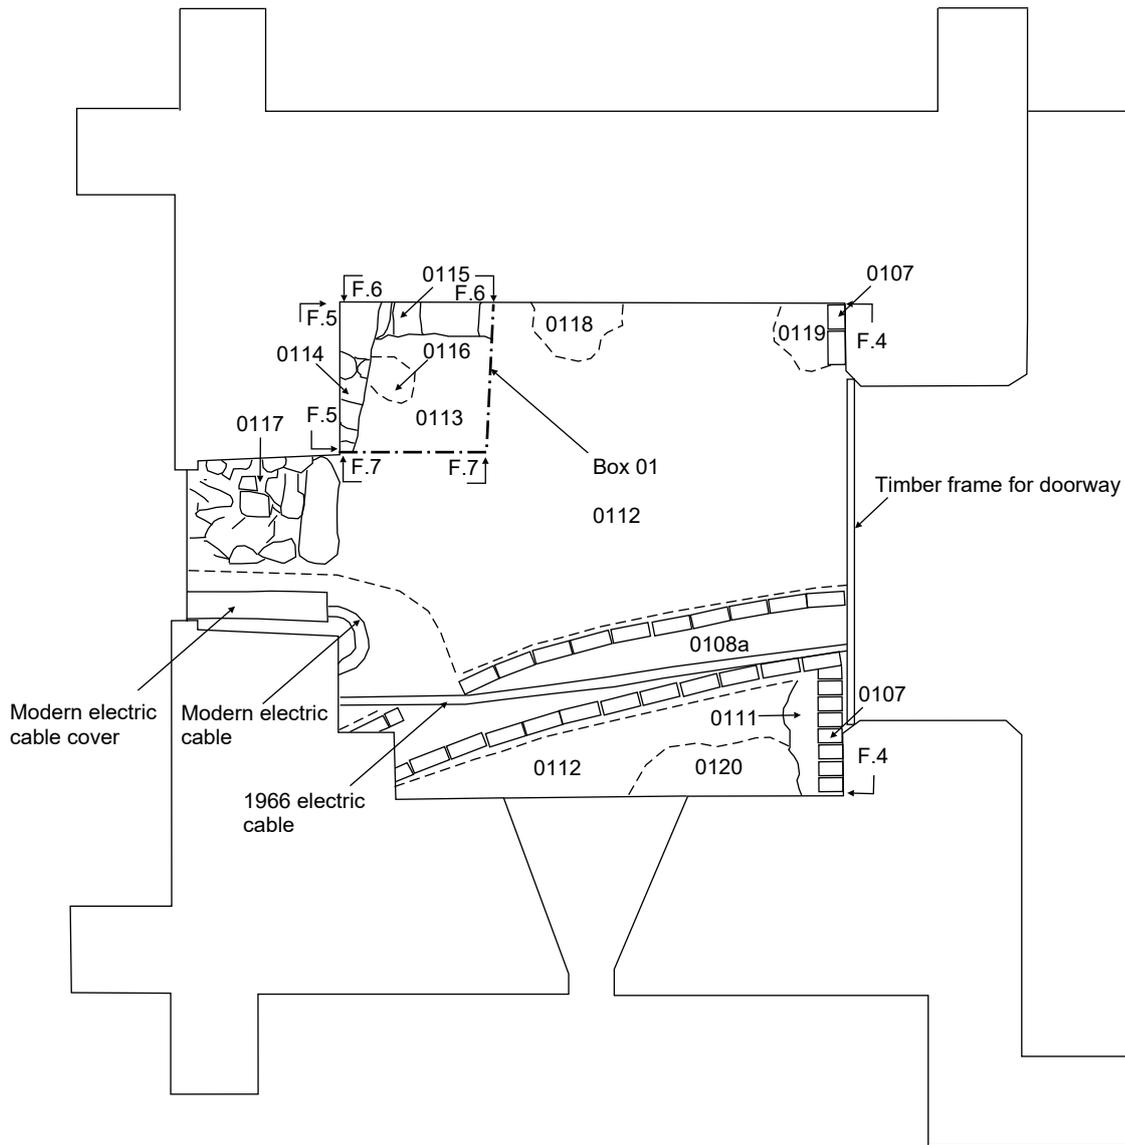
SPS Church of St Peter, Sibthorpe, Nottinghamshire.
Figure 3: Area 01 post excavation plan.
Scale 1:50 at A4.

5.2.1. The thirteenth century foundations 0114 and 0115 of the tower were encountered in Box 01 comprising thinly coursed angular sandstone bonded with dark brown sandy clay loam. Three courses were exposed exceeding 0.24m in depth. Further thirteenth century foundations 0117 were exposed by the west doorway. They had been truncated by the insertion in the fourteenth century of the doorway and recently by electric cables.

5.2.2. In the base of Box 01 was well compacted dark greyish brown clay loam deposit 0113 which contained charcoal flecks and pinkish white to white lime mortar fragments. It was essentially the

same deposit as 0112 though it did not contain limestone rubble. Deposit 0112, which incorporated deposits 0118 and 0120, was up to 0.22m thick and overlaid the foundations 0114 and 0115. Of note, 0112 contained a single piece of squat rounded and probably flared Cistercian ware pottery of fifteenth or sixteenth century date (Lee Elliott pers comm) providing a *terminus post quem* for the deposit. In the south-east corner of the tower, above 0112, was mortar deposit 0111. It was 0.03m thick and had a smooth upper surface suggesting that this is a fragment of a former mortar floor. It seems likely that 0112 and 0113 are thus levelling deposits for the mortar floor 0111, the pottery suggesting that it could have been laid as early as the fifteenth century.

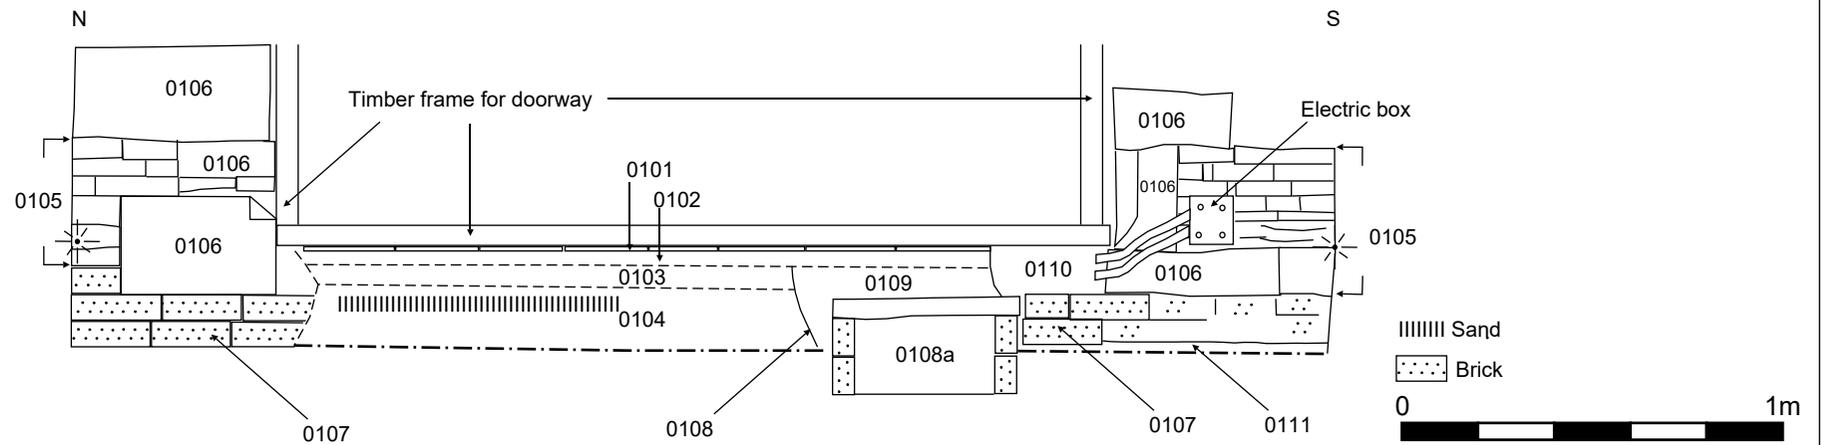
SPS Church of St Peter, Sibthorpe, Nottinghamshire.
 Figure 4: Area 01 west facing section beneath the tower arch.
 Scale 1:20 at A3.

5.2.4 During the excavation, the tower arch foundations 0107 were exposed and found to comprise two courses of hand-made bricks measuring $8\frac{1}{2} \times 4\frac{1}{2} \times 2\frac{1}{4}$ inches, with those supporting the northern part of the tower arch on a clay loam levelling deposit 0119 and bonded with brown sandy lime mortar. The lower course of the southern brickwork was also bonded with brown sandy lime mortar but the upper course with white mortar, identical to that used in the east wall of the tower and the tower arch, 0105 and 0106 respectively. The size of the bricks would be consistent with an interpretation that they were laid when the nave was restored in 1718/19 with the foundations to the south partially re-laid during the subsequent restoration which began in 1853 when the tower arch was opened out.

5.2.5 Overlying foundations 0107 was deposit 0104 which comprised loose angular stone, up to 0.16m thick above which was a thin layer of crushed white and pink lime mortar 0103. Both are likely to be levelling deposits for a no longer extant floor possibly laid during the eighteenth century restoration.

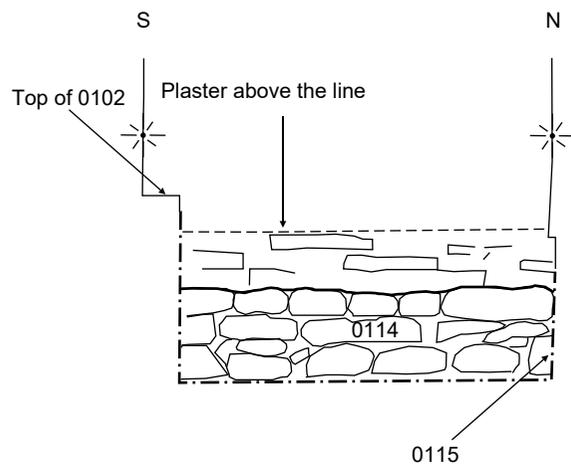
SPS Church of St Peter, Sibthorpe, Nottinghamshire.
 Figure 5: Area 01 east facing section of Box 01.
 Scale 1:20 at A3.

5.2.3 The tower walls exposed in the east and south facing sections of Box 01 had a white to pinkish white lime plaster which terminated 0.18m above foundations 0114 and 0115 and was overlaid by layer 0103. The plaster therefore pre-dates the current floor 0101 which is of likely Victorian date (see below).

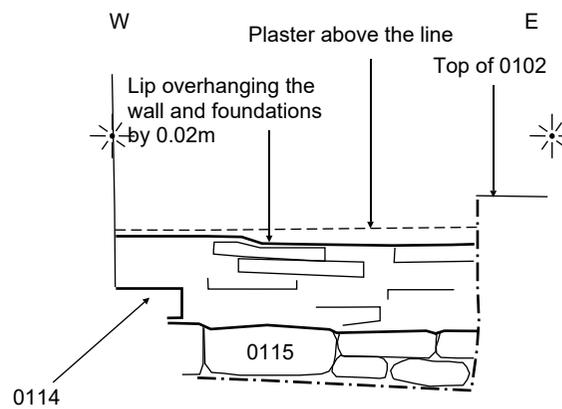
SPS Church of St Peter, Sibthorpe, Nottinghamshire.
 Figure 6: Area 01 south facing section of Box 01.
 Scale 1:20 at A3.

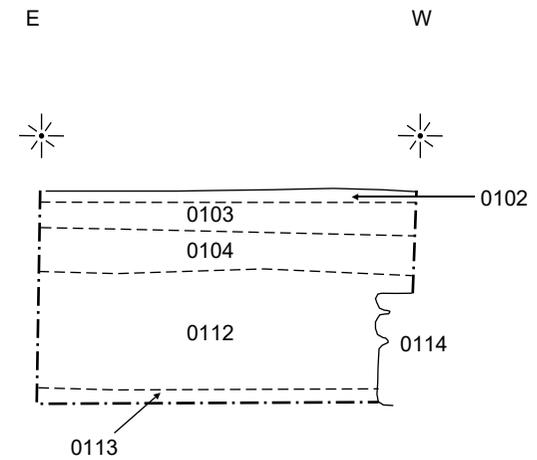
SPS Church of St Peter, Sibthorpe, Nottinghamshire.
 Figure 7: Area 01 north facing section of Box 01.
 Scale 1:20 at A3.

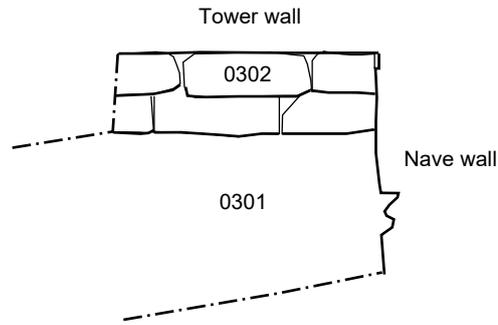
Figure 8: Area 03 post excavation plan of the tower foundations 0302 at the east end of the trench.
Scale 1:20 at A4.

5.4.1. A basic stratigraphy of two deposits was present in Area 03 comprising topsoil 0300 and grave earth 0301 which were the same as described above in Area 02 though small amounts of disarticulated skeletal material were present in the grave earth. The stepped foundations 0302 of the tower were encountered in the south facing section extending to a depth exceeding 0.43m from ground level. Four sandstone courses were exposed bonded with firm dark brown sandy clay loam. Two pieces of red tile, ½ inch thick, had been incorporated into the foundation. No foundations for the nave were identified. Though poor foundations for churches are common it is unlikely that nave walls would have been built on grave earth with no foundations. It is feasible that the nave wall considerably overhangs the foundations which is why they were not encountered in the sections.

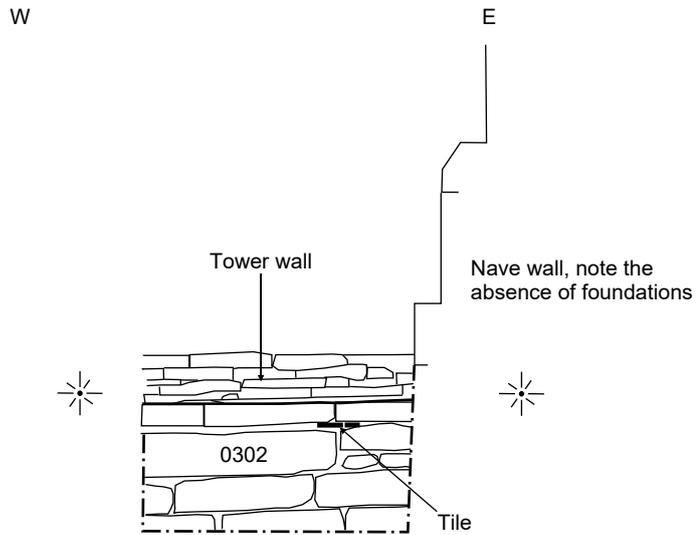
Figure 9: Area 03 south facing section of the tower foundations 0302 at the east end of the trench.
Scale 1:20 at A4.

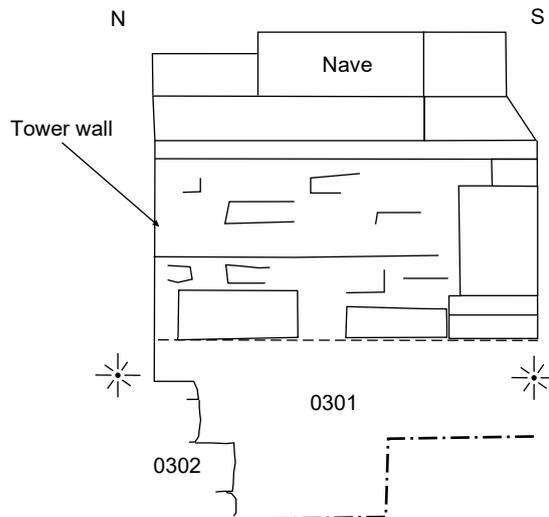
Figure 10: Area 03 west facing section of the tower foundations 0302 at the east end of the trench.
Scale 1:20 at A4.

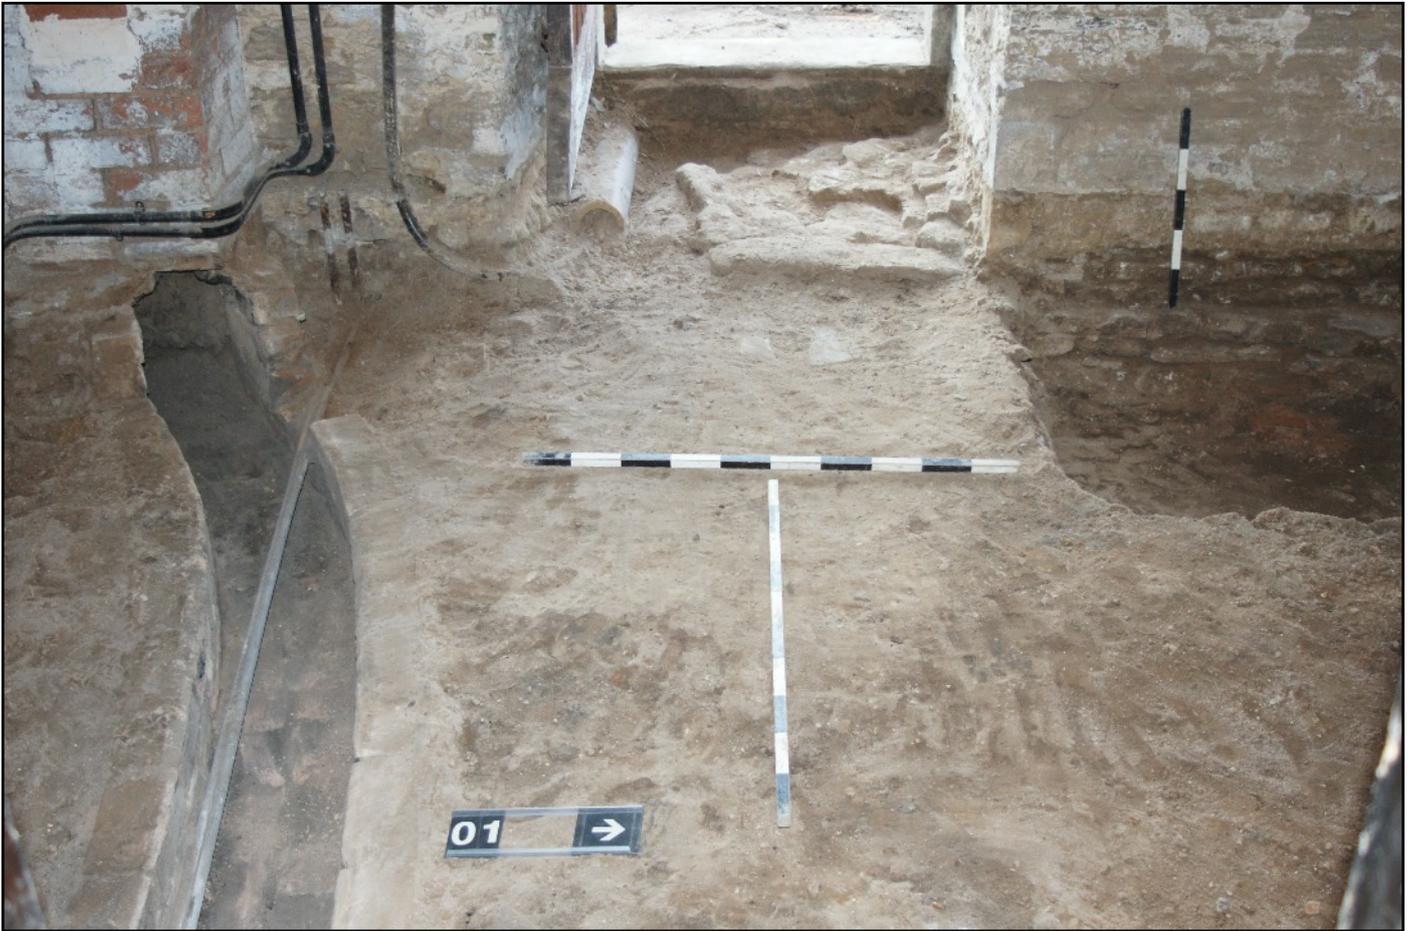
Plate 1: Area 01 general view looking west.

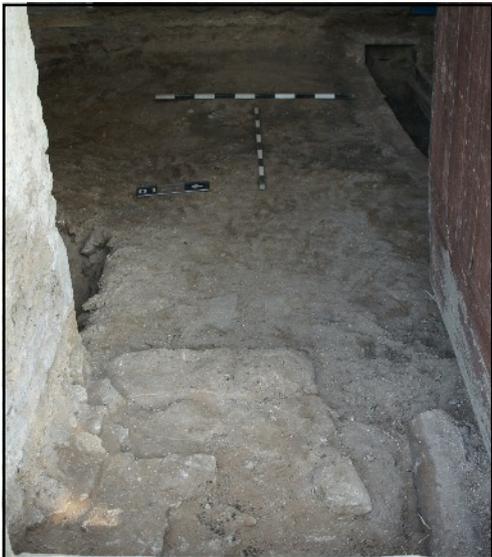
Plate 2: Area 01 general view from the doorway in the west elevation, looking east.

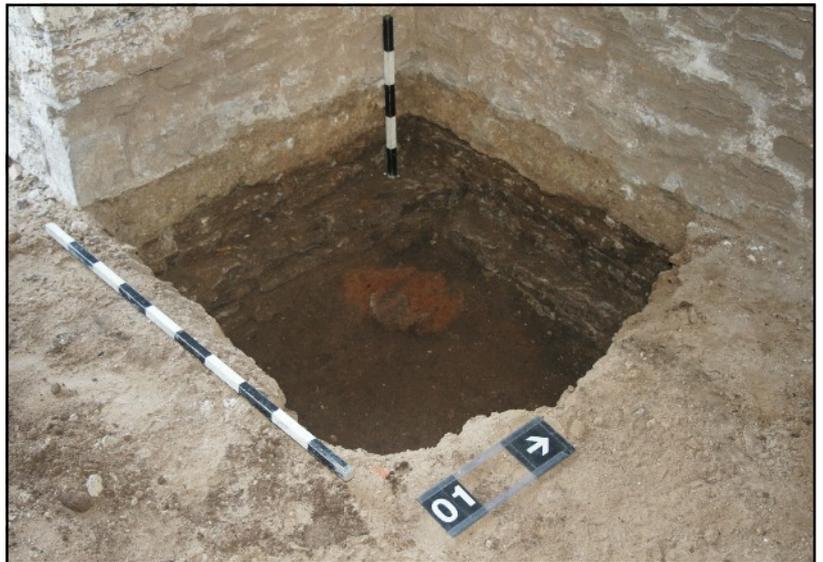
Plate 3: Area 01, Box 1 with foundations 0114 and 0115 exposed and deposits 0113 and 0116 in the base of the trench, viewed looking north-west.

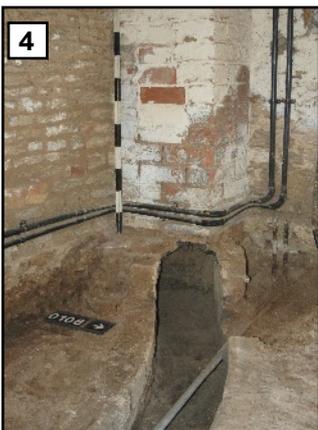
Plate 4: Area 01, the former chimney in the south-west corner of the tower and flue 0108a truncated by the electric cable of 1966, viewed looking south-west.

5.2.6 Truncating 0104 and 0103 was trench 0108 that housed a brick conduit 0108a that comprised a row of parallel bricks 0.5m apart and two courses high extending across the southern half of the tower. It had a concrete capping and a brick base. The bricks measured $9 \times 4\frac{1}{2} \times 3$ inches, were laid in stretcher bond and were bonded with a grey concrete mortar. Inside the conduit the bricks and capping were sooted. The bricks of the conduit were tied into a vertical brick structure which extended through the ceiling above in the south-west corner of the tower. The only possible interpretation is that the conduit is the flue a no longer extant heating system used to take smoke from a former fire, probably a cast iron stove located within the nave, beneath the floors of the building to the chimney in the tower. These were popular during the Victorian period (Roberts 2008) with the bricks of 0108a consistent with a mid to late nineteenth century date.

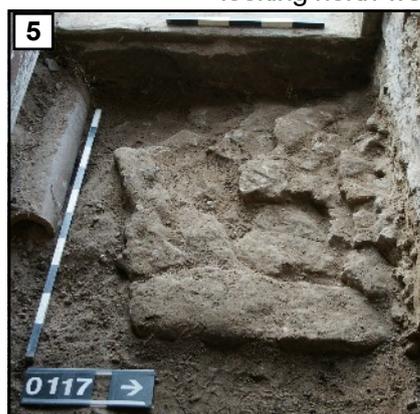
Plate 5: Area 01, foundation 0117, clearly truncated by the modern electric cable, viewed looking west.

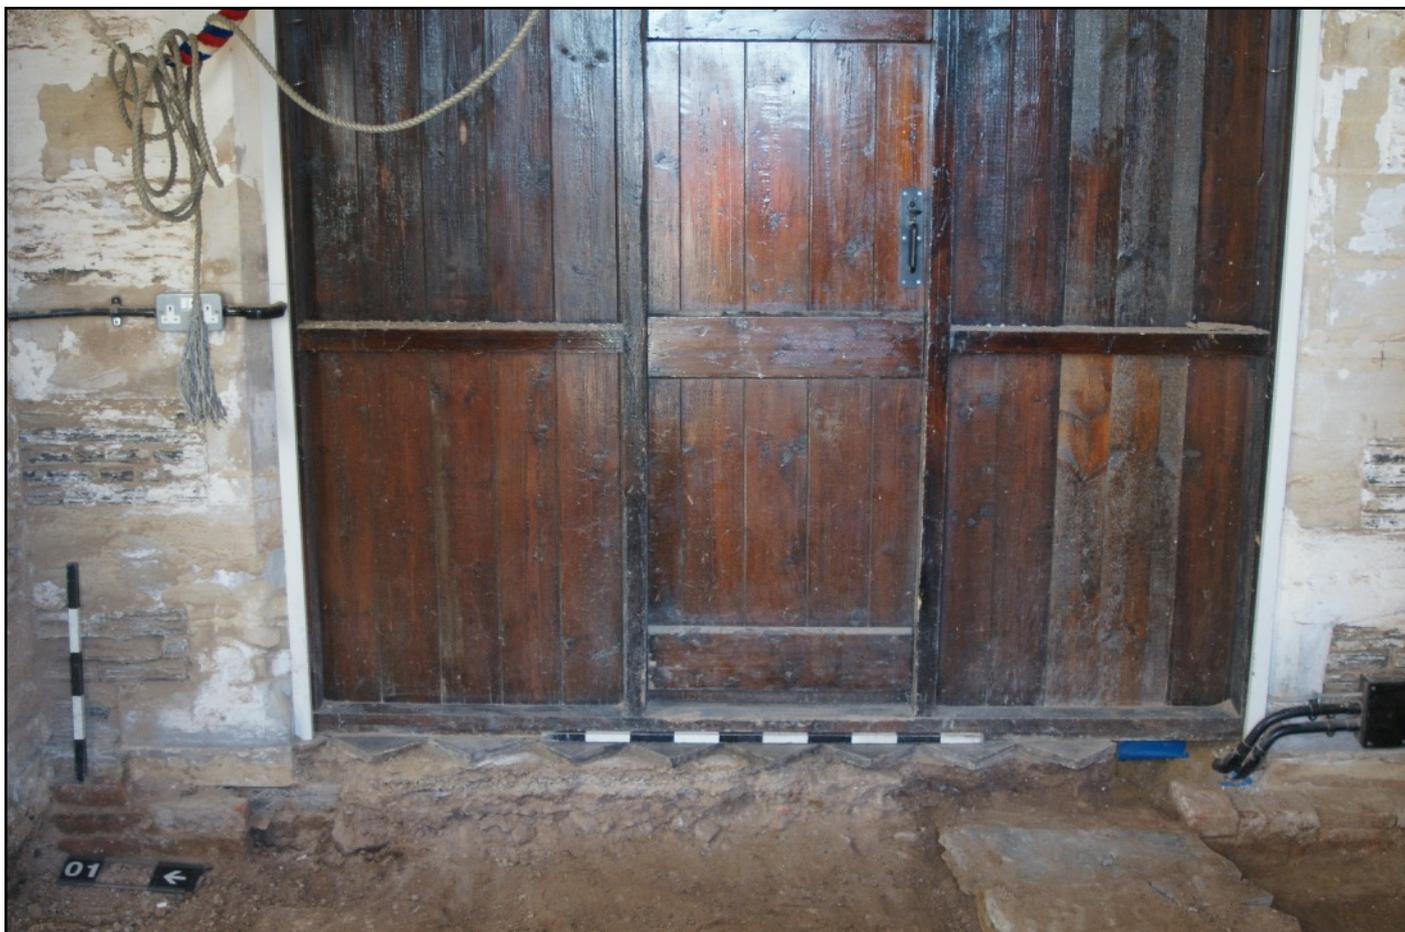
Plate 6: Area 01 west facing section beneath the tower arch, viewed looking east.

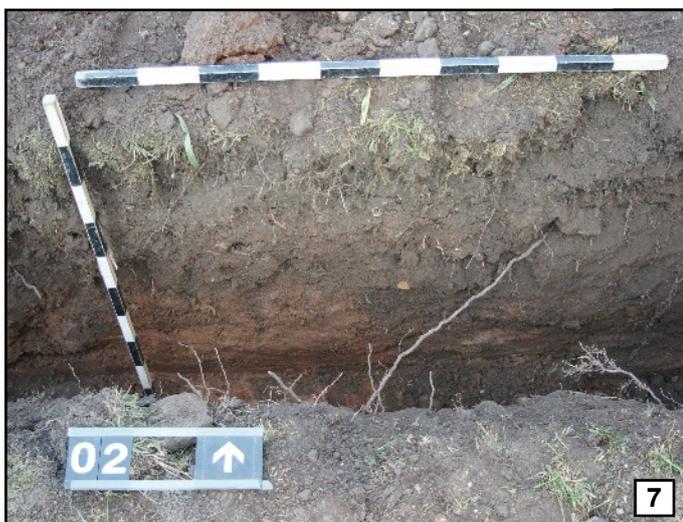
Plate 7: Area 02, representative section, south facing, located centrally between the churchyard wall and the tower, viewed looking north.

5.3.1. The excavation of Area 02 revealed a basic stratigraphy of three deposits comprising topsoil 0200, grave earth 0201 and natural substrata 0202. The topsoil 0200, which extended to a maximum depth of 0.19m, consisted of a weal dark brown silty clay loam. Beneath 0200 was grave earth 0201, which was up to 0.42m thick and comprised firm dark brown silty clay with no disarticulated human

remains present. Firm strong brown silty clay natural substrata 0202 was encountered below 0201.

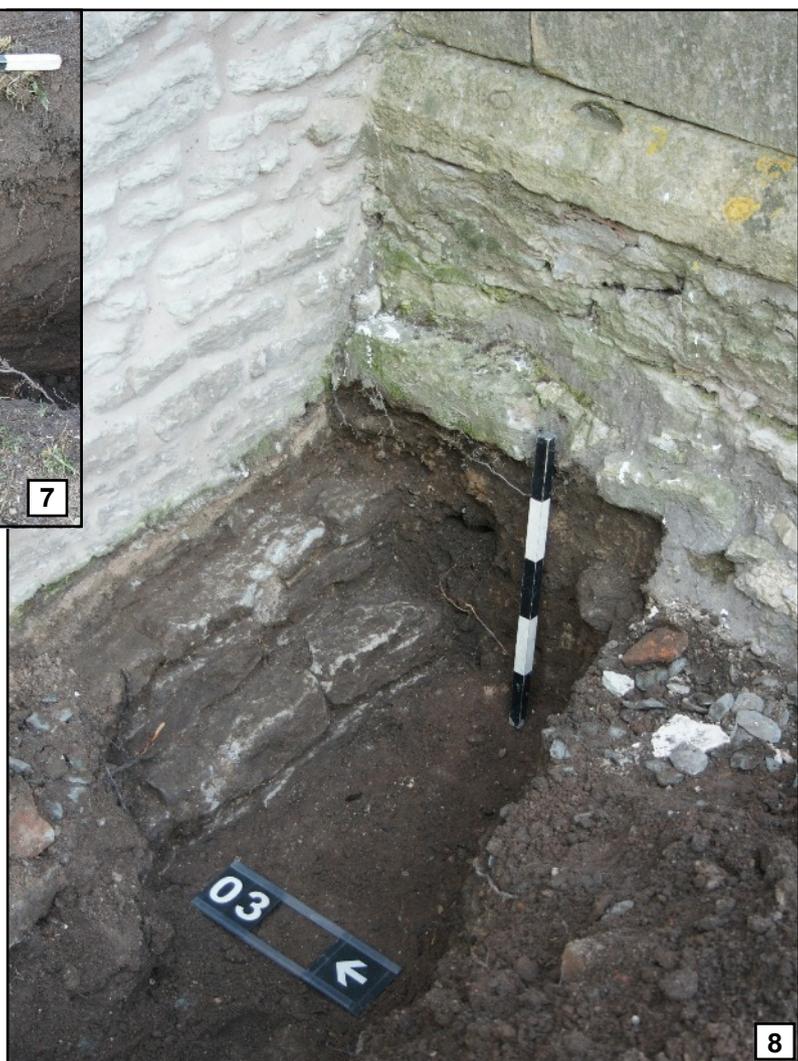
Plate 8: Area 03, tower foundation 0302, viewed looking east. Note that the nave wall to the east has no foundations.
