*Ryedale Archaeology Services Ltd*

**Archaeological Report on  
St Helen's Church South Wheatley**

Survey work and report undertaken by  
Stuart Harrison F.S.A.

July 2013

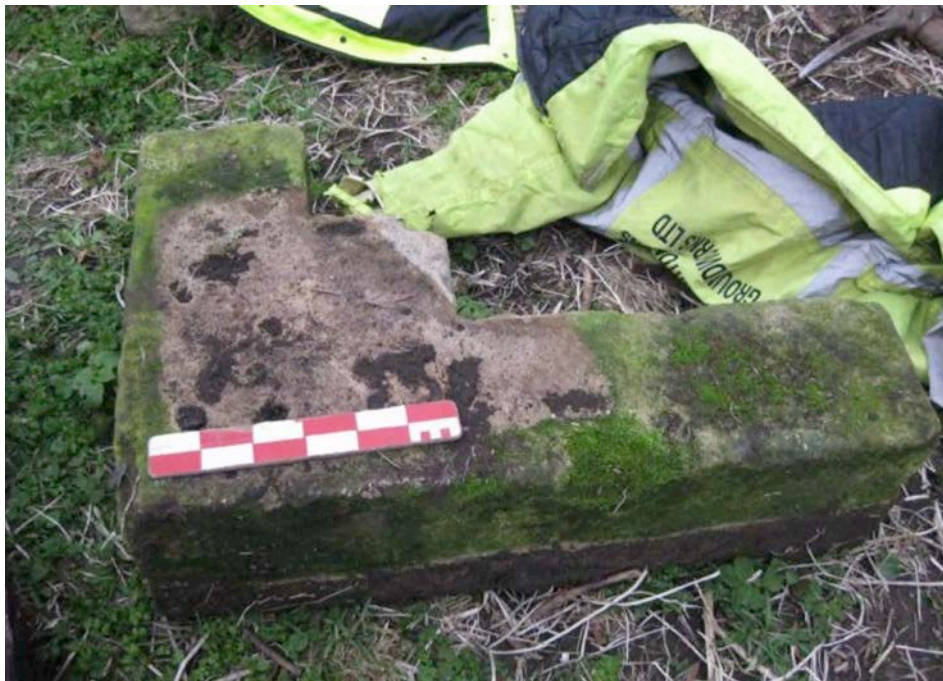
Above typical L-shaped corner block with long and short arms

The L-shaped blocks were so designed to form overlap joints of the coursing below it for strength of construction. This was achieved by having a short and long arm to the L-shaped block that alternated in direction with each course.

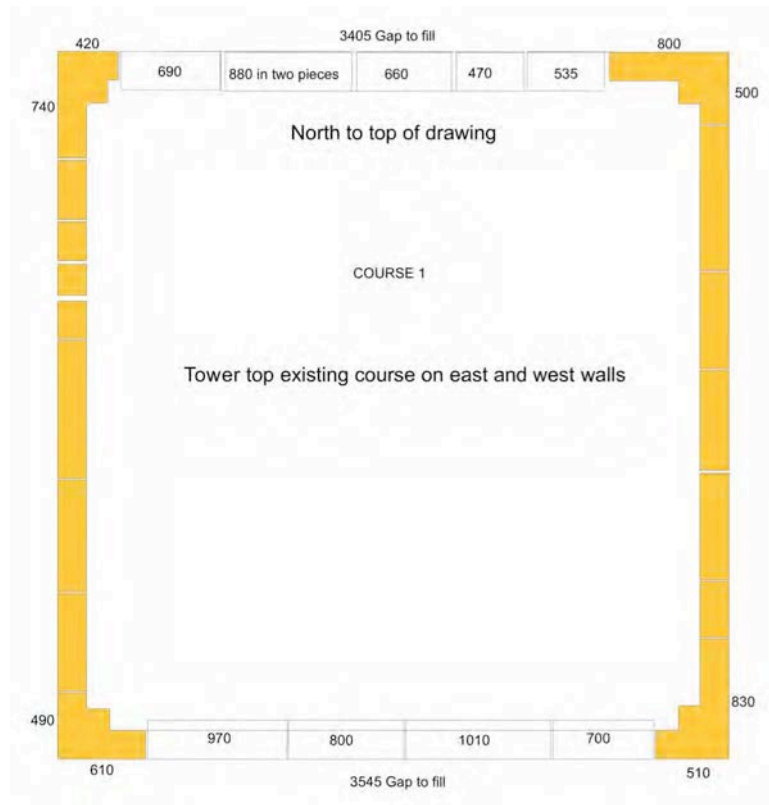
Above first course plan

The upper parts of the tower were carefully measured and worked into a CAD plan. The lengths of plain coursework and corner assemblages were carefully measured and drawn into the plan. This gave an indication of how much coursing had been lost- in fact remarkably little new stonework was required. Based on these calculations a colour-coded drawing of each face of the tower and course was prepared as a guide to reinstatement.

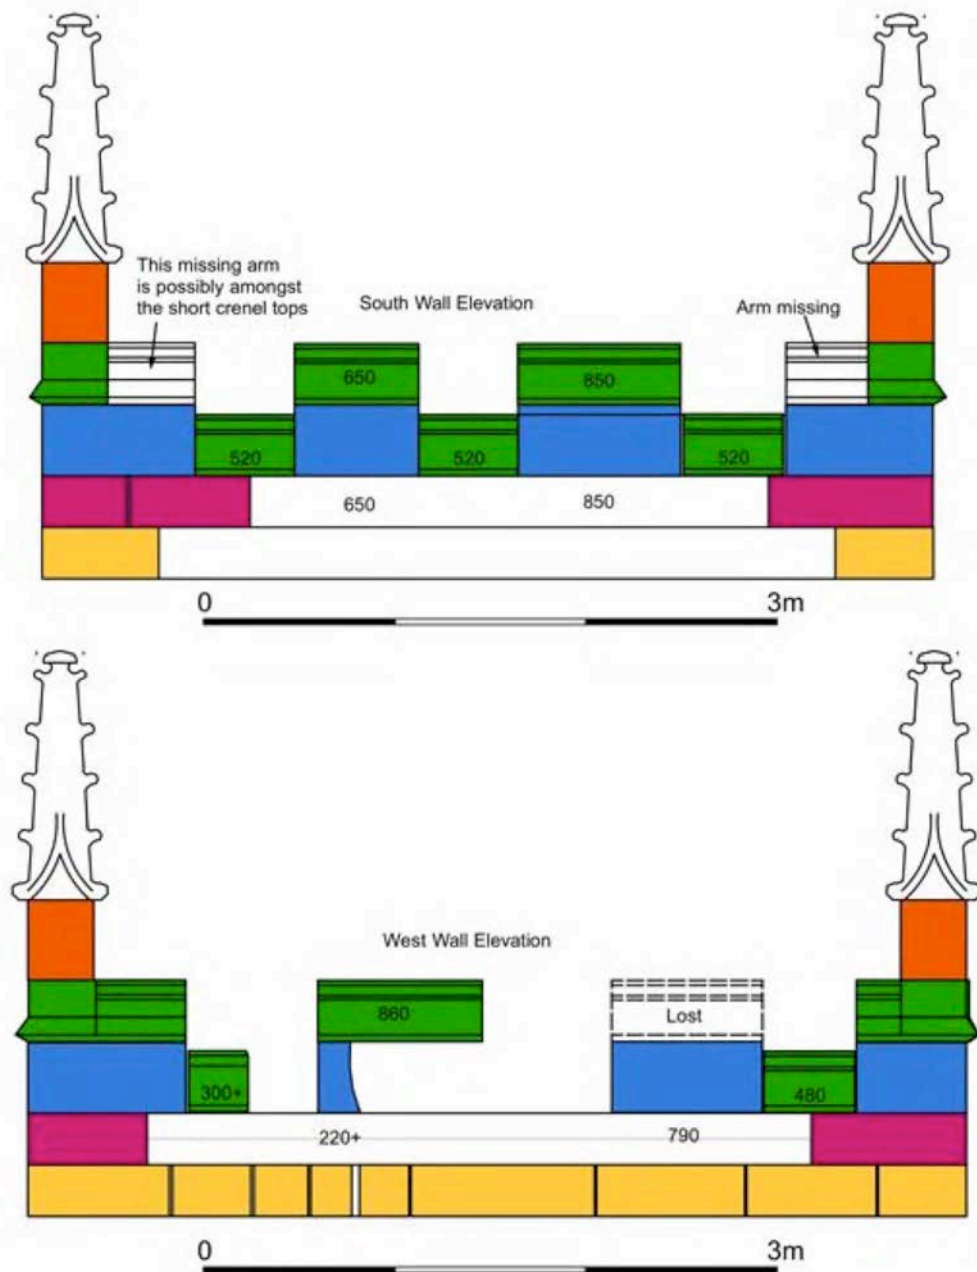
Above reconstructed elevations of south and west wall parapets

The reinstatement of the masonry was undertaken by the contractors following the guidance given in the reconstruction drawings of the parapets and the relevant assemblages of material on the ground. Though all four pinnacles survived and a fifth in a different stone that may be a replacement, they were too damaged to be replaced on the tower without substantial reinforcement.

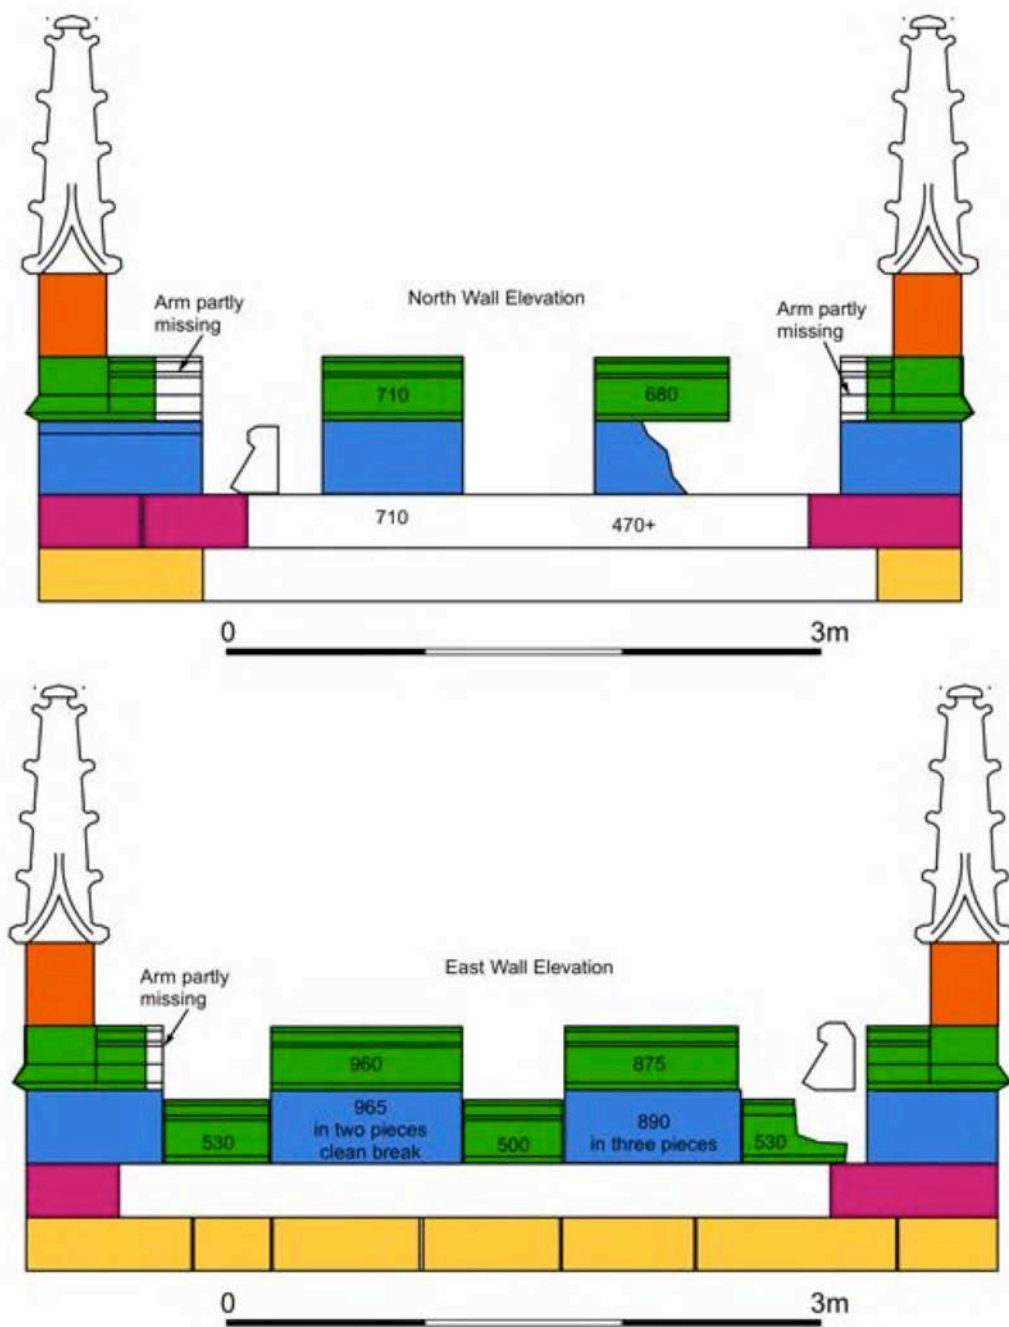
Above reconstructed elements of north and east wall parapets

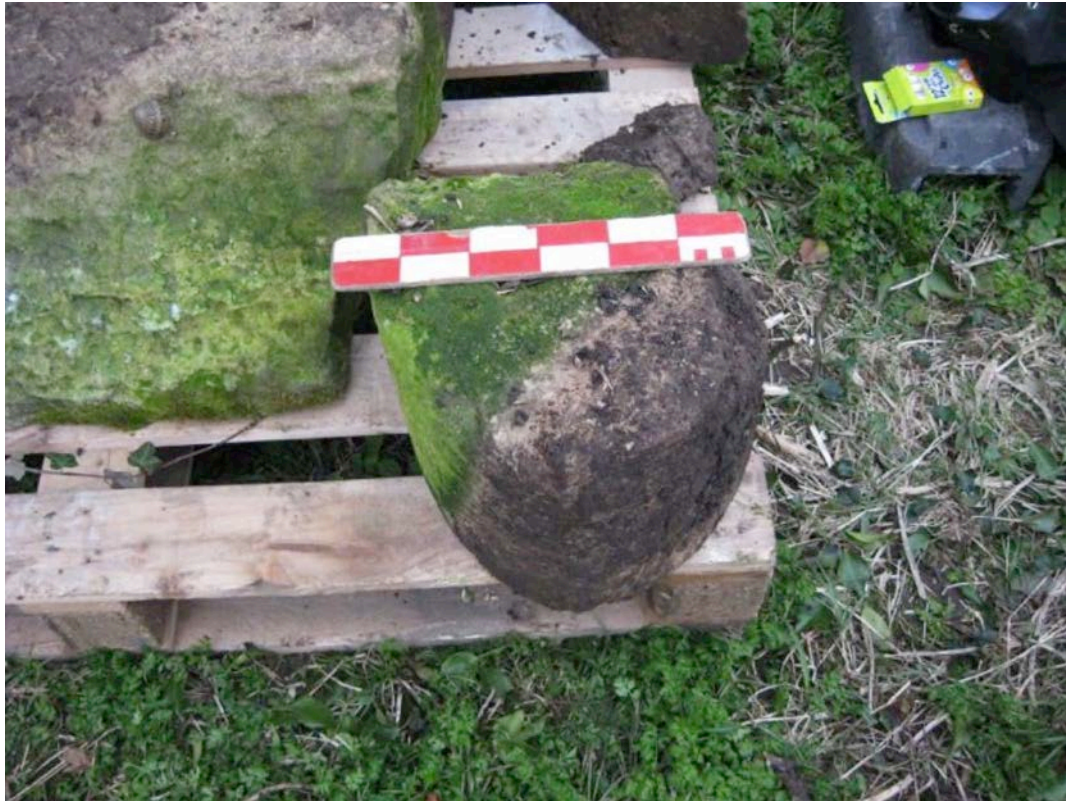
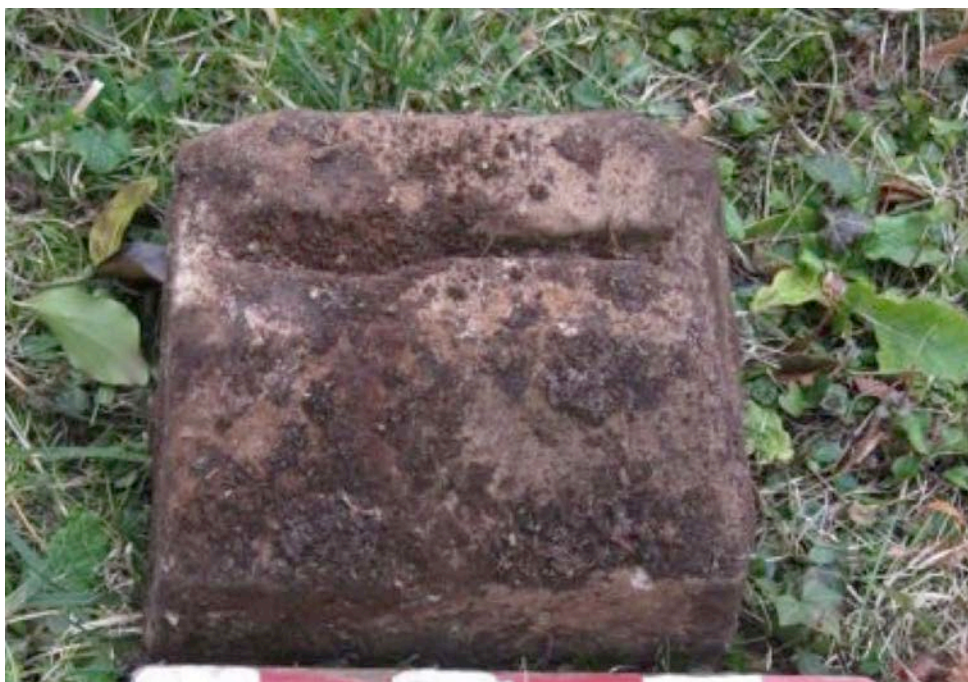
Above keeled shaft of 12<sup>th</sup>-century date  
Below single window voussoir with glazing groove

The remaining fragments that have not been reinstated and those from the demolished arcade pier etc. are to be stored within the tower basement and will remain there for future archaeological reference.

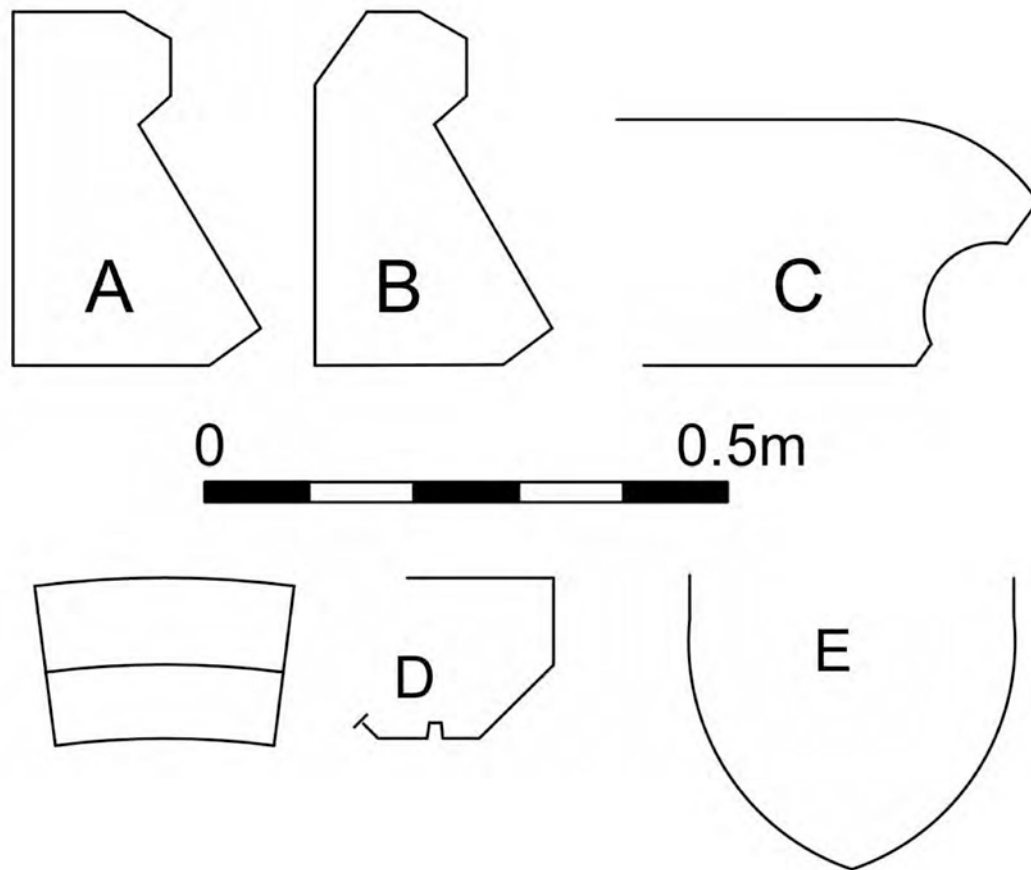
The upper stringcourses of the tower were very weathered and in many places the top face was badly eroded. A moulding was taken off the stringcourse to record its form. Similarly the moulded upper parts of the parapets were also badly weathered. These were noted to be of two slightly different profiles with an upper angled chamfered back from those from the upper crenellations and a more solid squared back profile to the lower crenellations.

Above moulding profiles –

- A Lower moulded parapet
- B Upper moulded parapet
- C Stringcourses on upper part of tower
- D Voussoir with glazing groove
- E Keeled shaft
