# **CHURCH OF ST ANDREW, SKEGBY, NOTTINGHAMSHIRE:**

**ARCHAEOLOGICAL MONITORING**

**Contractor Project Code: CAK.1**

**Report Number: 016/2026**

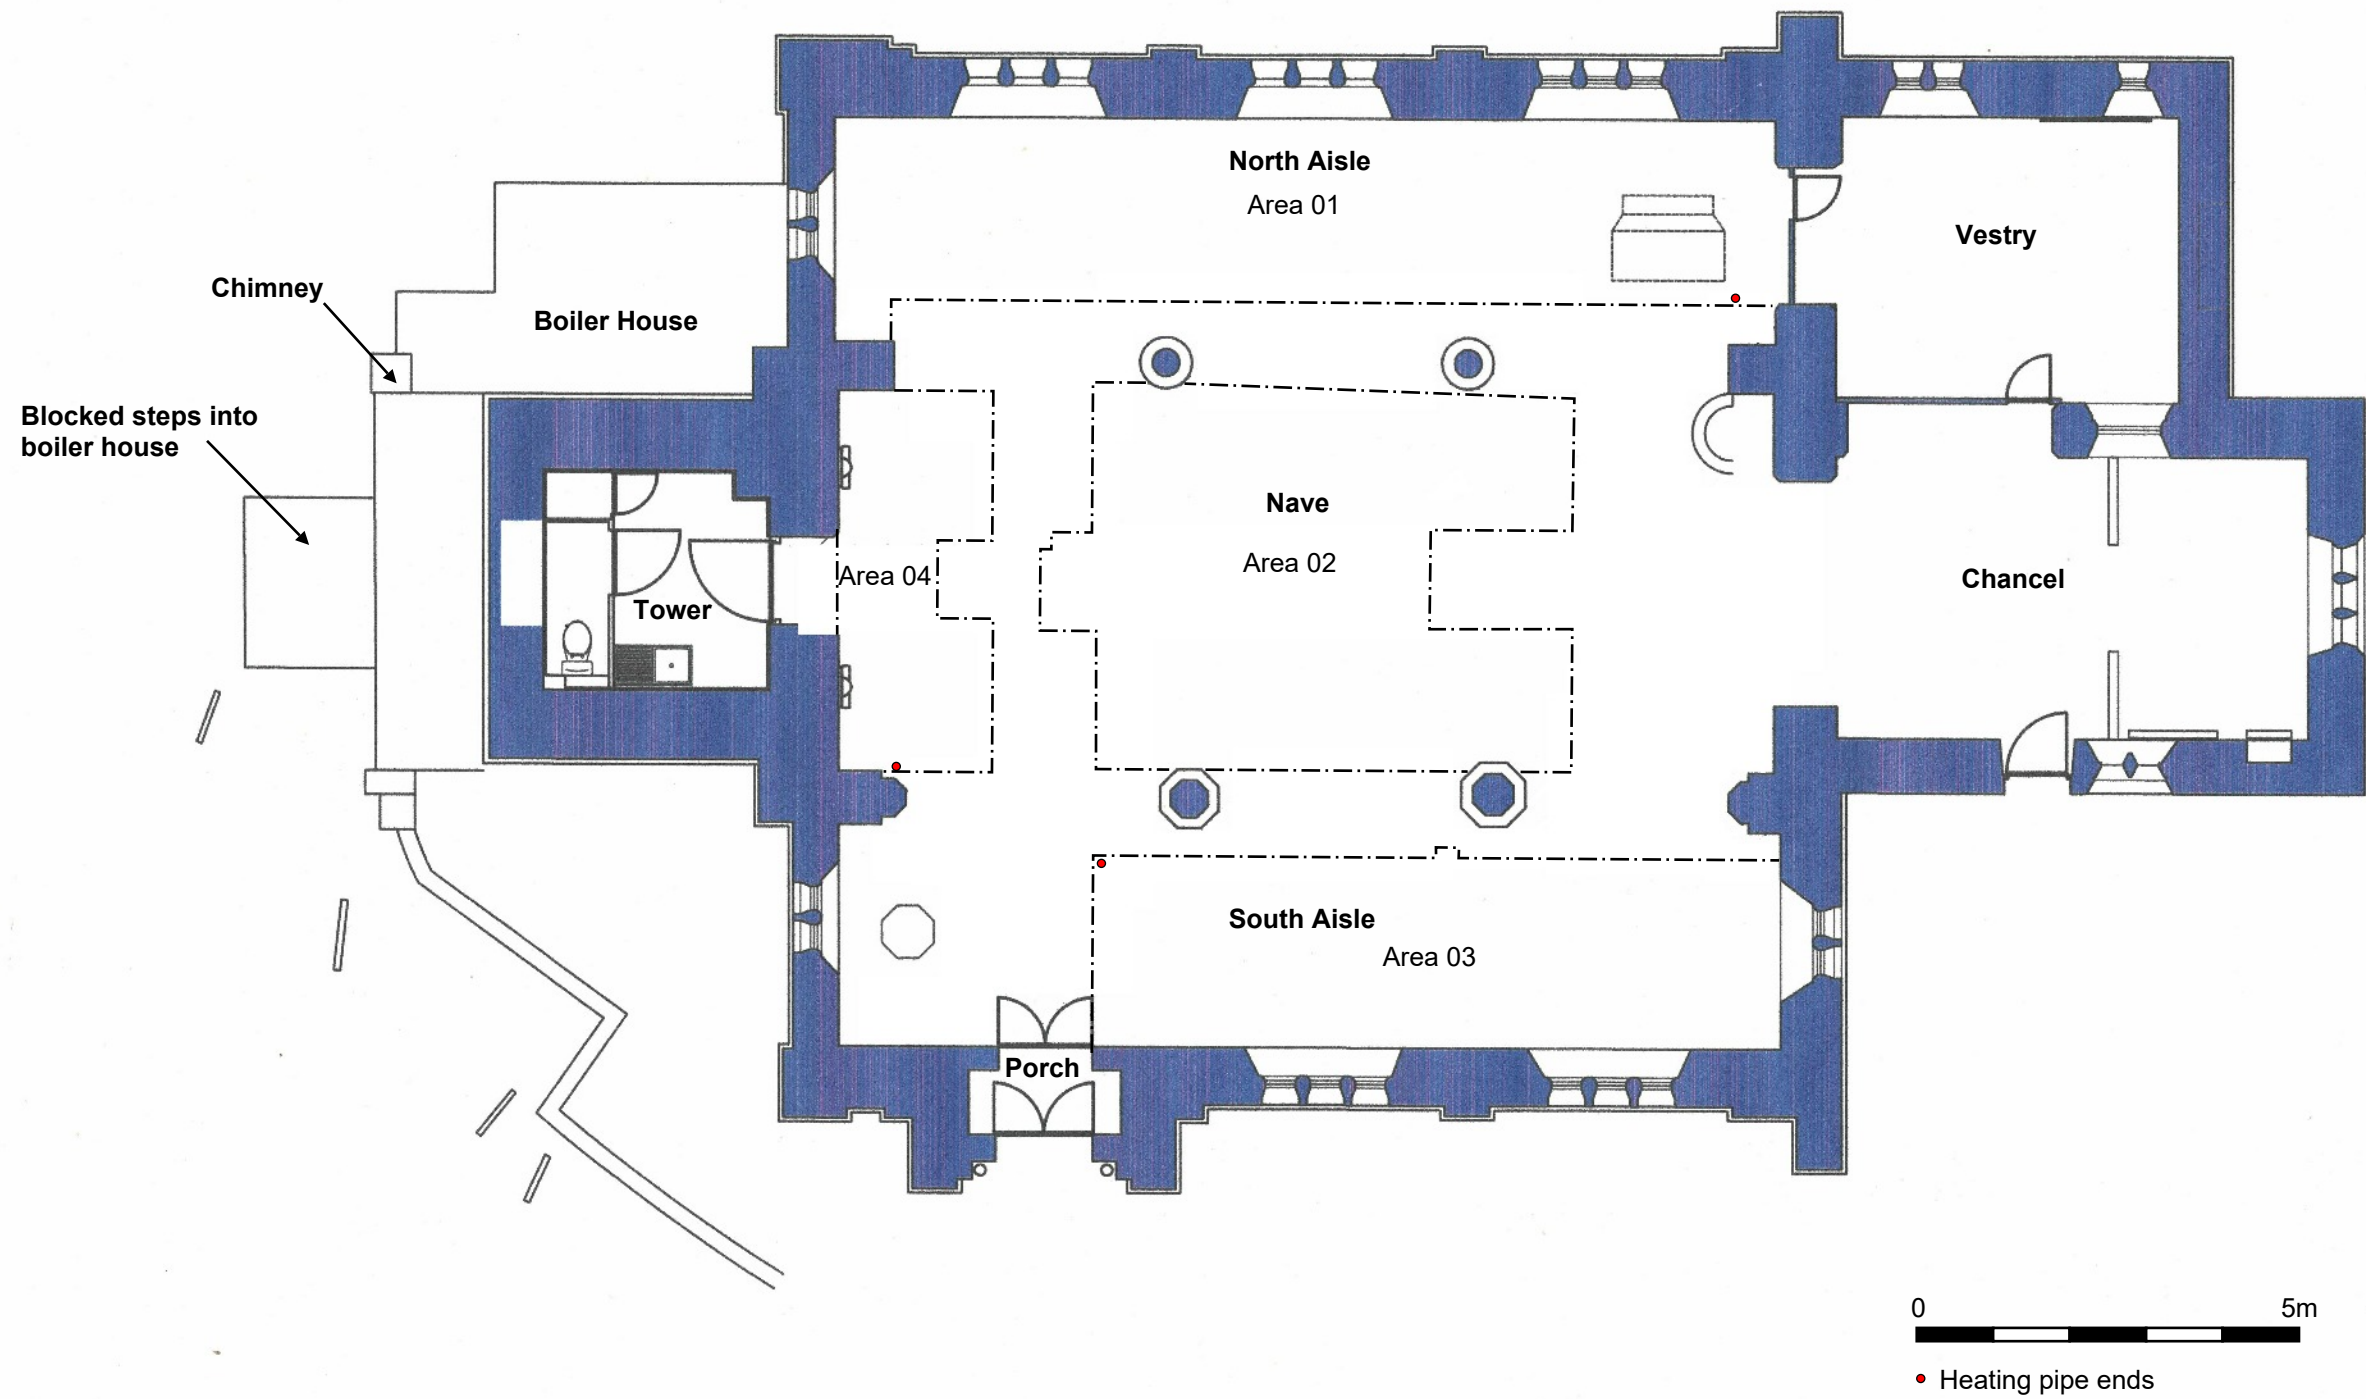
CAK.1 Church of St Andrew, Skegby, Nottinghamshire.  
Figure 2: Area plan, based on a drawing provided by the client.  
Scale 1:100 at A3.

Areas 01-04: the removal of the pew platforms in the north aisle (Area 01), the nave (Areas 02 and 04) and south aisle (Area 03) with the resulting exposed deposits recorded. A new floor was to be laid on the exposed surface (Figure 2).
- 2.3. The pew platforms were removed by staff of the main contractor.
- 2.4. The recording was to result in *'the preparation of a report and ordered archive'*, in line with the guidelines of the CIFA Chartered Institute for Archaeologists, (Standard and Guidance: for an archaeological watching brief published December 2014 and updated in June and October 2020).

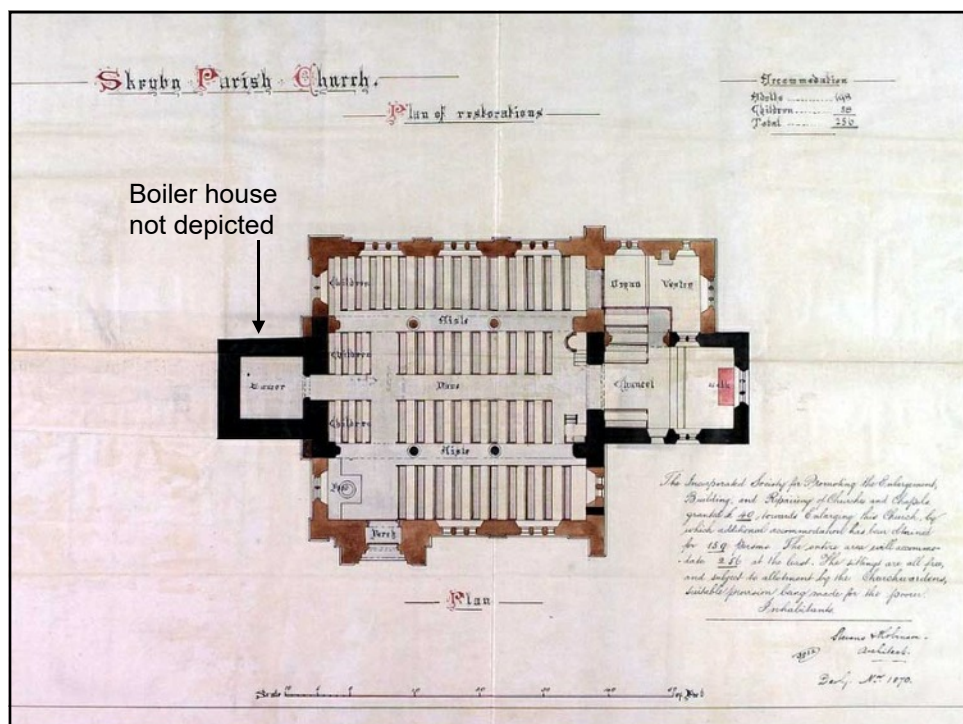
Figure 3: Architects plan for the restoration dating to 1870 (Southwell & Nottingham Church History Project 2026). Note that the boiler house is not depicted.
