**A Report on an Archaeological Evaluation**

**The Church of St Mary Magdalene, Keyworth, Nottinghamshire**

***JSAC 205/97/002***

**September 1997**

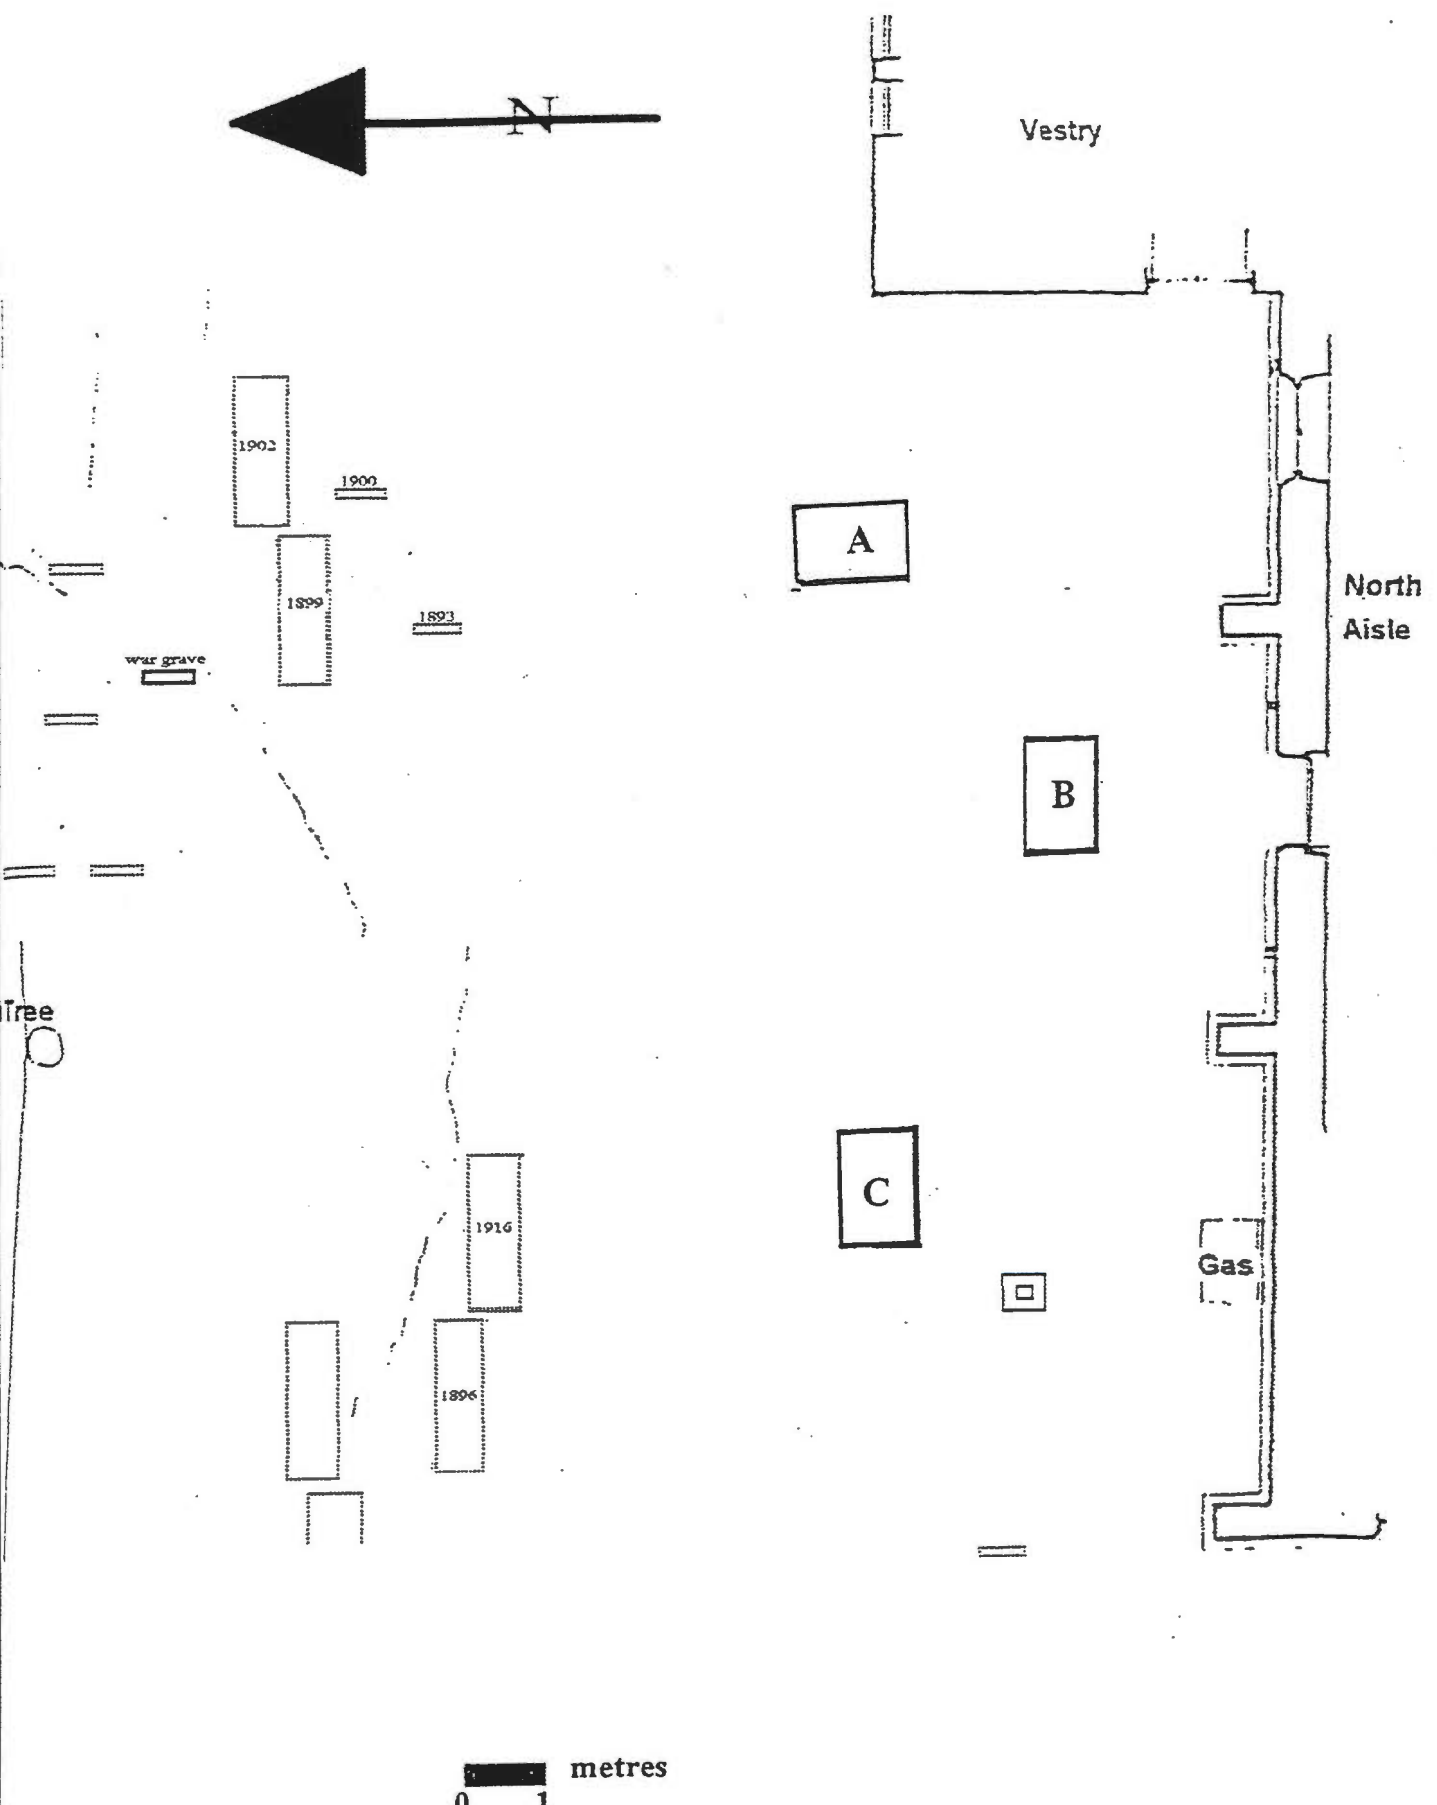
Figure 2 : Location of Excavation

- 3.1 All trenches were 1m x 1.5 m in plan and excavated to a depth of 1.10 m. The area of evaluation was all contained within a raised area of the church yard on the northwest side of the church. It is believed that this area has been landscaped in relatively modern times.

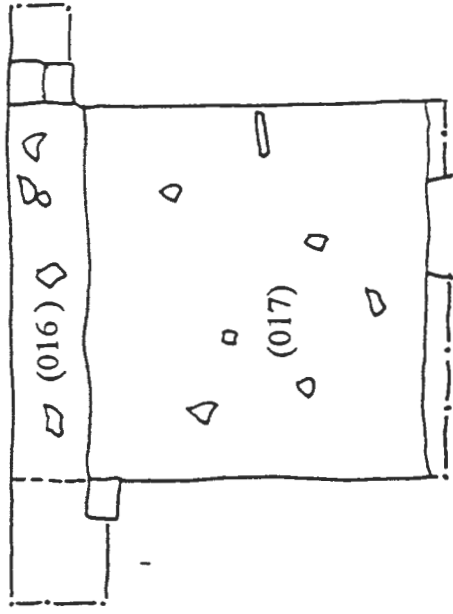
W SECTION OF EXCAVATION A

- 3.2 Trench A : Twenty five centimetres beneath the topsoil mortared brick work [020] was encountered. On excavation this was found to be the side walls of a brick lined burial vault. The whole of the vault was filled with a dark brown clayey silt which contained large quantities rubble material [017]. At the limit of excavation, 1.10 m, the surface of a small coffin [019] was exposed, possibly the burial of a child. The coffin was made of lead but had some wood adhering to its surface, indicating that this may originally have been a wooden coffin with a lead lining. The coffin was not disturbed during excavation.

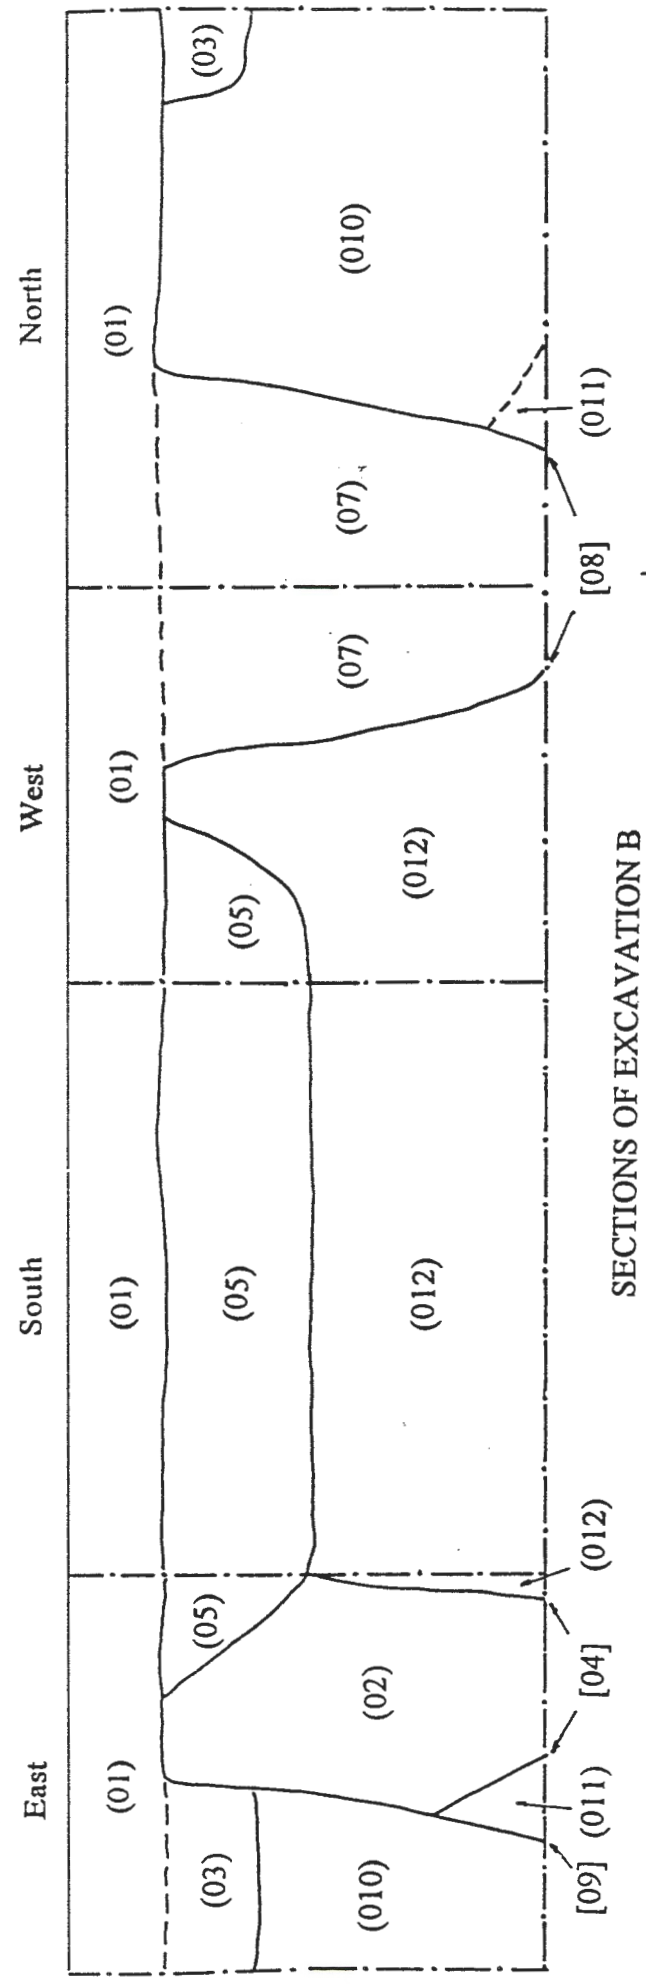
SECTIONS OF EXCAVATION B

- 3.3 Trench B : Within this trench 3 grave cuts were identified [06] [08] [09], no human remains were recovered in any of the grave cuts. The absence of human remains may be attributable to them having been removed during landscaping; as the fill of the grave cuts comprised redeposited materials.

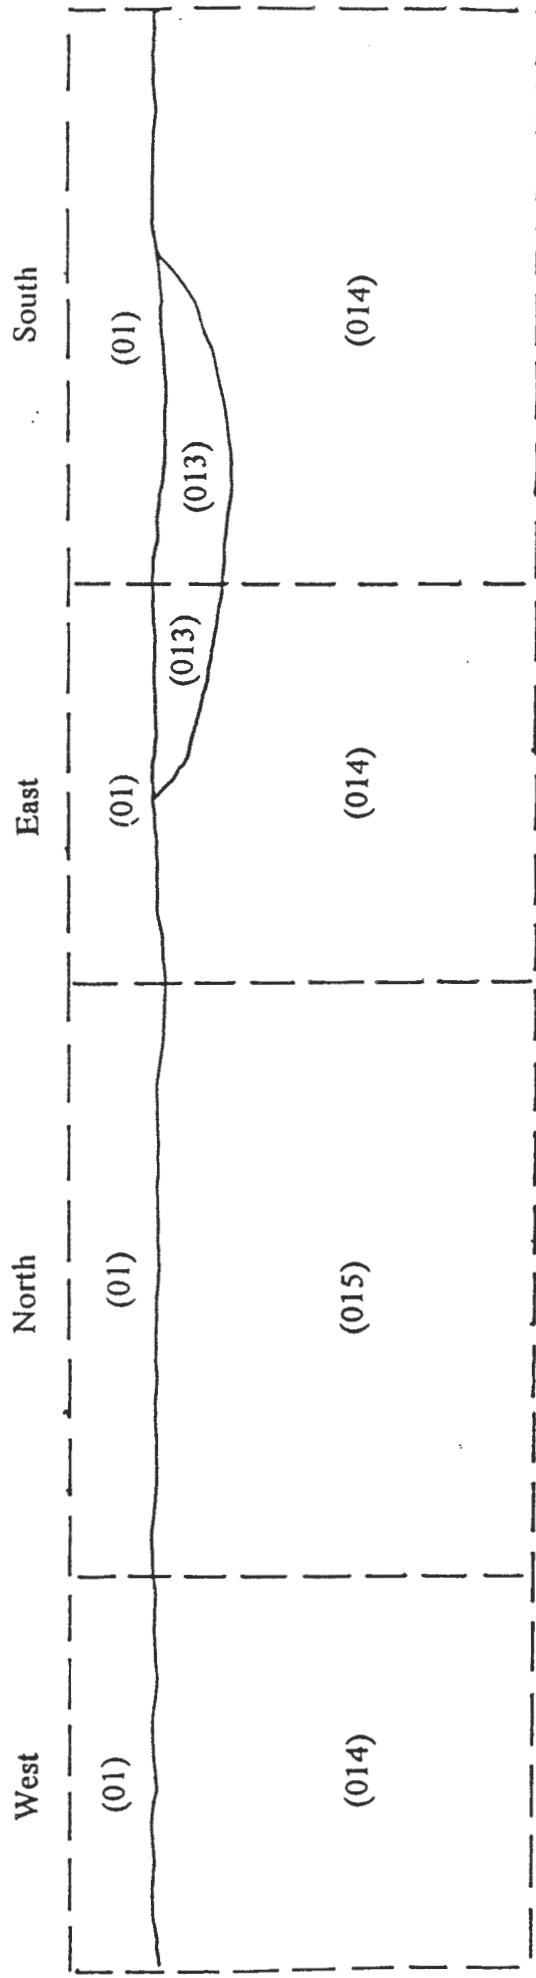
SECTIONS OF EXCAVATION C

- 3.4 Trench C : Beneath a covering of 0.25m of darkgrey/black clayey silt topsoil were three distinct redeposited soils [013] [014] [015]. These are believed to be the result of relatively modern landscaping activity.
